HISTORIC STRUCTURE REPORT

BRYN COED DAIRY FARM COMPLEX
1422 St. Matthews Road, West Vincent Township,
Chester County, Pennsylvania

October 2019

RICHARD
GRUBB &
ASSOCIATES

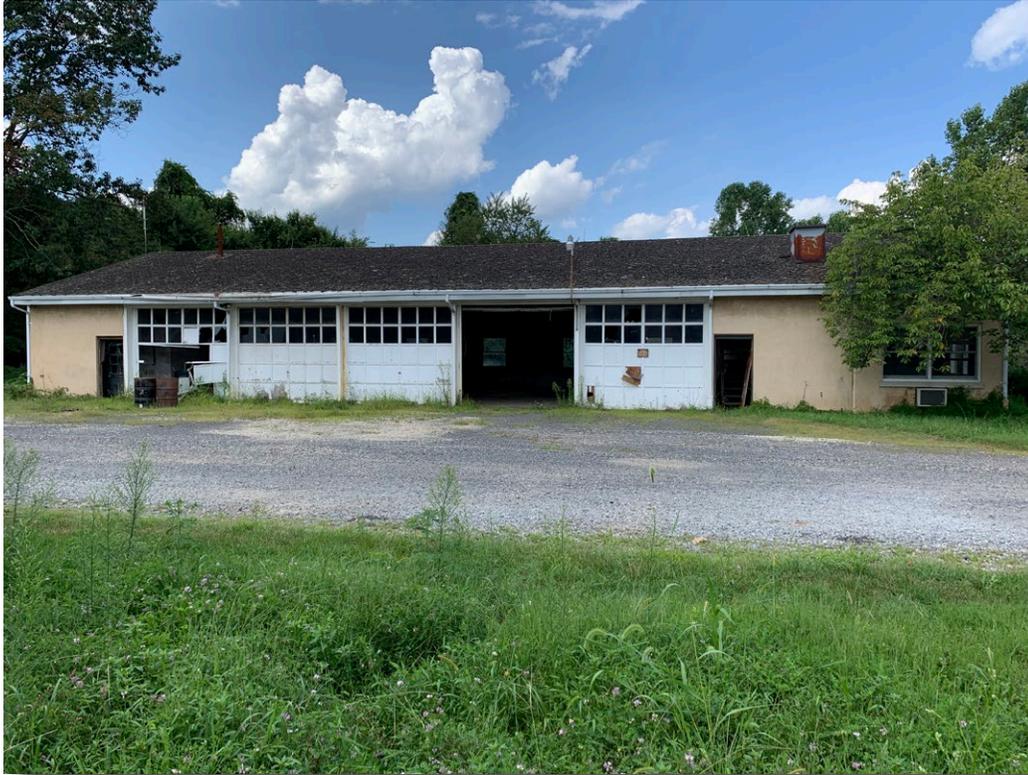
Plate 3.1: Building 1 Farm Office and Shop, main (south) elevation.

The building has an end-gabled roof clad with standing seam tin, with overhanging eaves on the north and south elevations but with flush eaves on the east and west end walls. A mechanical vent on the south slope east of center mimics a modern chimney. The main (south) elevation has eight bays and stucco-over-concrete block walls. Five contiguous bays feature overhead garage doors on this elevation, providing access to the primary interior space. The bays flanking the garage doors feature a metal hollow core door. The east bay contains a paired window unit that provides natural light to an interior office. The concrete walk mentioned above leads to a small porch on the east end, where a metal hollow core door opens between two sets of paired one-over-one double hung sash window units. The north (rear) elevation features eight windows with slightly protruding sills; the windows are one-over-one double hung sash units, some with simulated divided lights creating the appearance of eight-over-eight units. The west end is a solid stucco-over-concrete block wall. The building has a concrete foundation.

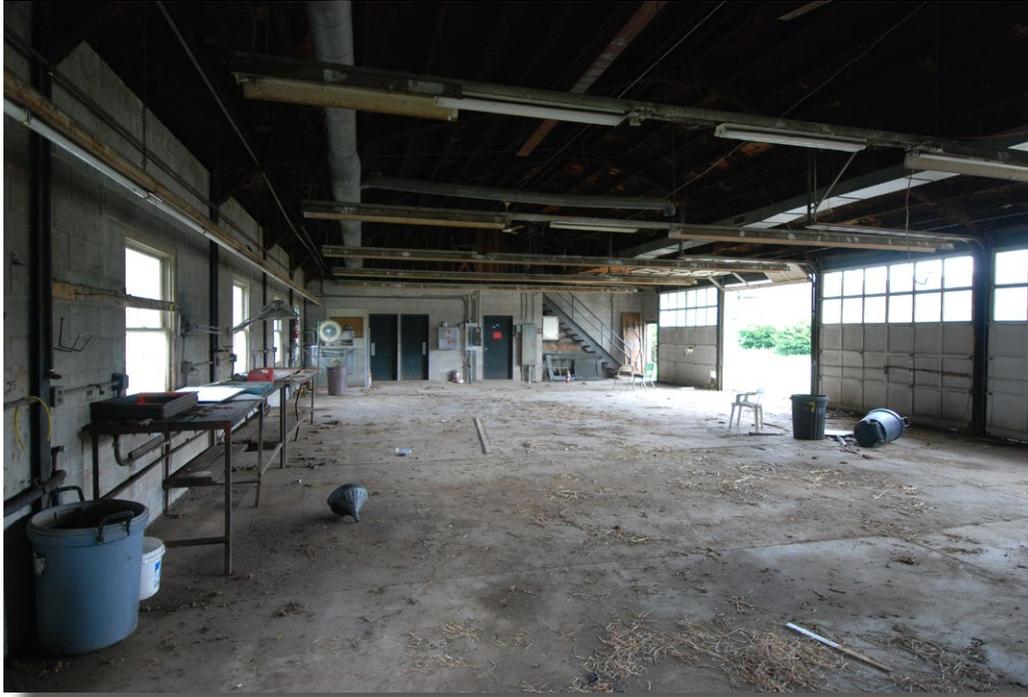
Plate 3.9: Building 1 Farm Office and Shop, main storage room.

Note, the door with the red sign leads to the offices, and the doors to the left access restrooms.

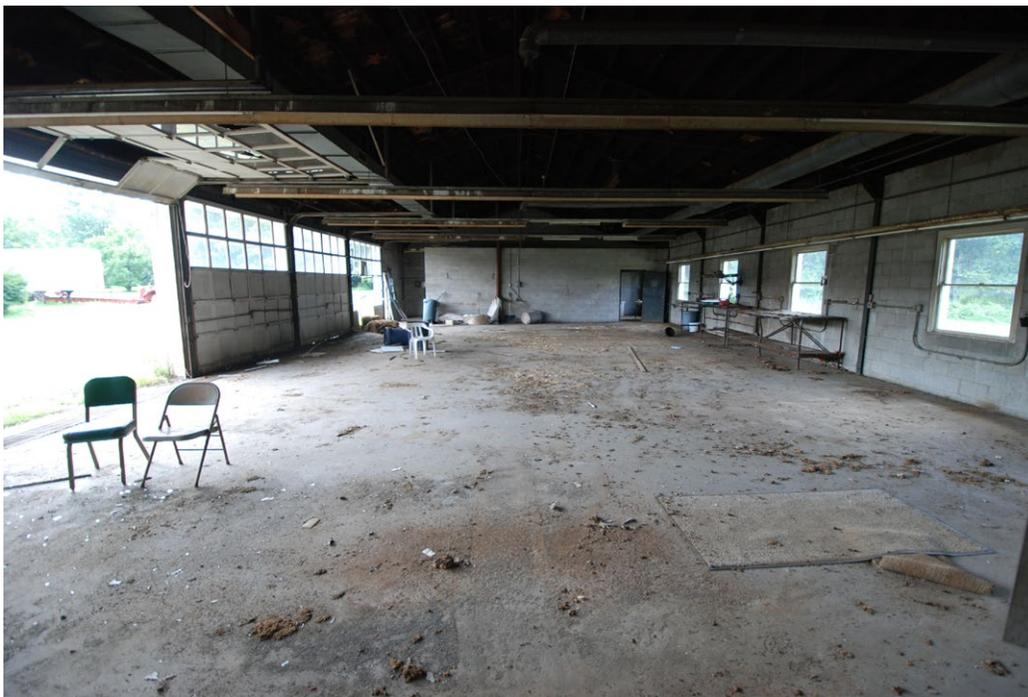
Plate 3.10: Building 1 Farm Office and Shop, main storage room.

Note, the metal hollow core door in the far right leads to the storage areas in the west part of the building.

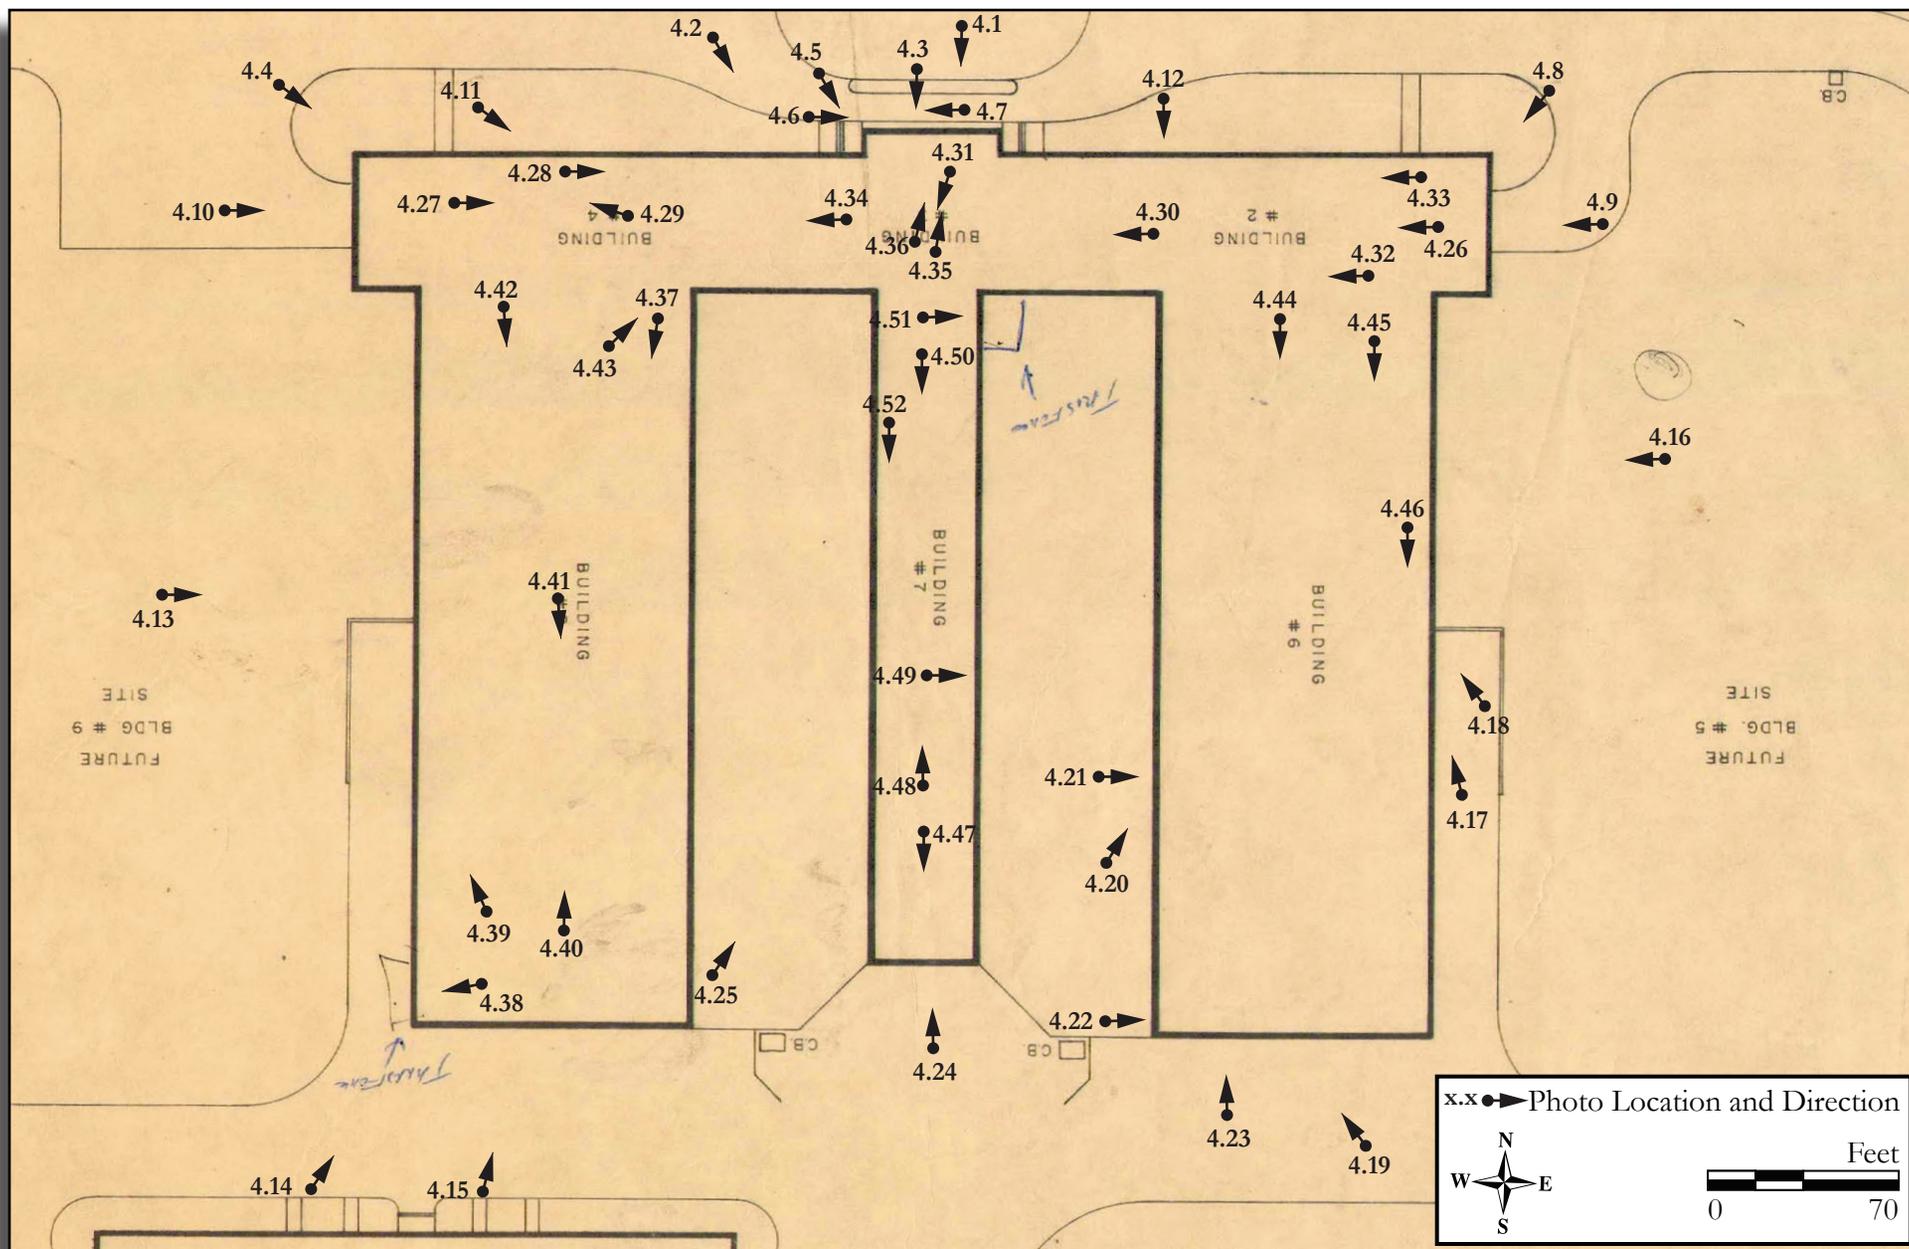
Figure 4.1: Main Barn Complex.

Due to the complexity of the building, the camera angles are plotted on a reduced version of the 1968 Eisenhower and Hunter plans for the main barn complex (see Appendix B).

The Main Barn Complex (Figure 4.1; Plates 4.1 to 4.25, exterior; Plates 4.26 to 4.54, interior) is an E-shaped building complex with the stem (composed of Buildings 2, 3 and 4) running east/west and the three prongs (composed of Building 6, to the east, Building 7 center, and Building 8, to the south) attached perpendicularly to the south side of the stem. Together they form one large building. Building 3 is the centerpiece of the complex, both visually and geographically speaking. Behind its portico decorated façade is the heart of the dairy farm: the milk finishing and storage facility. Buildings 2 and 4, which apiece measure some 180 feet, flank Building 3 and, as mentioned, form the stem of the E. These buildings contain processing operations and storage areas, as well as an observation V-shaped, tube like structures enabling managers to observe activities in these buildings, as well as those in Buildings 6, 7 and 8. The latter buildings are some 264 feet in length (Building 7, in the center, is 240 feet long). These building hold the milking stalls, hay storage areas, and cattle holding and loading areas. Concrete courtyards between these sections enabled the herd to venture outside of the enclosed environment, but in a confined area that, like the buildings, was equipped with waste removal system. All of the buildings exhibit essentially the same construction: slab floor with sanitary system gutters and auger systems, steel framed walls consisting of vertically spaced I-beams connected to the steel roof rafter and truss system overhead, cinderblock walls laid between vertical steel elements, and stucco-clad exterior walls. Each building contains a shallow-pitched gabled roof, with a ridge ventilation system and other means of HVAC.

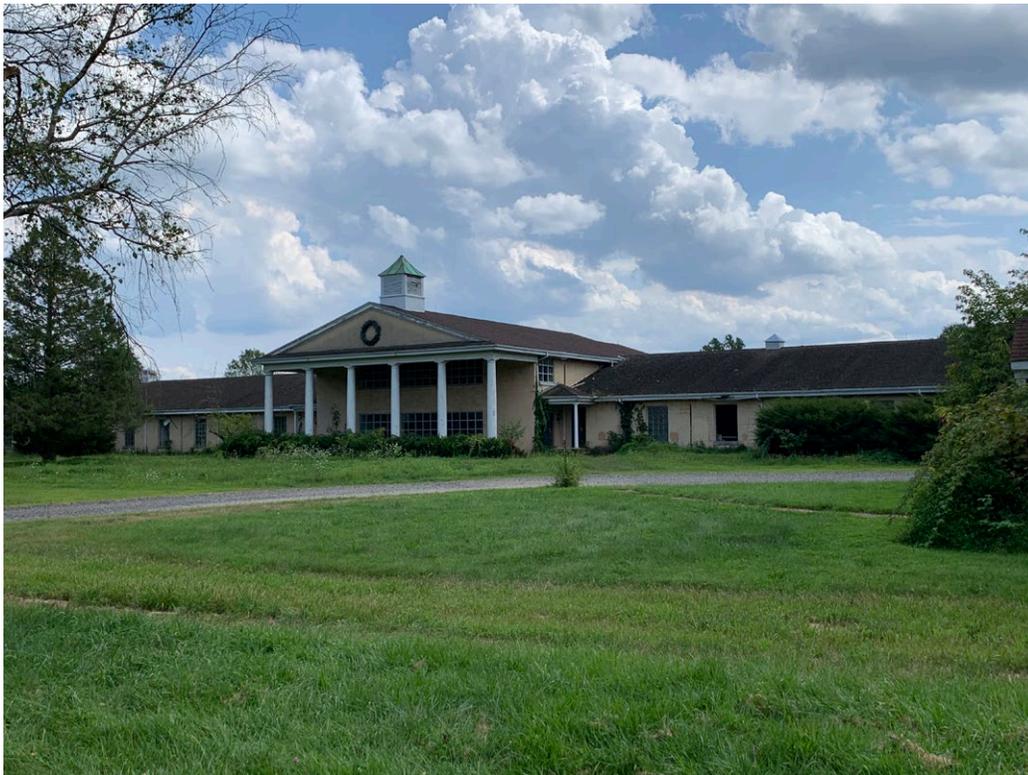
Plate 4.2: Front portico of Main Barn Complex (Building 3).

The front portico on Building 3 is part of a two-story cross-gabled section with overall measurements of 50 feet wide and 70 feet deep (Plate 4.2 and 4.3). This cross-gabled portico section has the highest ridge of the various parts of the Main Barn Complex. Near the front end of the ridge is a large cupola, which features a splayed pyramidal roof, louvers on the four sides, and a square base (Plate 4.5). The portico features a blank tympanum, molded cornice with return, and six unfluted wooden columns standing on a scotia base. The stuccoed wall surface below the tympanum consists of large window units comprised of Belgian block. On either side of the projecting portico, small porches provide access into the interior (Plate 4.6). The porches have hipped roofs supported by a single unfluted Ionic corner column. Each porch has one metal door leading into the interior of the portico section and a two-leaf entrance leading into the flanking wing. The porches are accessed by concrete steps on their north sides. The portico has a concrete foundation. On the wall of the portico over these small porches is a Belgian block window unit lighting the upper interior level.

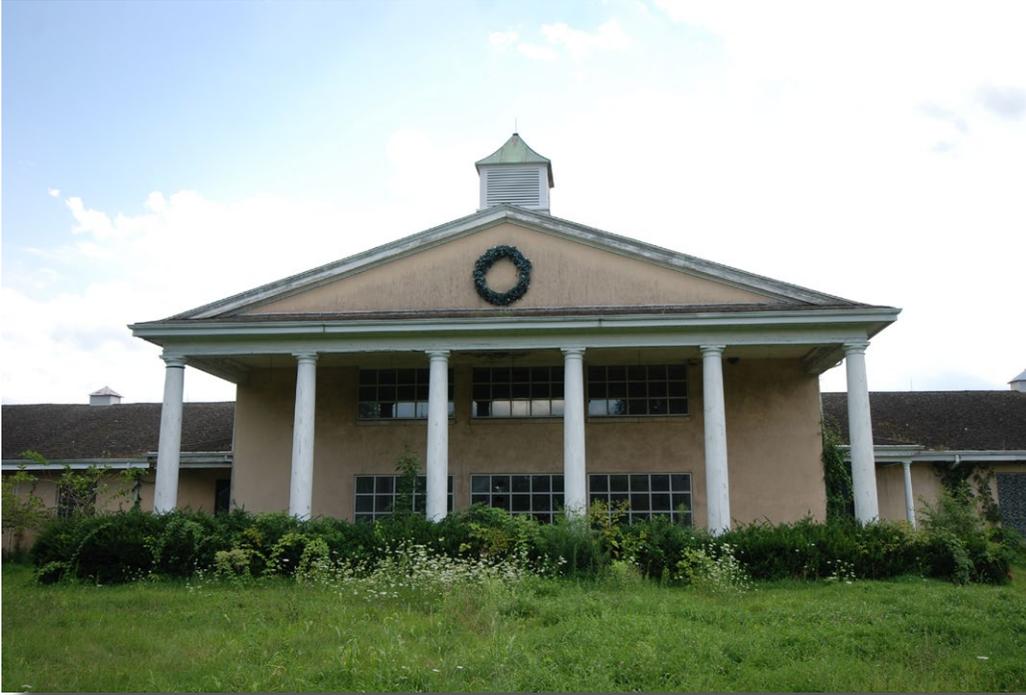
Plate 4.3: Front portico of Main Barn Complex (Building 3).

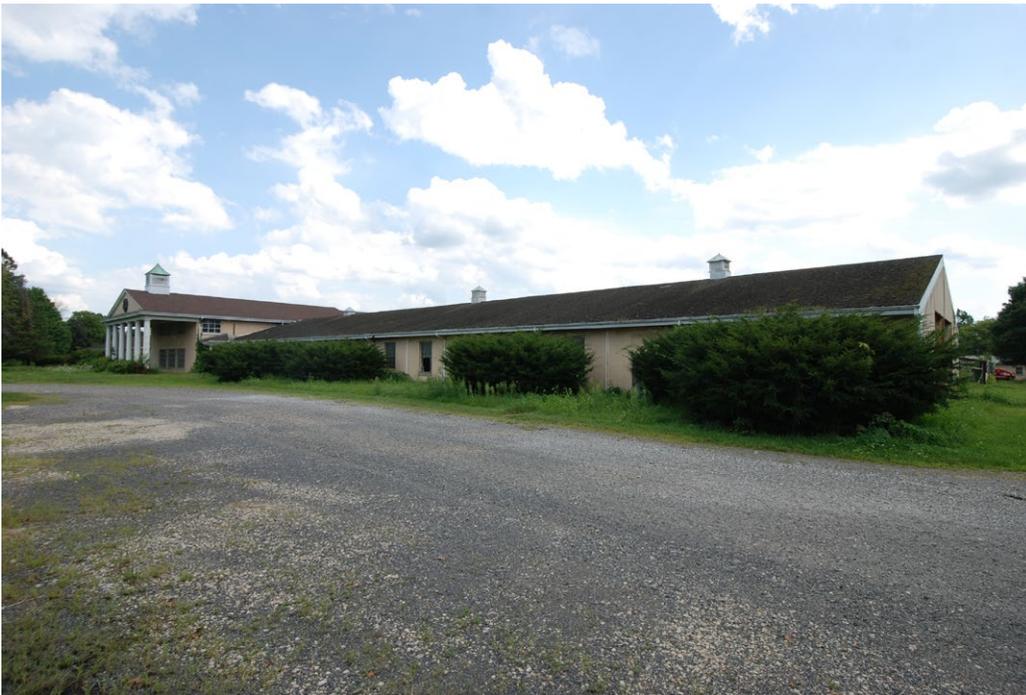
Plate 4.4: Buildings 3 and 4 of Main Barn Complex.

Buildings 2 and 4 flanking Building 3 are nearly identical and will be described together (Plates 4.4 and 4.8). Each wing measures 180 feet long and 50 feet deep. They are one-story elements clad with asphalt shingles on the roof and stucco over concrete block walls. Each wing has three small cupolas, each with a pyramidal roof, four louvered sides, and a slightly elevated base (Plate 4.11). The wings feature large Belgian block window units on the north elevation (Plate

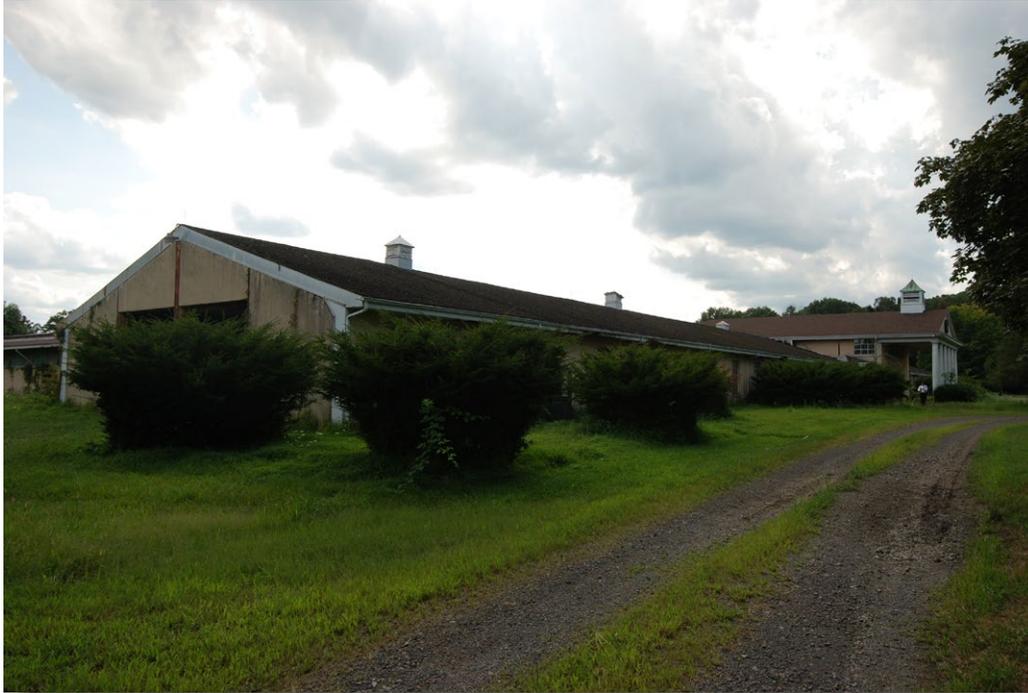
Plate 4.8: Building 2 (left) and Building 3 (right).

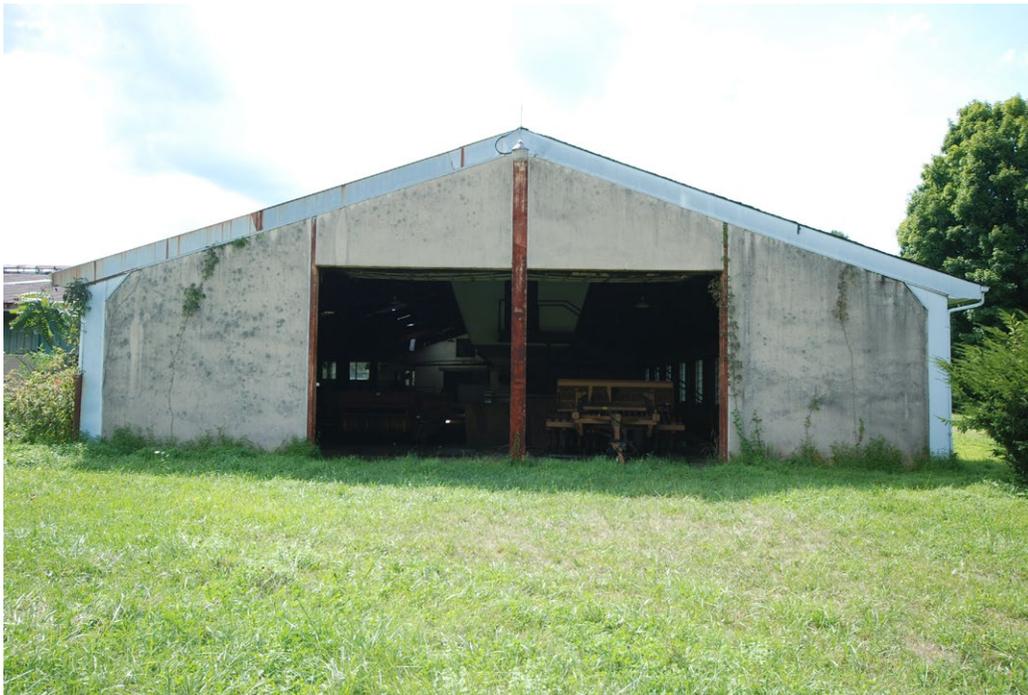
Plate 4.9: East end of Building 2, Main Barn Complex.

4.12). The end walls feature two large open bays that could be enclosed with large metal swinging gates (Plates 4.9 and 4.10). A steel I-beam separated the bays and connected with the ridge of the wings.

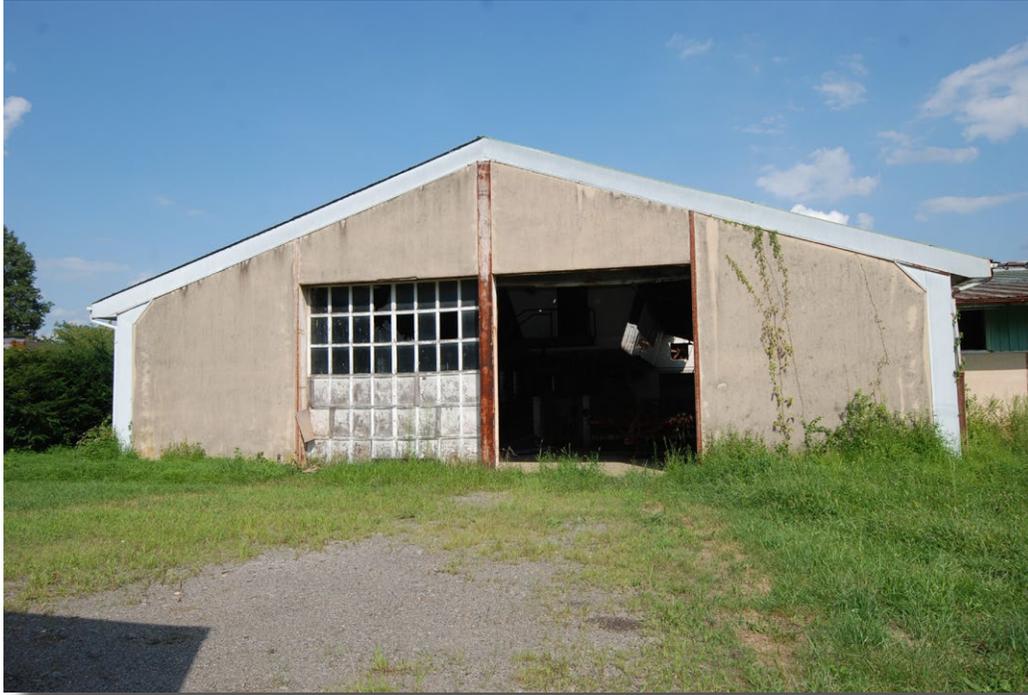
Plate 4.10: West end of Building 4, Main Barn Complex.

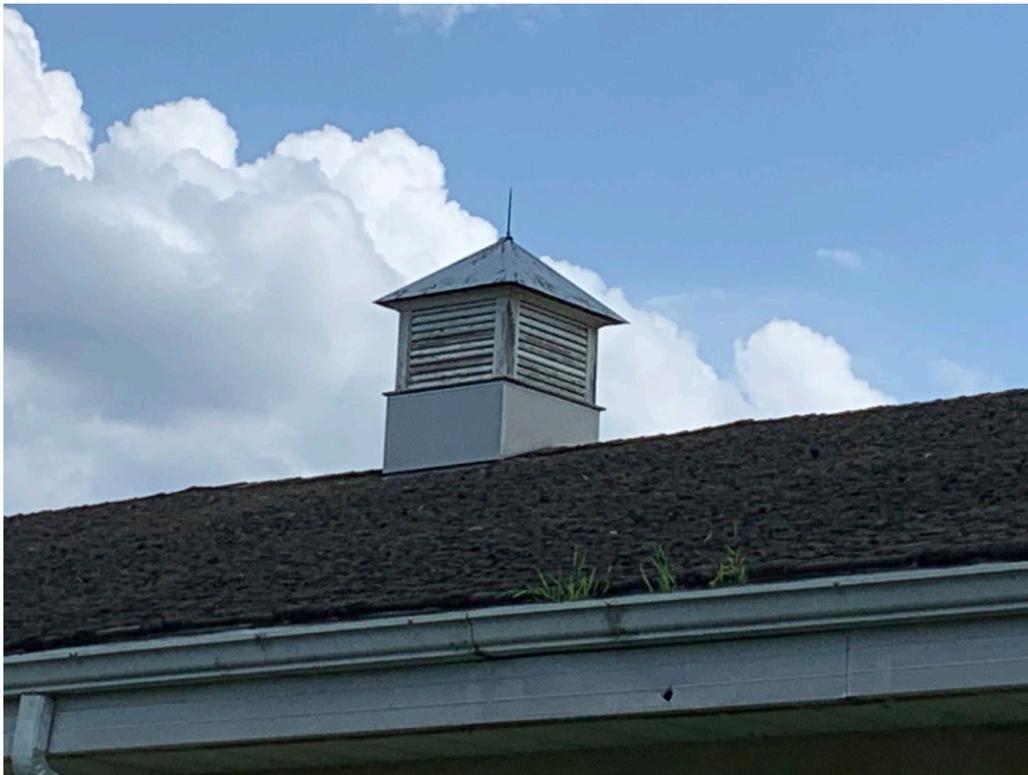
Plate 4.11: Small cupola on Building 4, Main Barn Complex.

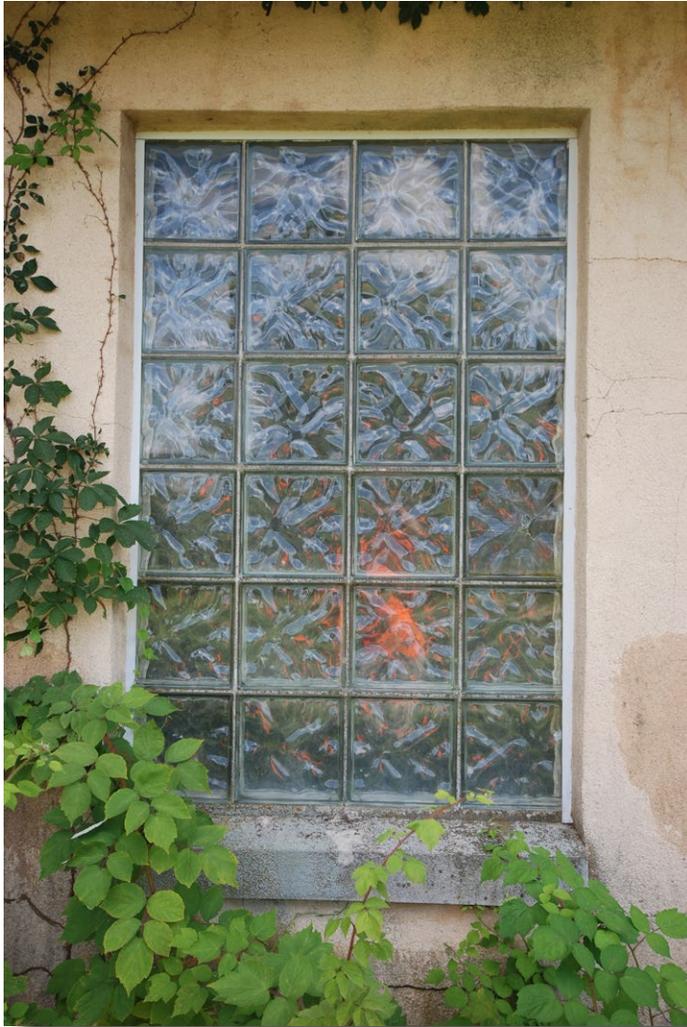
Plate 4.12: Belgian block window unit on Building 2.

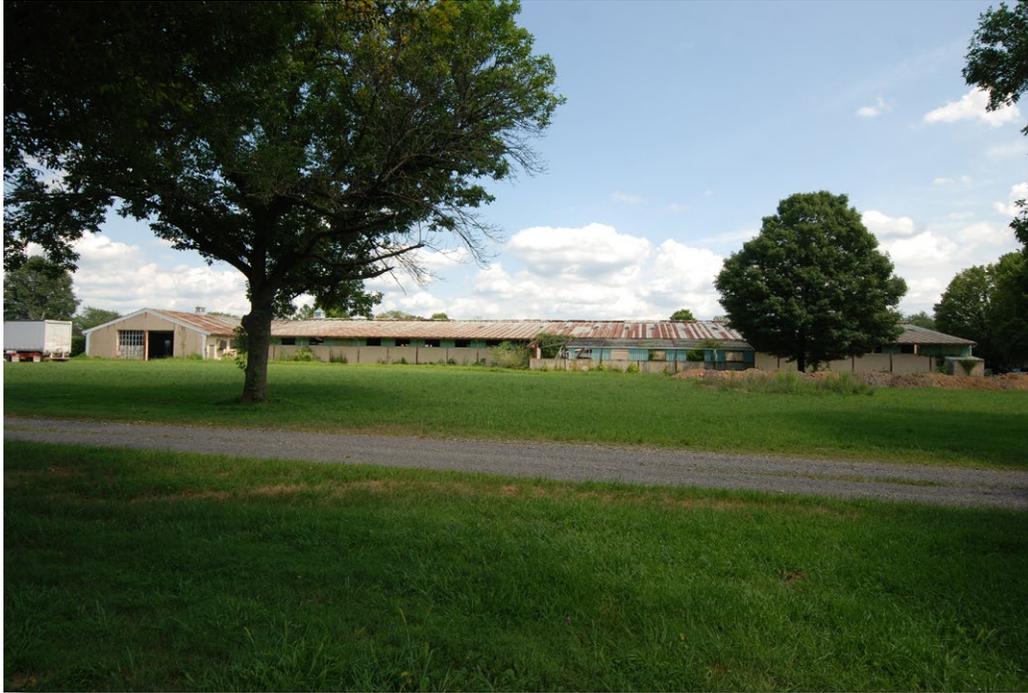
Plate 4.13: West elevation, Main Barn Complex, showing Building 4 (far left) and Building 8 (right).

Buildings 6, 7 and 8 extend from the south side of Buildings 2, 3 and 4. Buildings 6 and 8 are nearly identical in appearance and are described together with differences noted (Plates 4.13 and 4.16). The two wings are the main dairy wings of the entire complex, designed to produce the majority of the milk. These wings are larger than the center wing, and measure 264 feet long by 100 feet wide. The wings are set back 24 feet from the east and west ends of Buildings 2 and 4, thus slightly altering the overall E shape. The roof of the wings are clad with standing seam tin, including 22 areas where the tin has been replaced with opaque material to function as skylights for the interior. The overhanging eaves on the east and west sides are clad with vinyl. The wall surface is stucco-clad up to a height of approximately six feet. Above six feet are hopper panels just below the eaves (Plate 4.21). The hopper panels are located in a band of corrugated tin siding. The southern end of Buildings 6 and 8 feature four large open bays that can be sealed with overhead garage doors (Plates 4.15 and 4.19). Two, two-panel metal hollow core doors are located on the end walls for use when the garage doors are closed to limit access to the exterior by the cows (Plate 4.23). On the sides of the two wings near the southern end, wide rolling metal doors face onto the concrete courtyard between the wings and the center wing (Plate 4.22). Both wings have a concrete foundation.

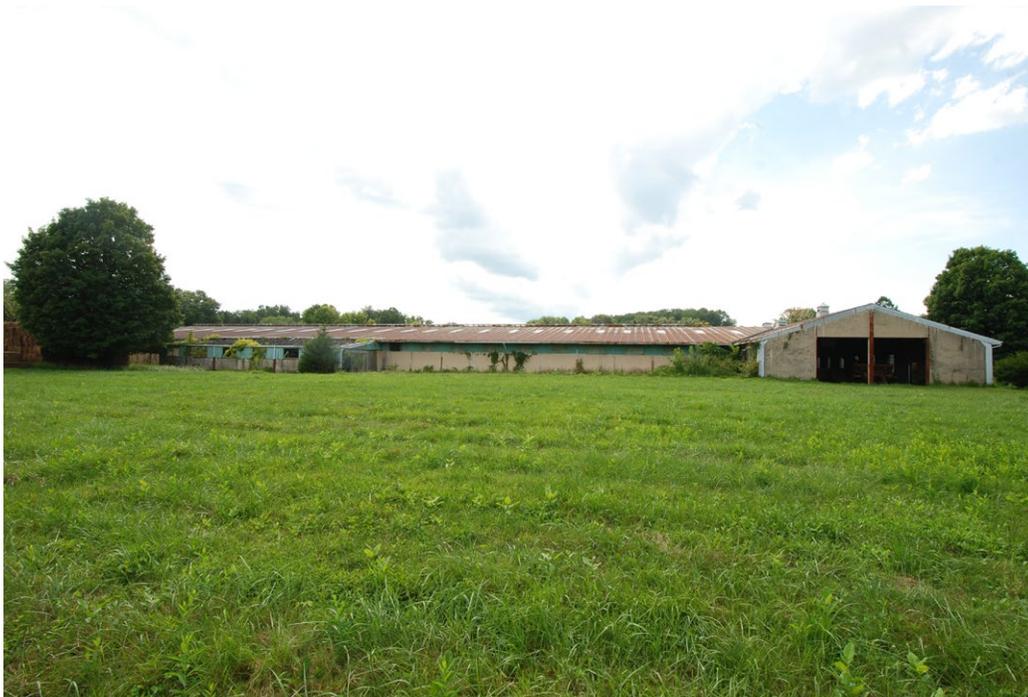
Plate 4.16: East elevation of Main Barn Complex, showing Building 2 (right) and Building 6 (left).

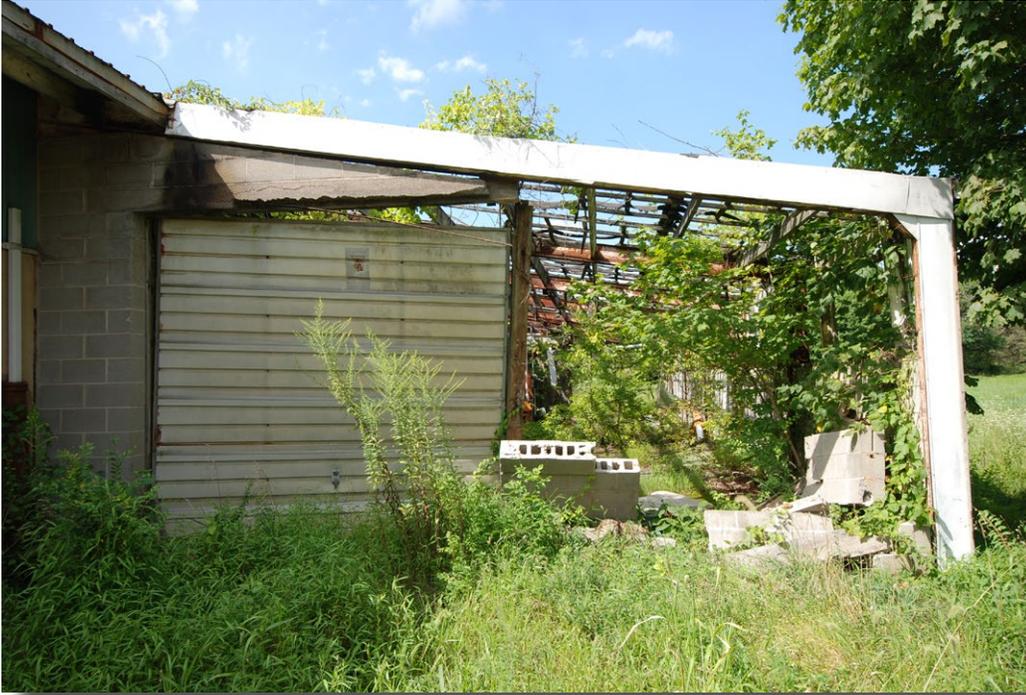
Plate 4.17: South elevation of east appendage on Building 6.

Appendages that were added onto the east elevation of Building 6 and the west elevation of Building 8 were used in part to pump manure from the buildings. Unlike the main buildings, both are in a state of ruin (Plate 4.17). These additions have overall measurements of 70 by 24 feet. They have a shed roof clad with corrugated tin and a steel frame. Overhead garage doors off the rear wings are located over a waste trough that leads into these appendages. Manure pumpers were located in the appendages, and the pumper remains in the appendage to the east (Plate 4.18). The framing for the western appendage has mostly collapsed, leaving it in a ruinous state. The eastern appendage is in slightly better condition, although the concrete block south wall has collapsed and most of the roof is missing.

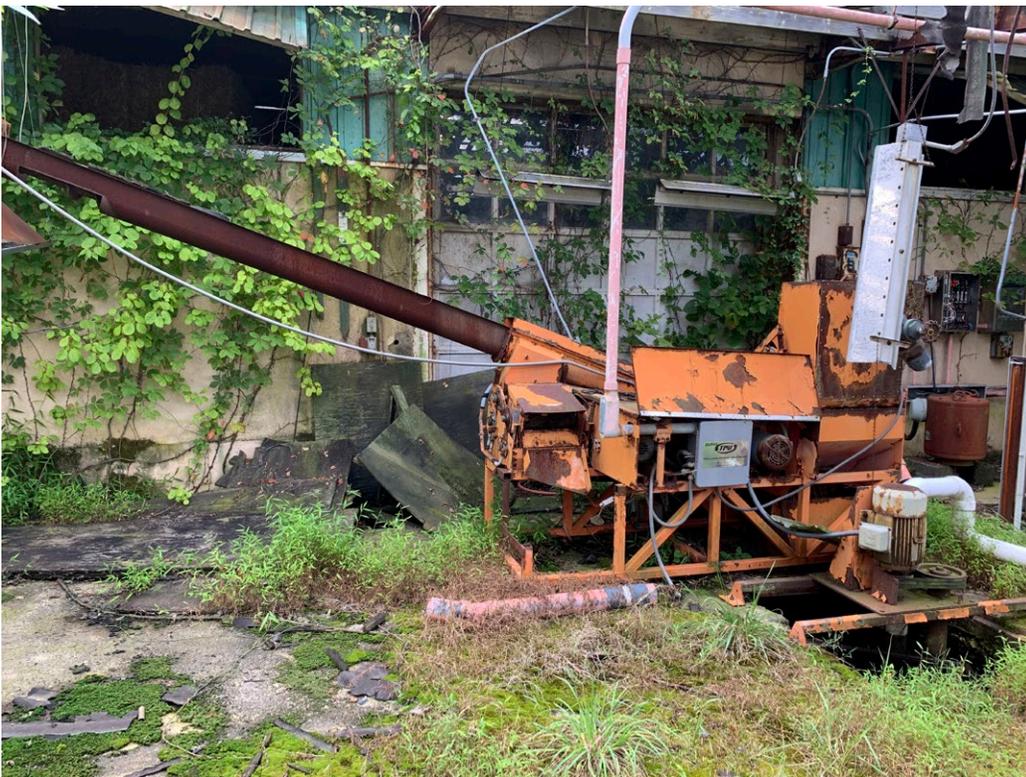
Plate 4.18: Manure pumper in east appendage.

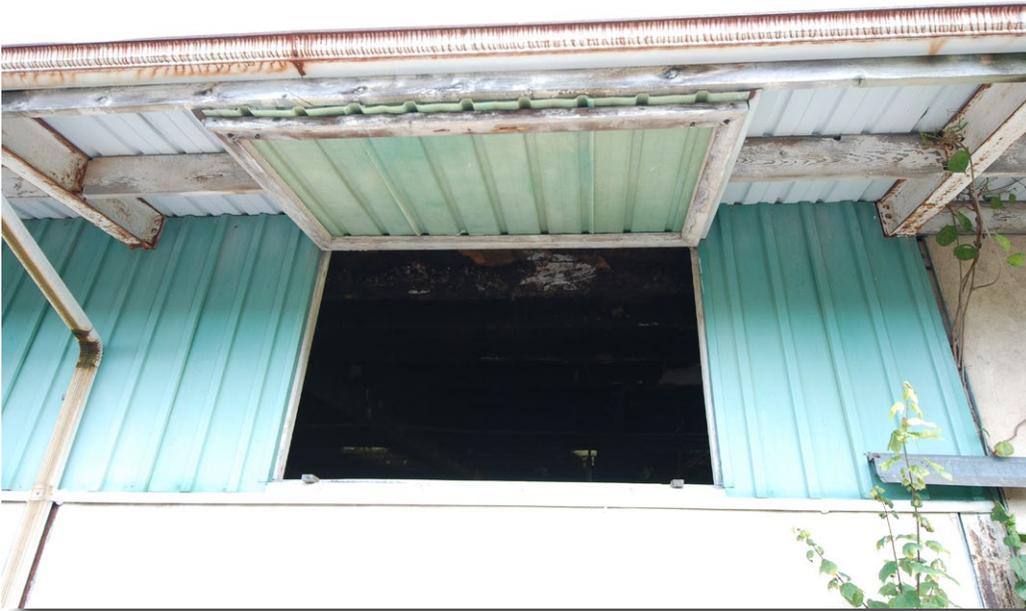
Plate 4.22: Metal rolling door on west elevation of Building 6.

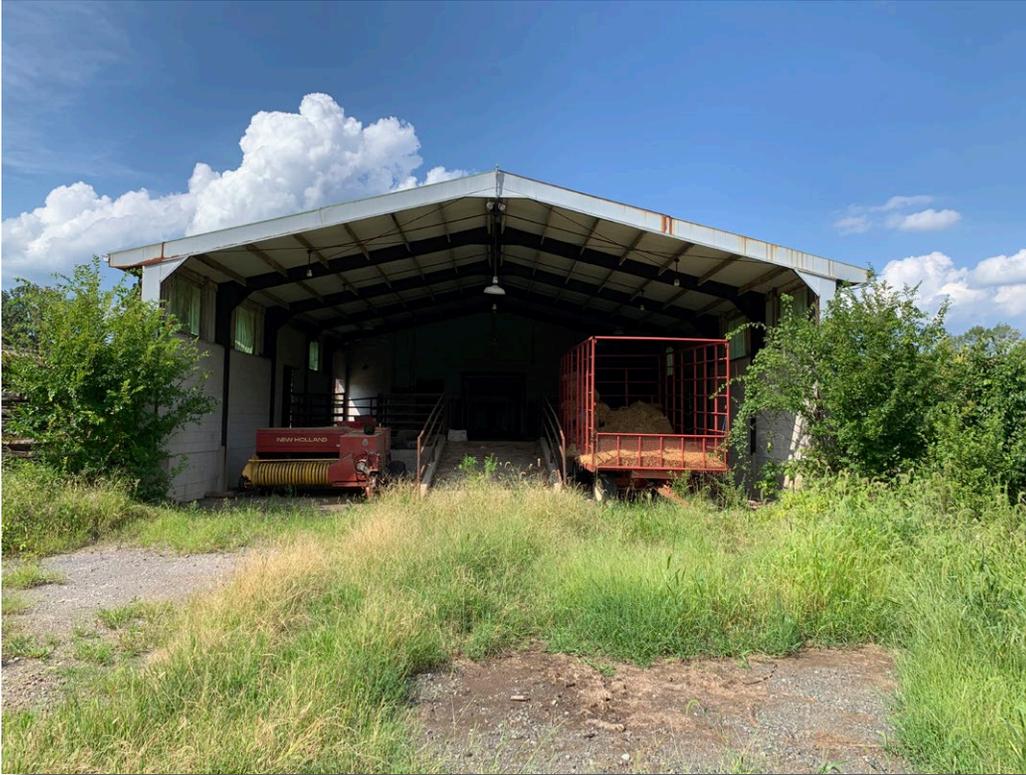
Plate 4.24: South elevation of Building 7.

The center prong of the E, Building 7, is a one-story section that extends south from Building 3 (Plate 4.24). Building 7 is smaller than Buildings 6 and 8 (220 by 40 feet), show animals were housed here. The center wing has a gabled roof clad with standing seam tin, with overhanging eaves on each side wall. Steel I-beams divide the exterior into bays, most of which contain large windows comprised of Belgian block. Each side wall has a wide rolling door near the center that accesses the concrete area connecting with the adjacent wings. The south end of the center wing features a large open bay with a center ramp leading up to the floor level and flanking storage areas for farm equipment. An iron railing lines the ends of the ramp and the elevated dock area on the main floor level. The interior contains stalls for the show cattle as well as the engine room at its north end. The southern end of Building 7 contains an open bay and a centered ramp that was used for moving cattle in and out of the building.

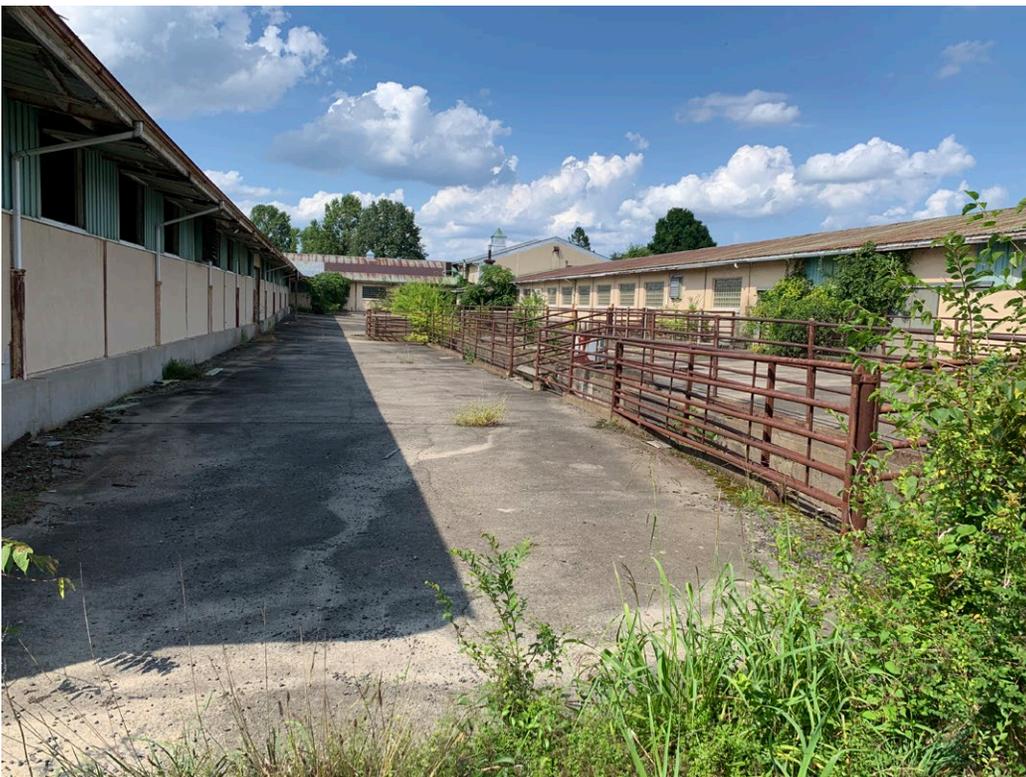
Plate 4.25: Concrete area between Building 8 and Building 7.

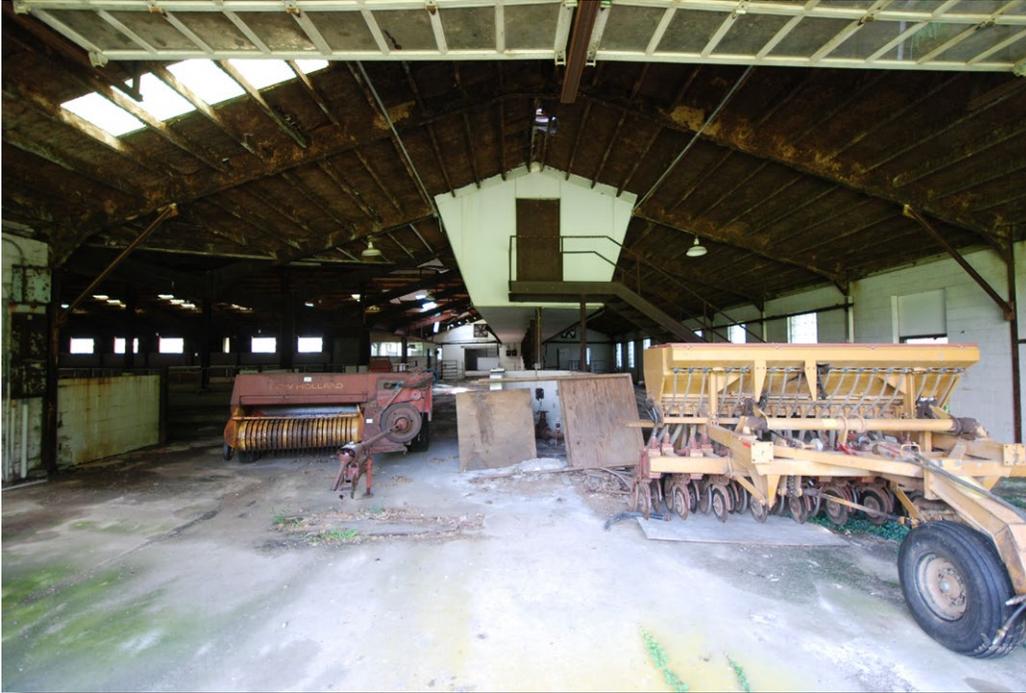
Plate 4.26: Interior of Building 6, as viewed from the bays on the east end.

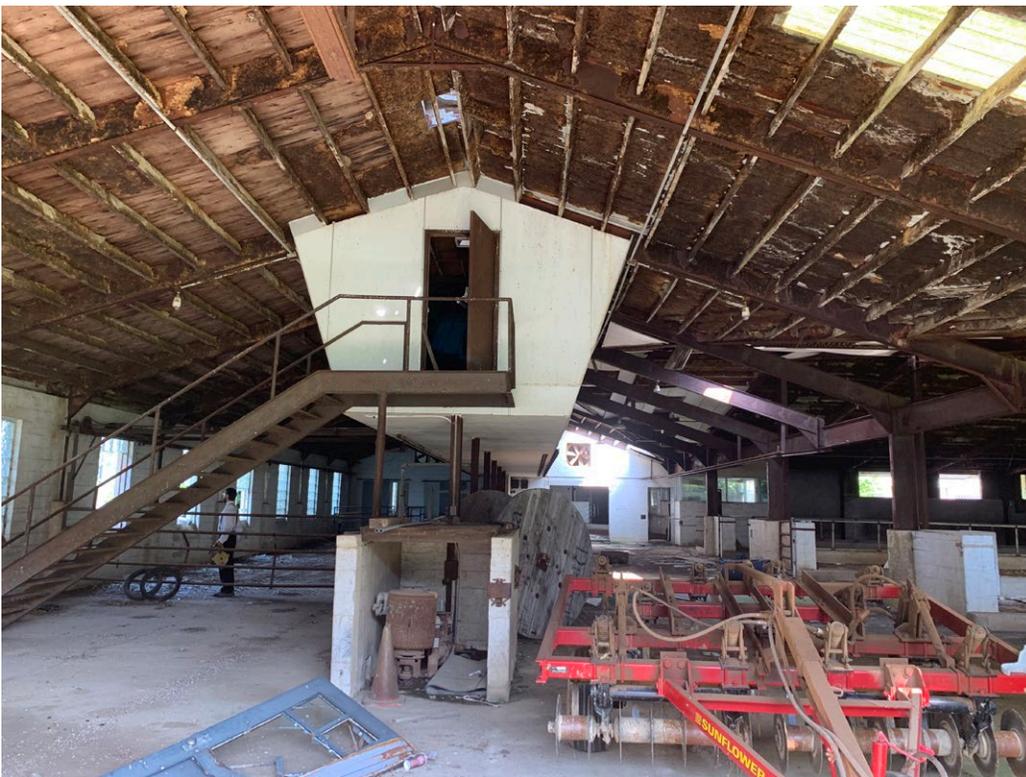
Plate 4.27: Interior of Building 8, as viewed from the bays on the west end.

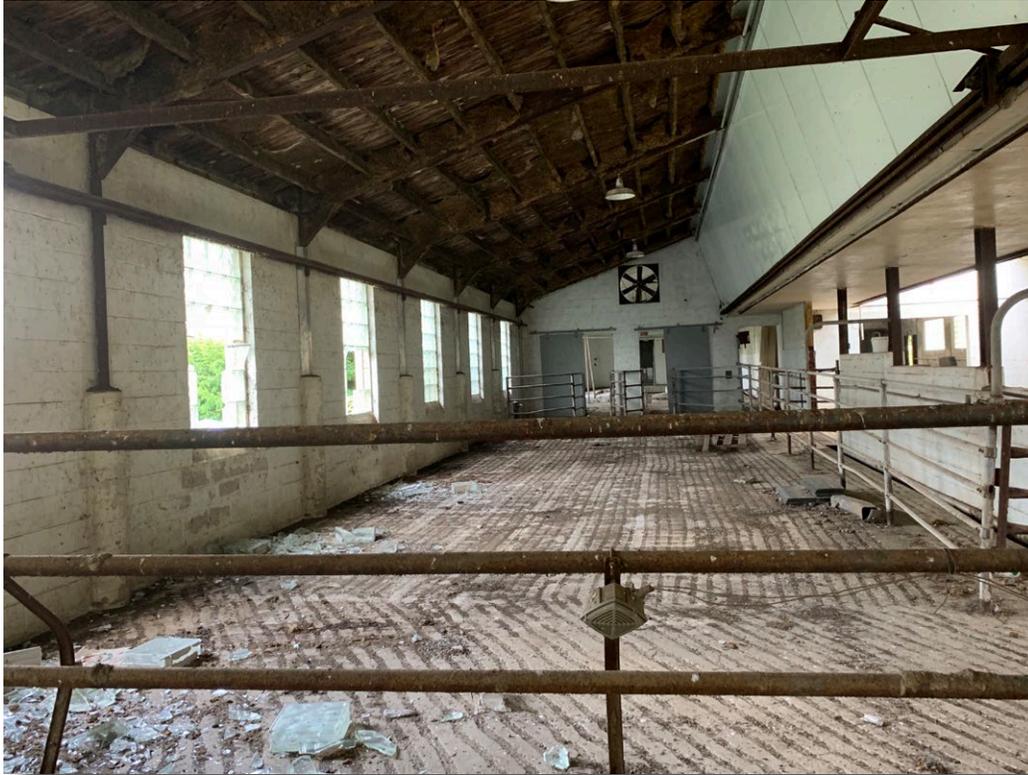
Plate 4.28: Bull pen in Building 4.

Note, the elevated observation area does not have windows facing into the bull pen.

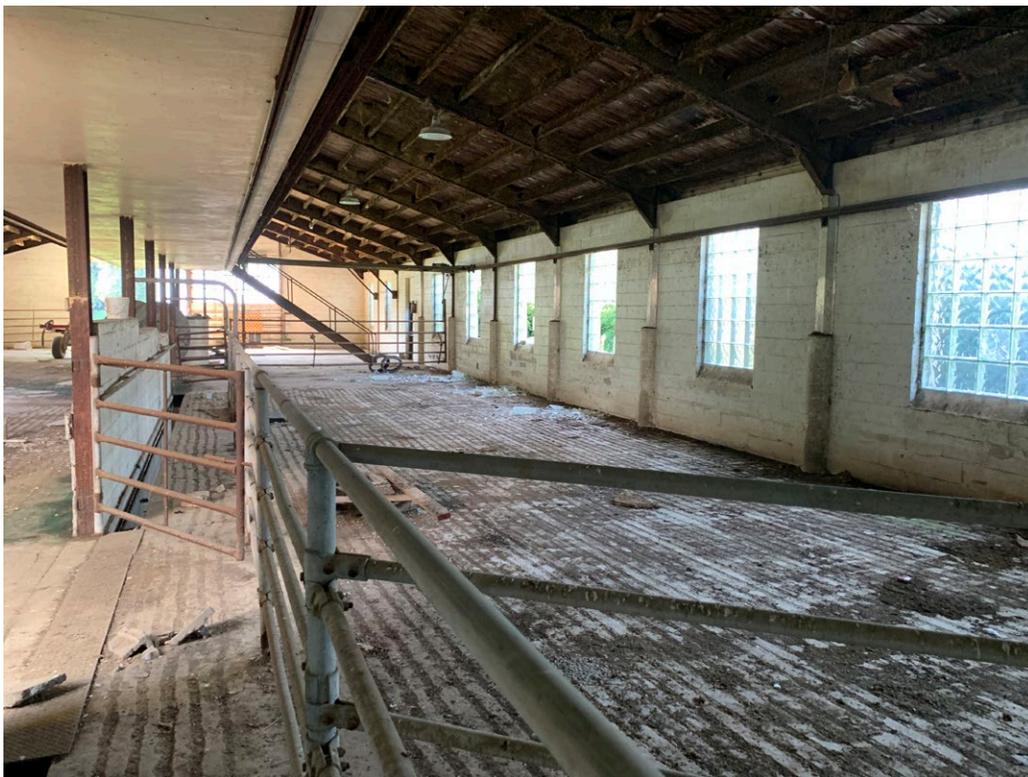
Plate 4.29: Bull pen in Building 4.

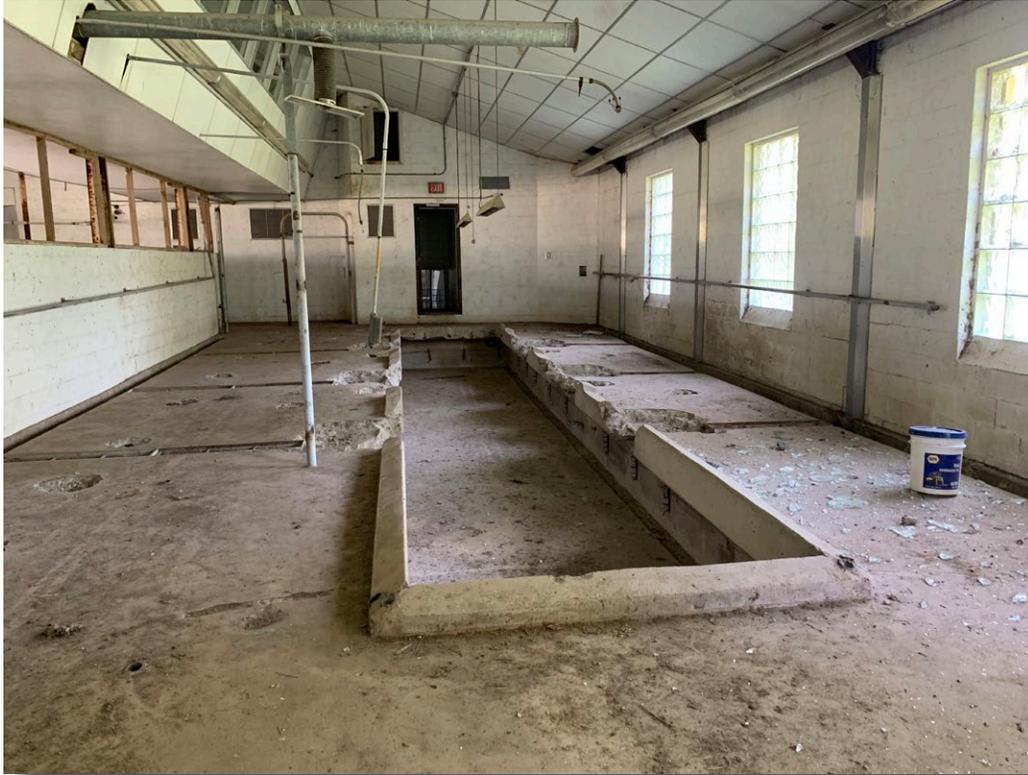
Plate 4.30: Eastern space of Building 2 with recessed center area.

Note, this area may have been intended for castration of bulls.

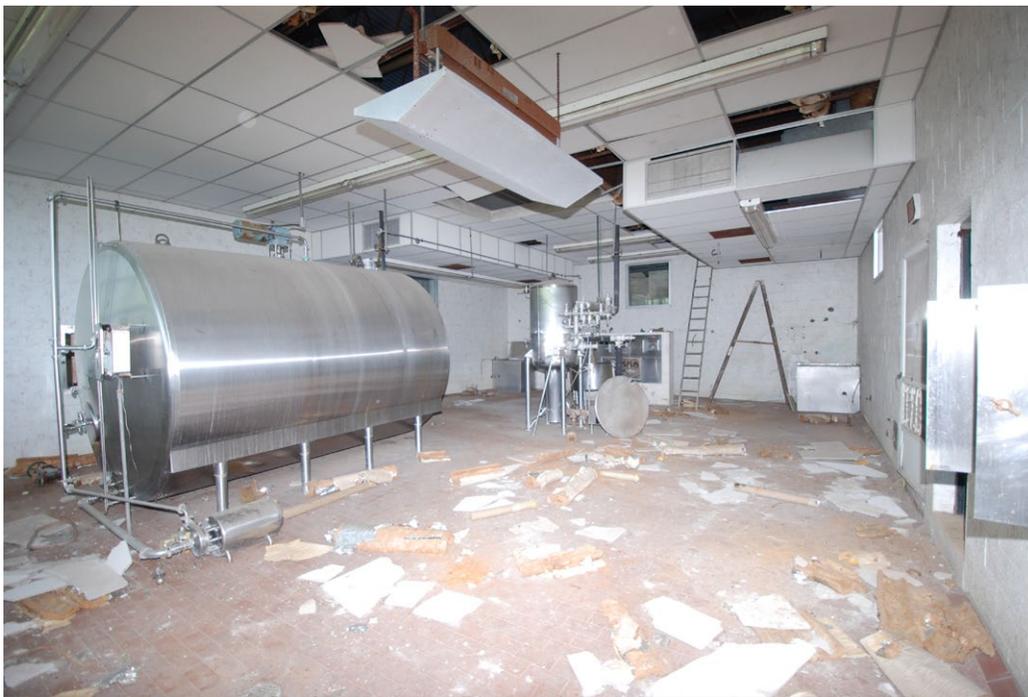
Plate 4.31: First floor room in center of Building 3, showing the large milk tank.

Note, this is one of the few rooms in the barn with a drop ceiling.
