HISTORIC STRUCTURE REPORT

BRYN COED DAIRY FARM COMPLEX
1422 St. Matthews Road, West Vincent Township,
Chester County, Pennsylvania

October 2019

RICHARD
GRUBB &
ASSOCIATES

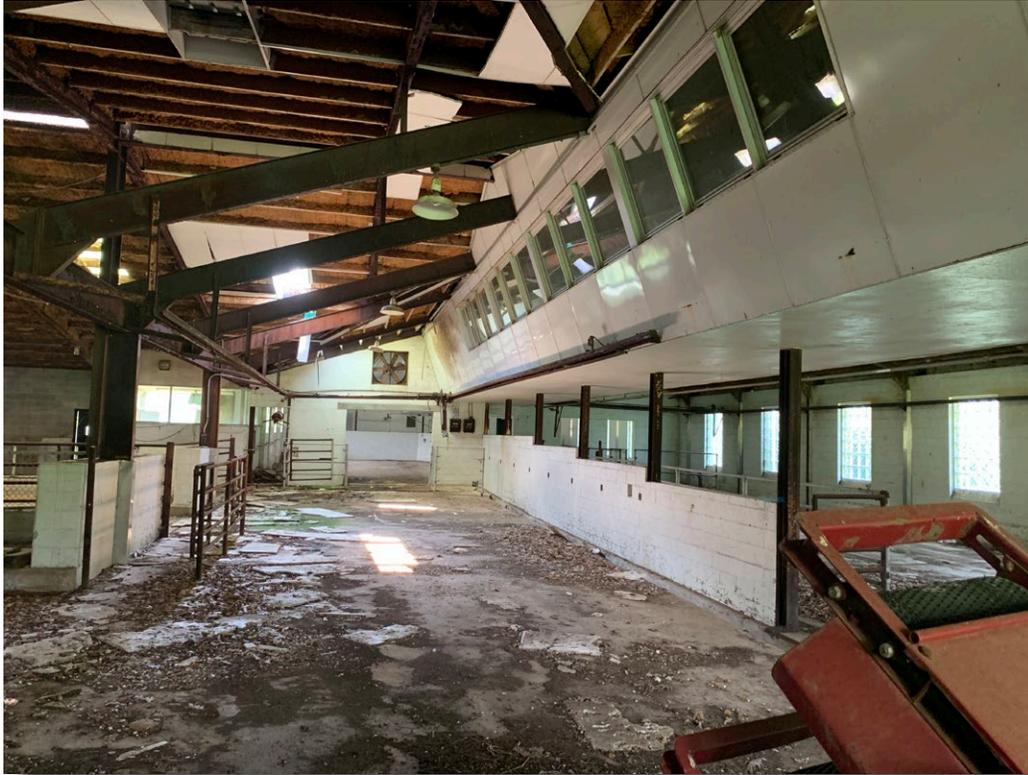
Plate 4.32: Passageway along south side of Building 2, showing the elevated observation area over the bull pen (left) and the stall area (right).

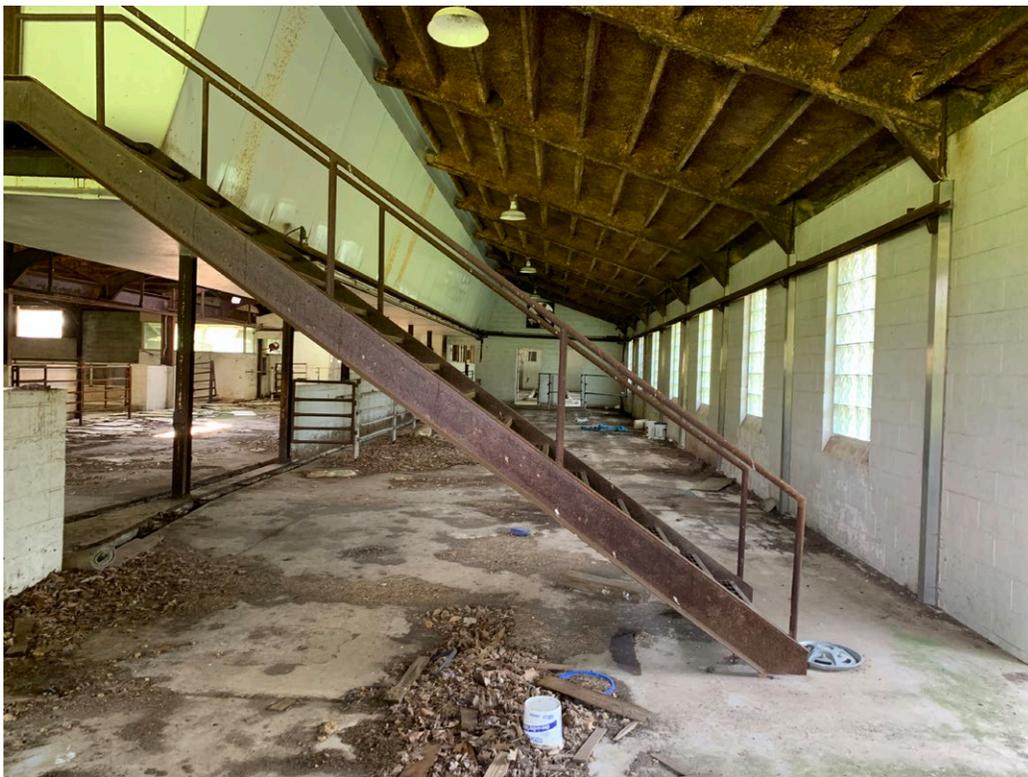
Plate 4.33: Set of metal stairs accessing the east end of the elevated observation area, Building 2.

Note, a similar set of stairs is located on the west end of the elevated observation area.

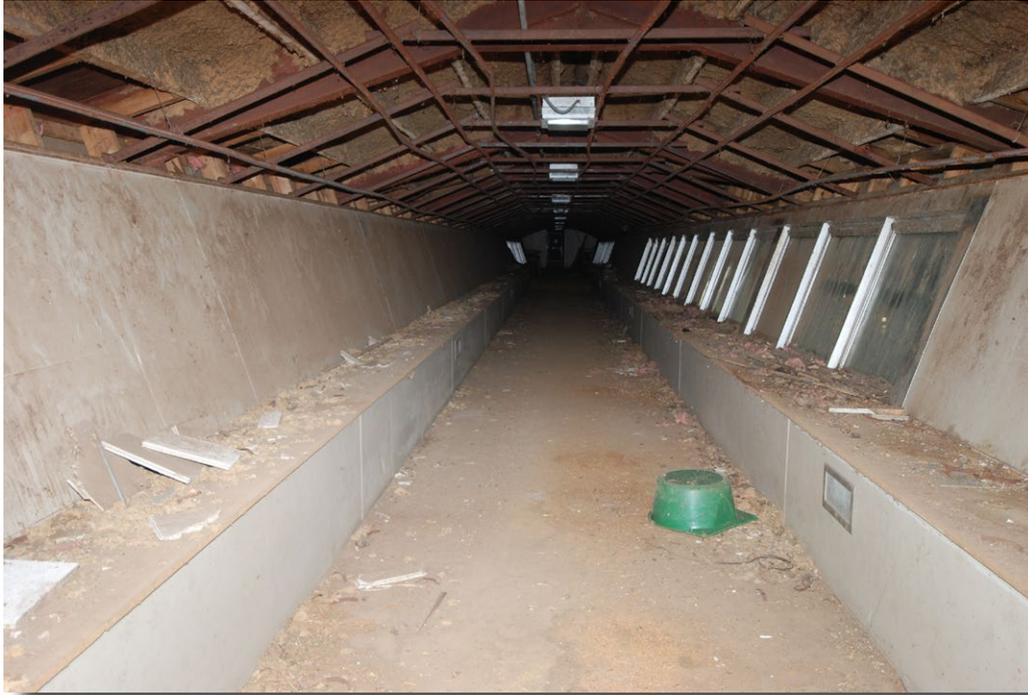
Plate 4.34: Interior of the elevated observation area, as viewed from the entrance off the second floor room in Building 3.

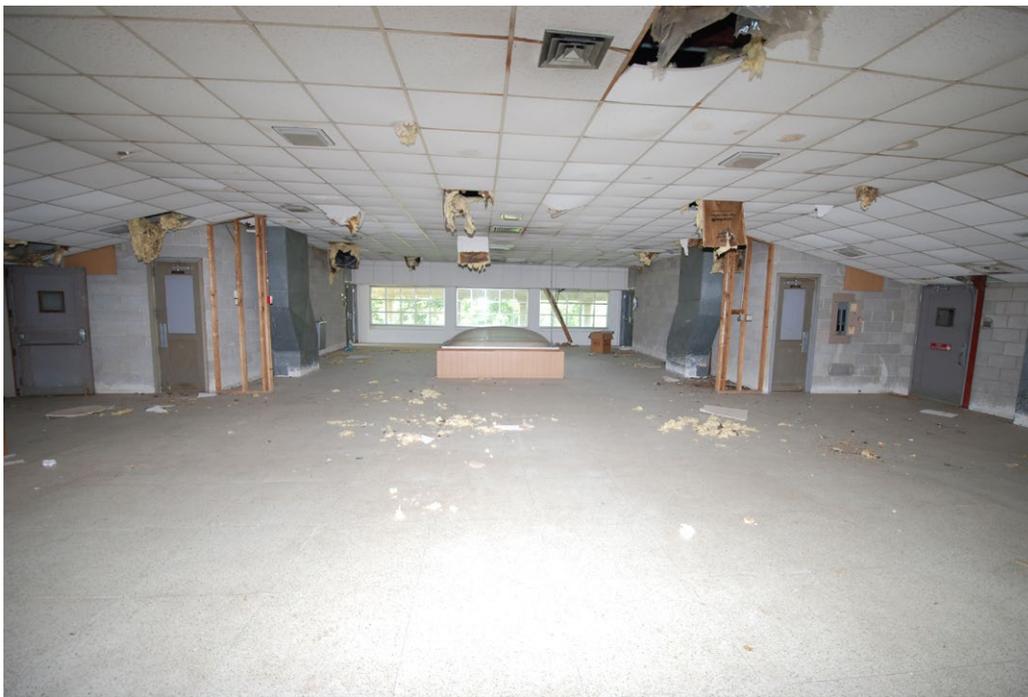
Plate 4.35: Second floor room in Building 3.

Note, the three windows in the center face into the portico.

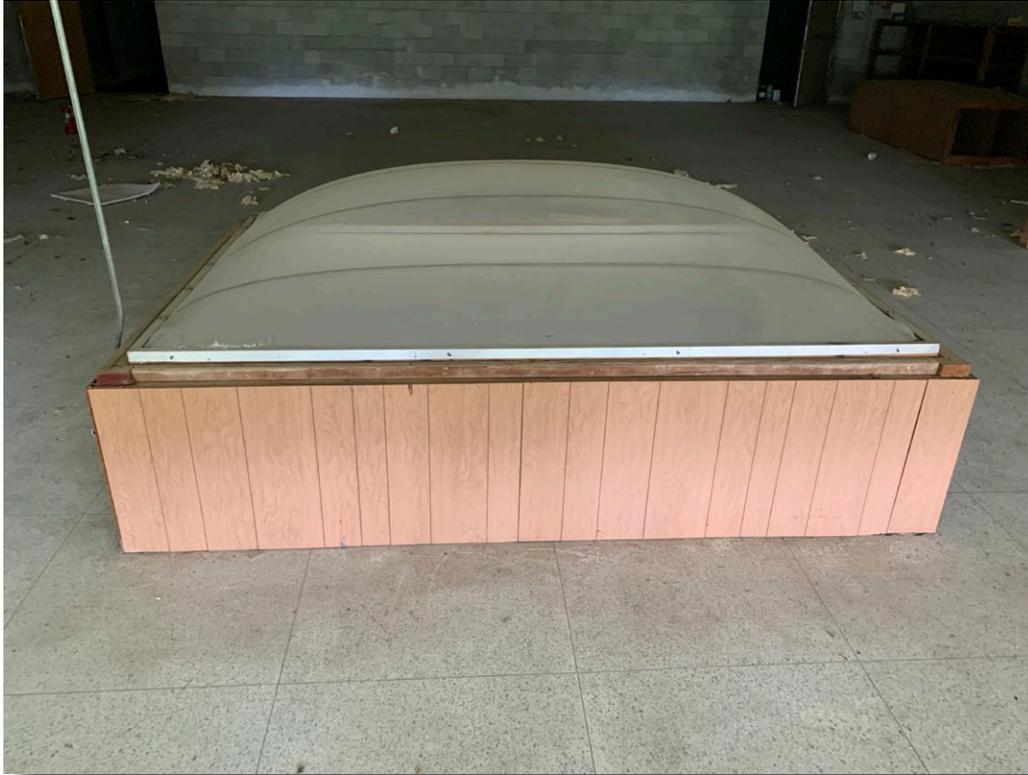
Plate 4.36: Opaque plastic element that admits light into the milk room below, Building 3.

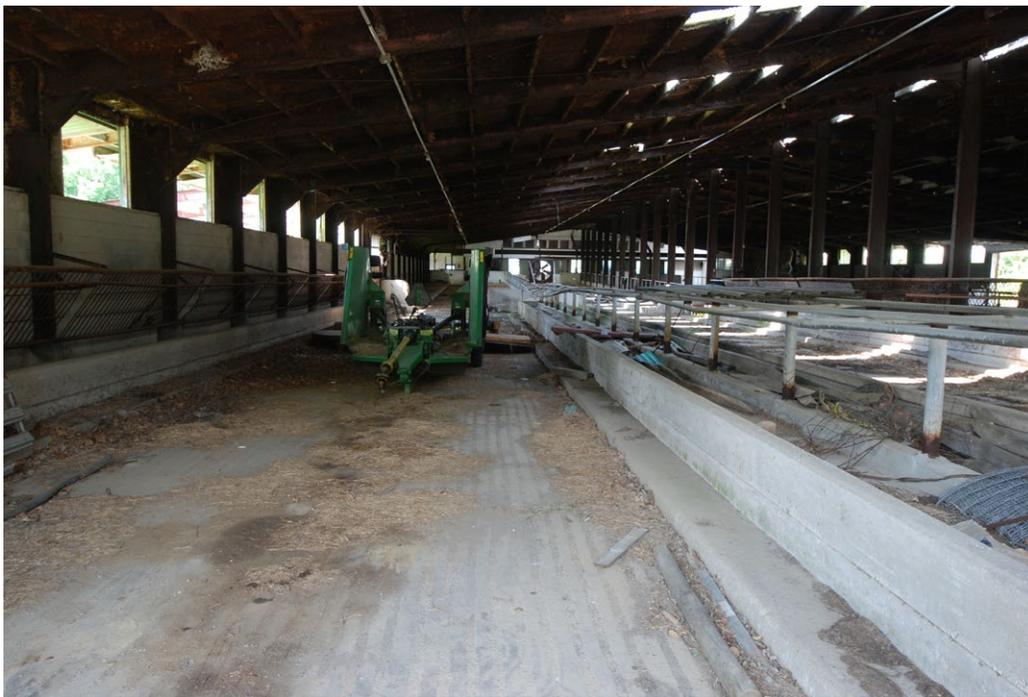
Plate 4.37: Building 8, as viewed from the north.

Note, hay was fed to the cows using the metal grates to the left, with a trough for grain below the hay. Water flowed through the trough on the right.

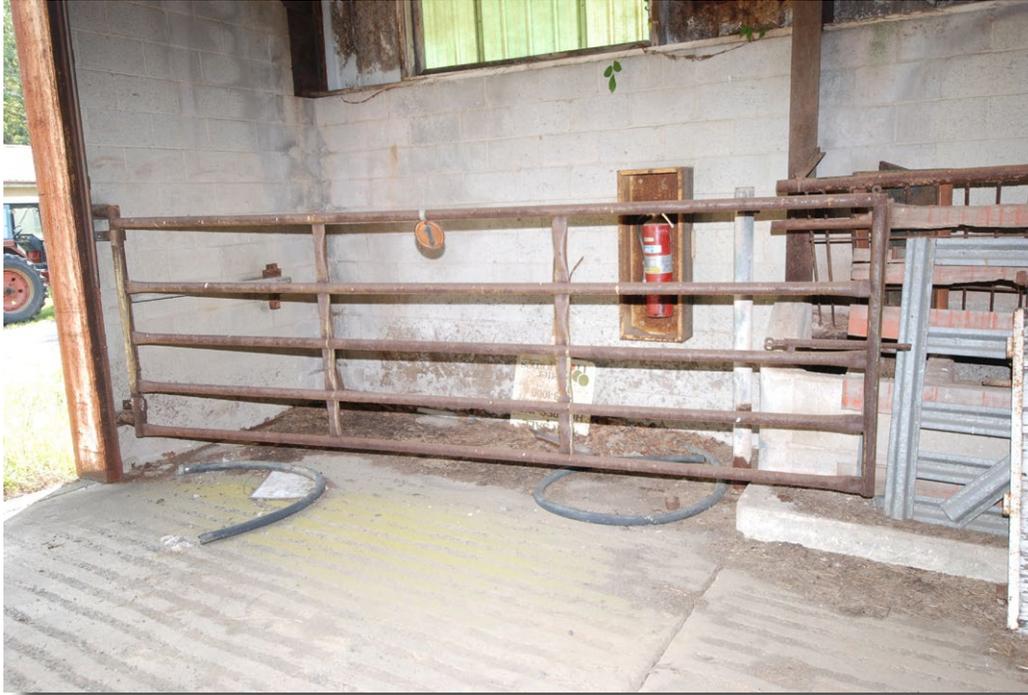
Plate 4.38: Metal gate in southwest corner of Building 8, originally used to seal the large open bay.

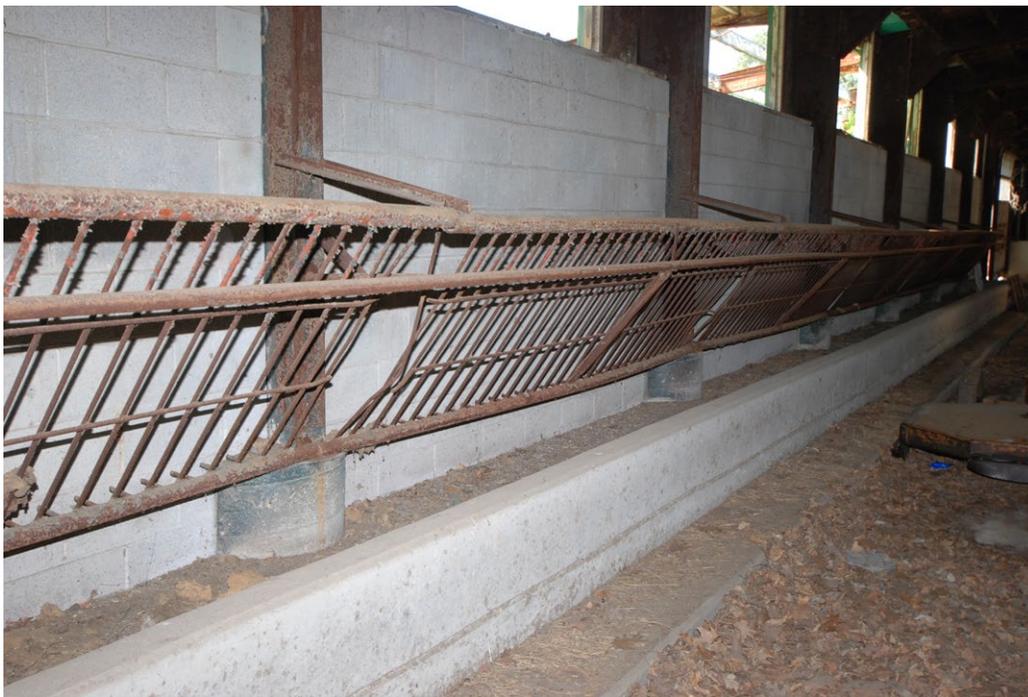
Plate 4.39: Metal hay grates along west wall of Building 8, above the grain trough.

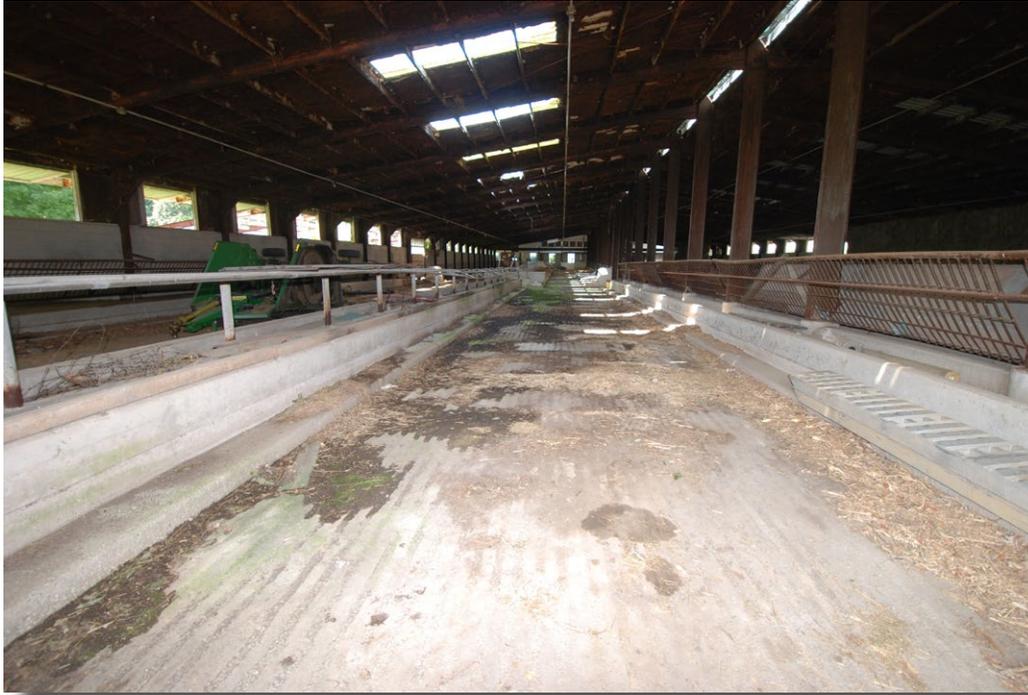
Plate 4.40: Aisle in Building 8 between the water trough (left) and the feed trough (right).

Note, the opaque skylights flood the interior with natural light.

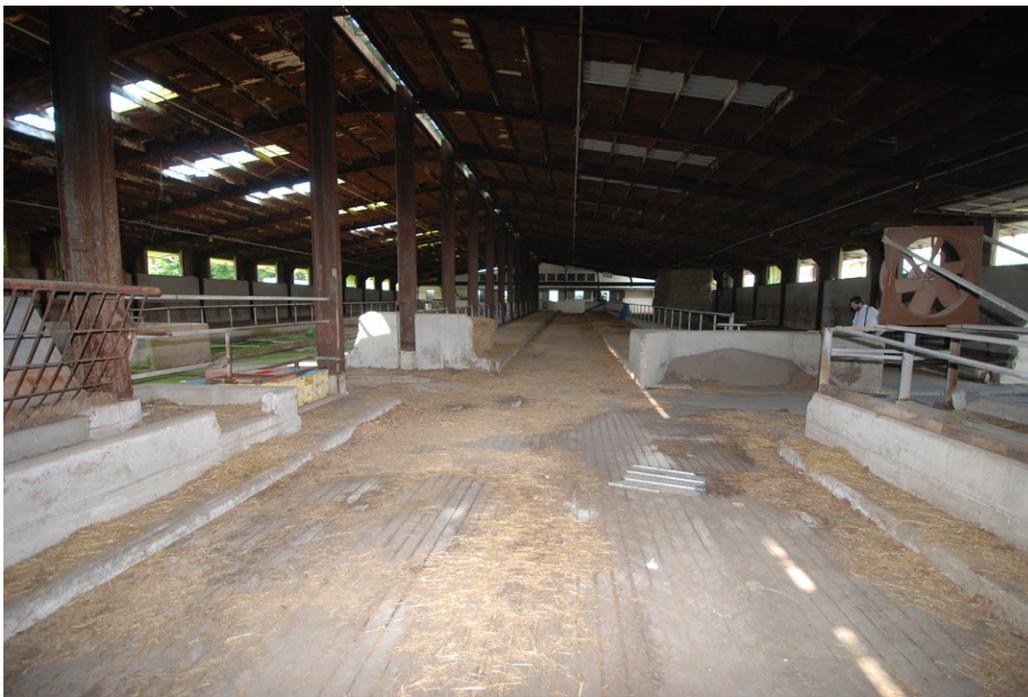
Plate 4.41: Aisle in Building 8, facing south from the center cross-aisle.

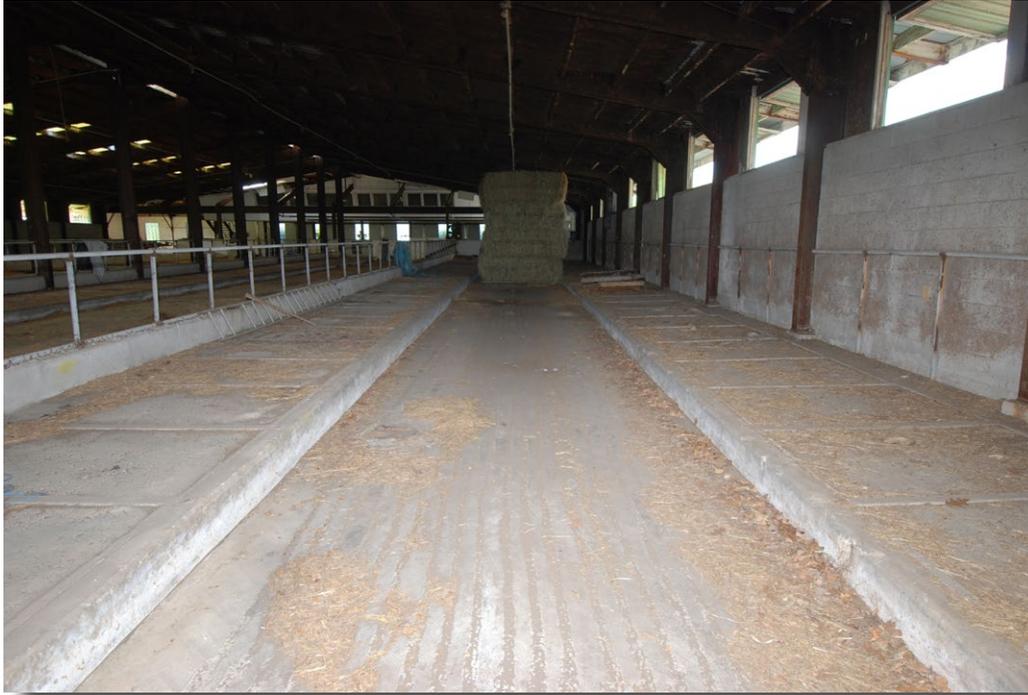
Plate 4.42: Aisle in the northern half of the Building 8.

Note, the metal stanchions in this area have been removed.

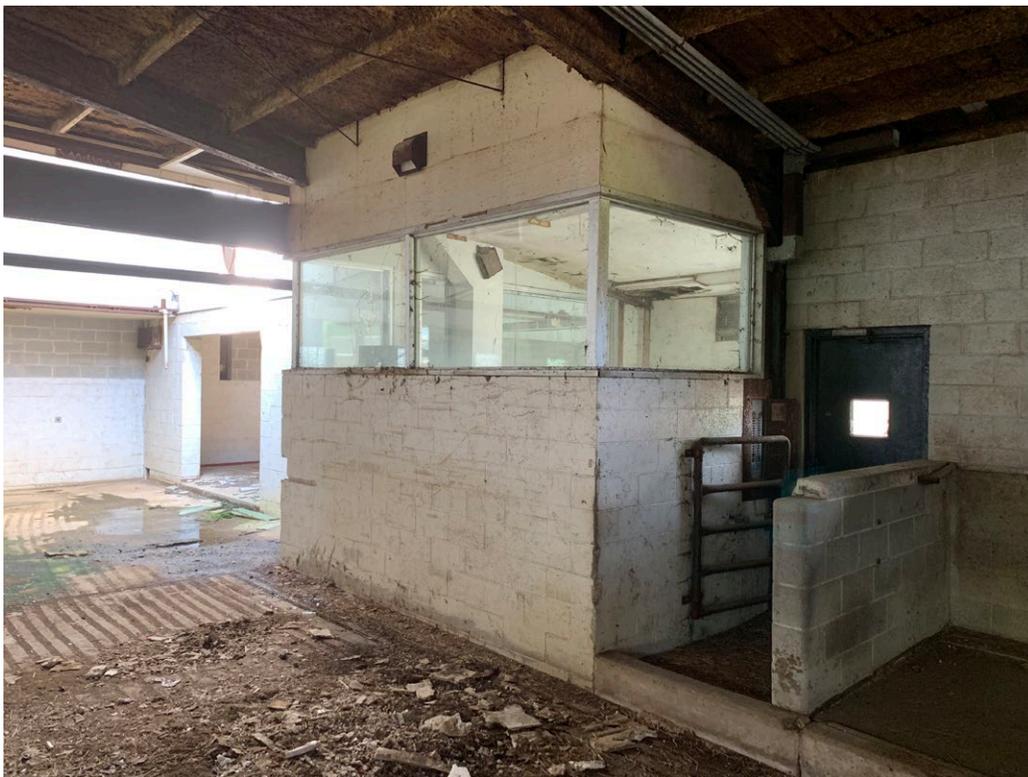
Plate 4.43: Observation post in Building 8.

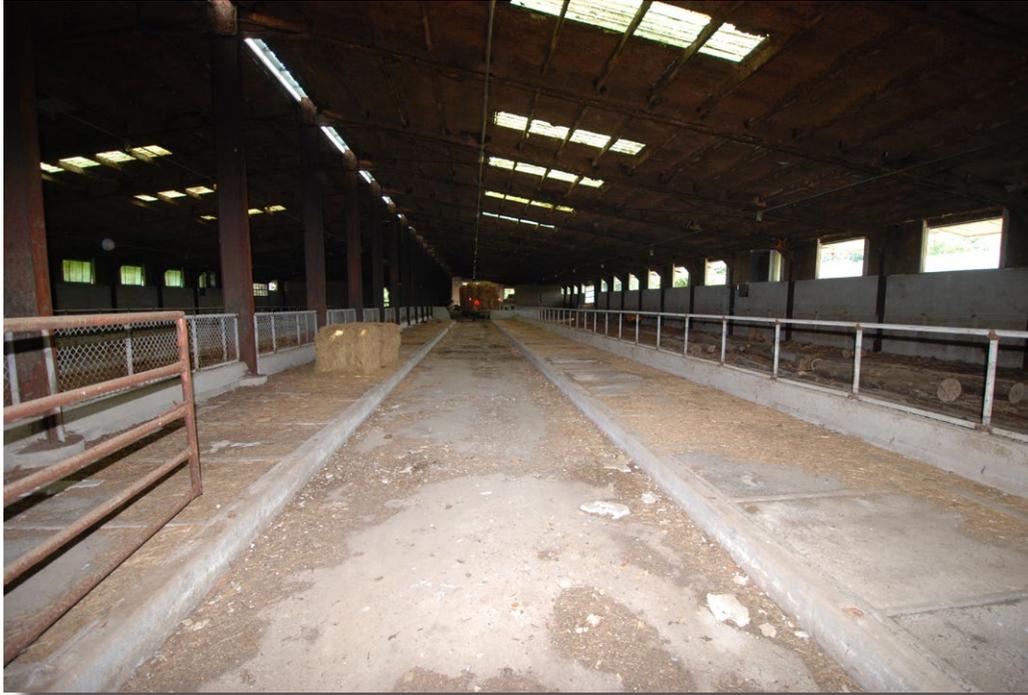
Plate 4.44: Northern portion of Building 6.

Note, the metal stanchions in this area have been removed.

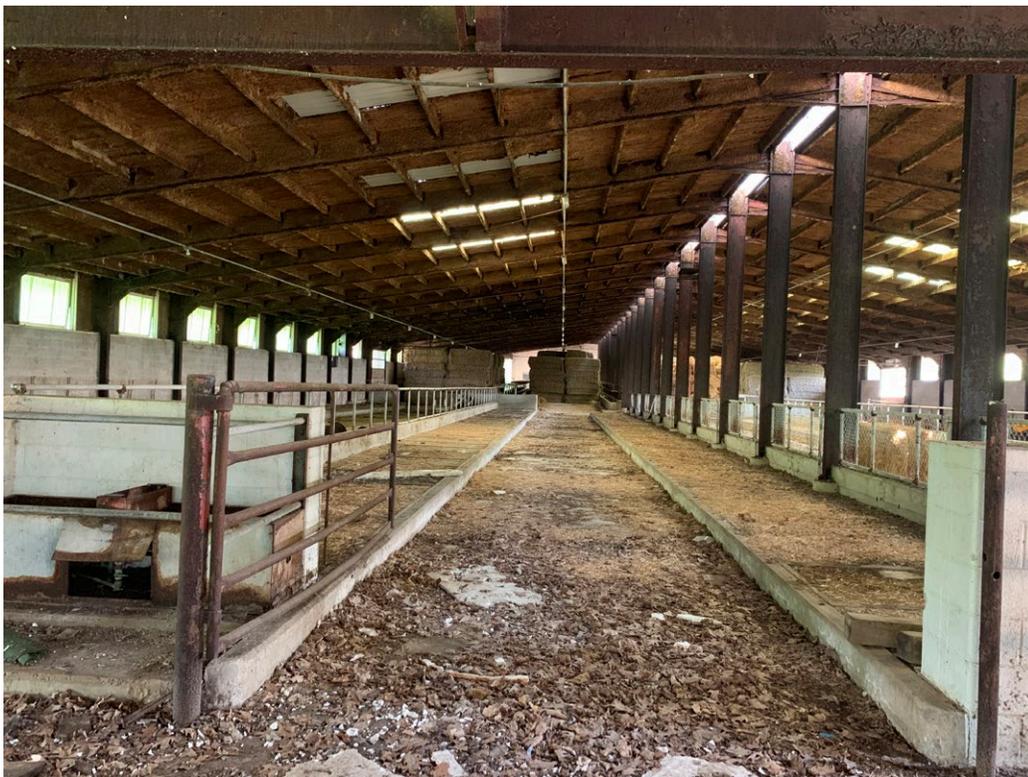
Plate 4.45: Northern portion of Building 6.

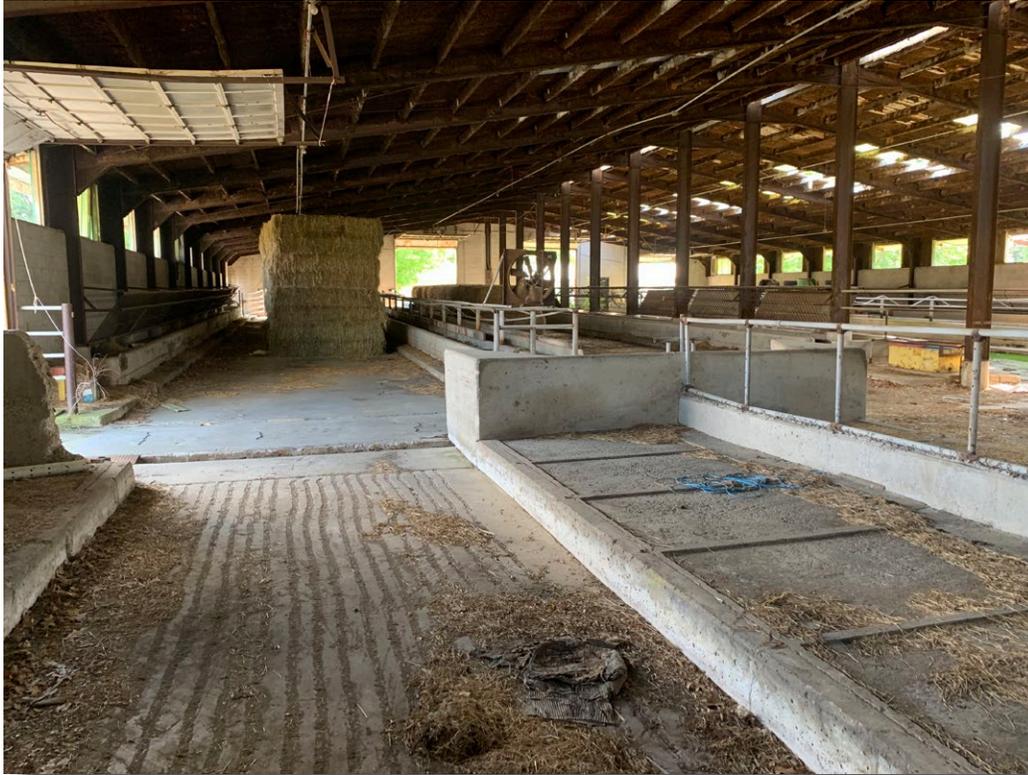
Plate 4.46: Central portion of Building 6.

Note, the overhead garage door on the left accesses the east appendage.

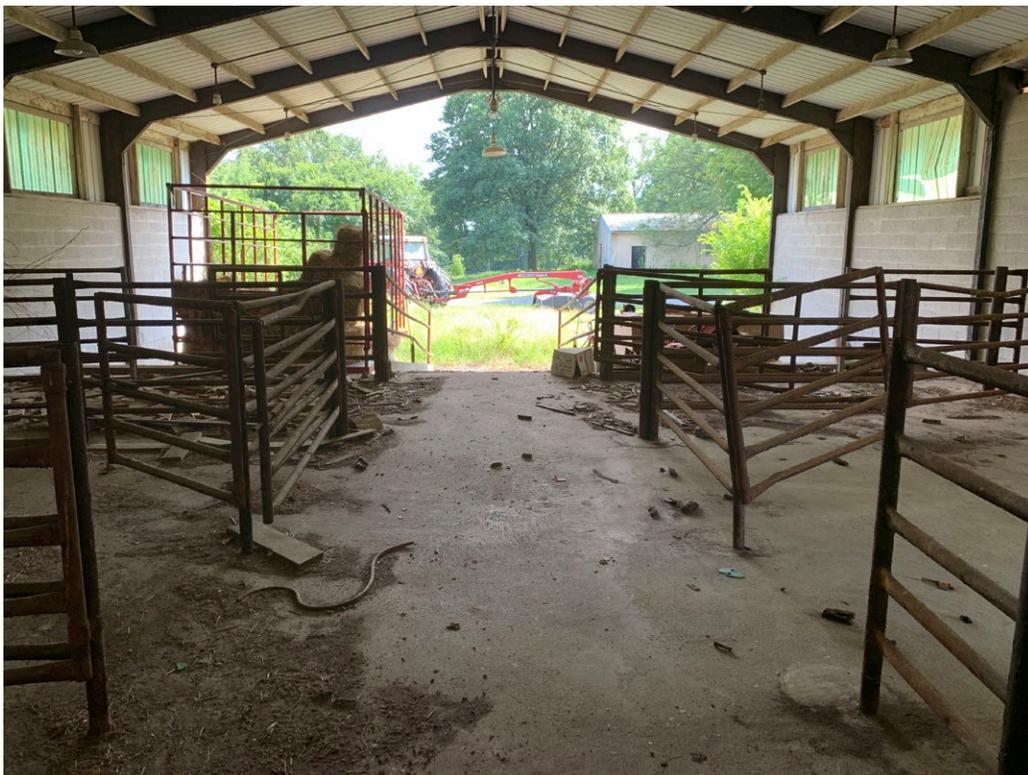
Plate 4.47: South end of the Building 7.

Note, the open bay features a central ramp leading up to the floor level and metal partitions that regulated bovine circulation through the space.

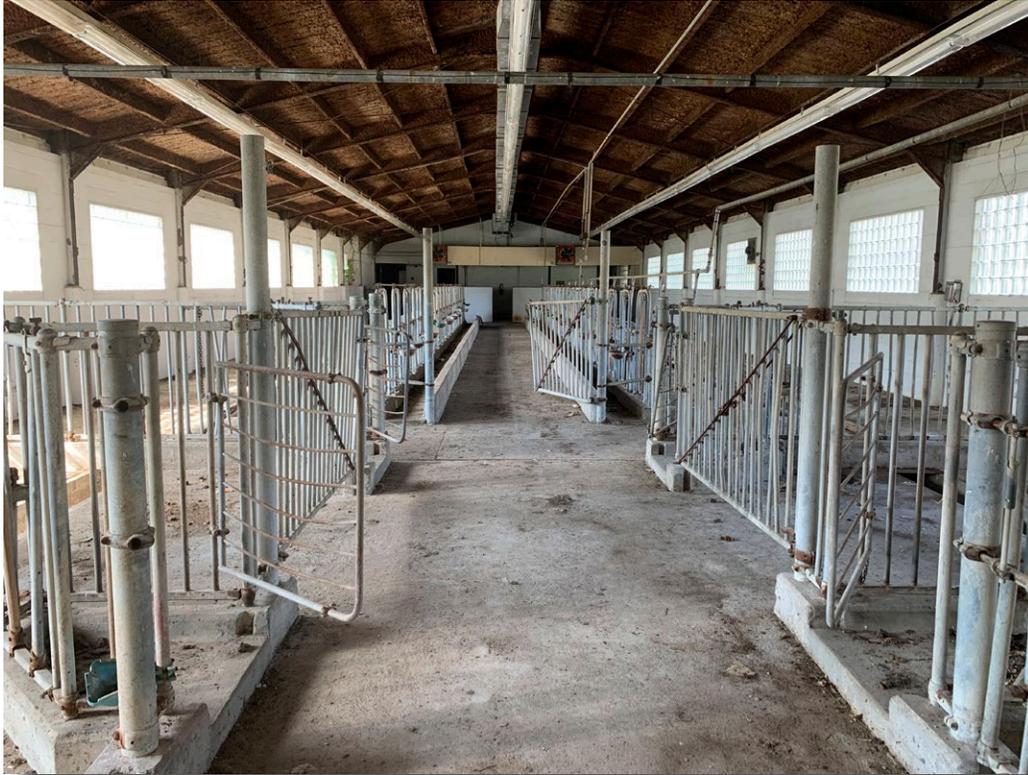
Plate 4.48: South end of the Building 7.

Note, the metal stalls occupy the central portion of the wing.

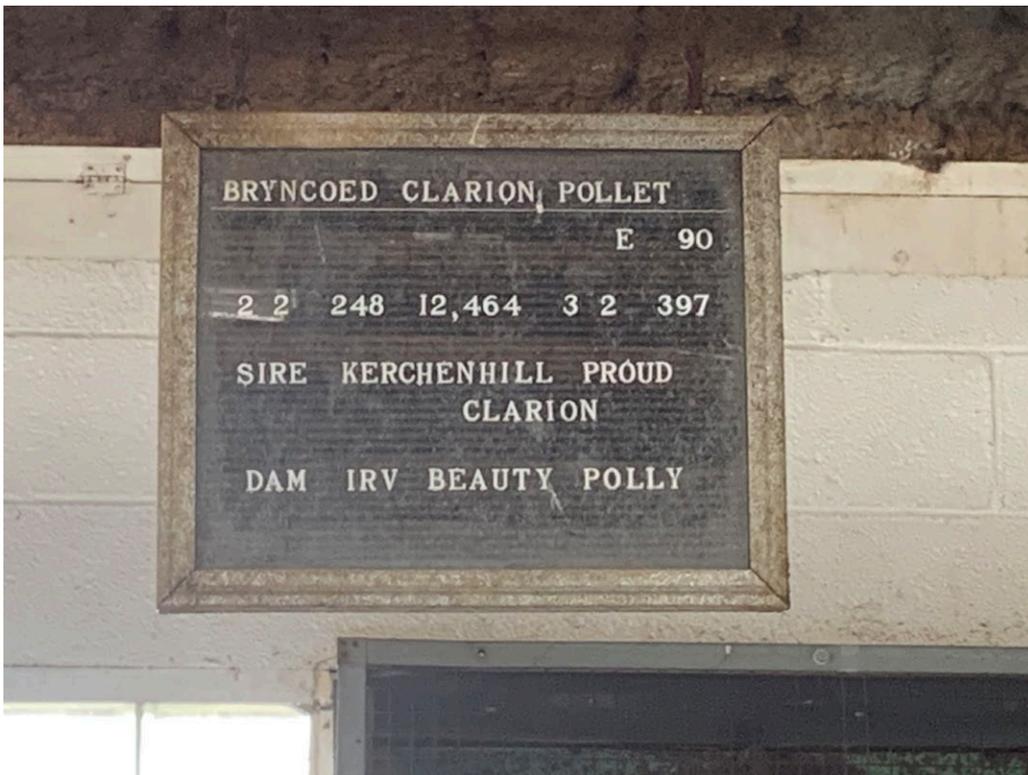
Plate 4.49: One of several letter boards for show cows in the Building 7.

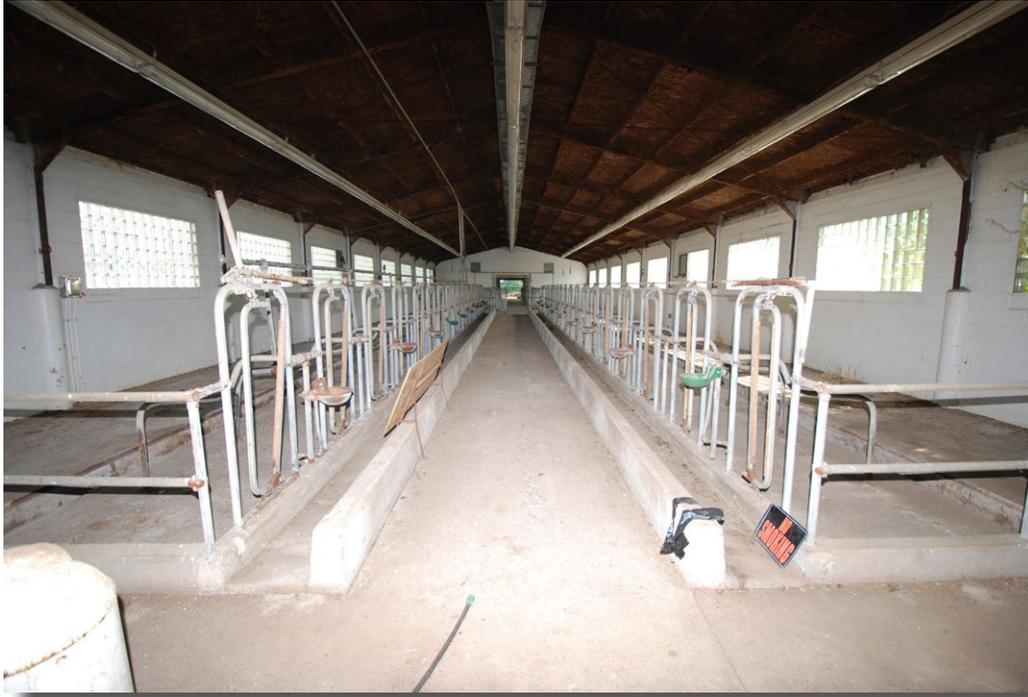
Plate 4.50: North end of the Building 7.

Note, the stanchions remain in place in the stalls.

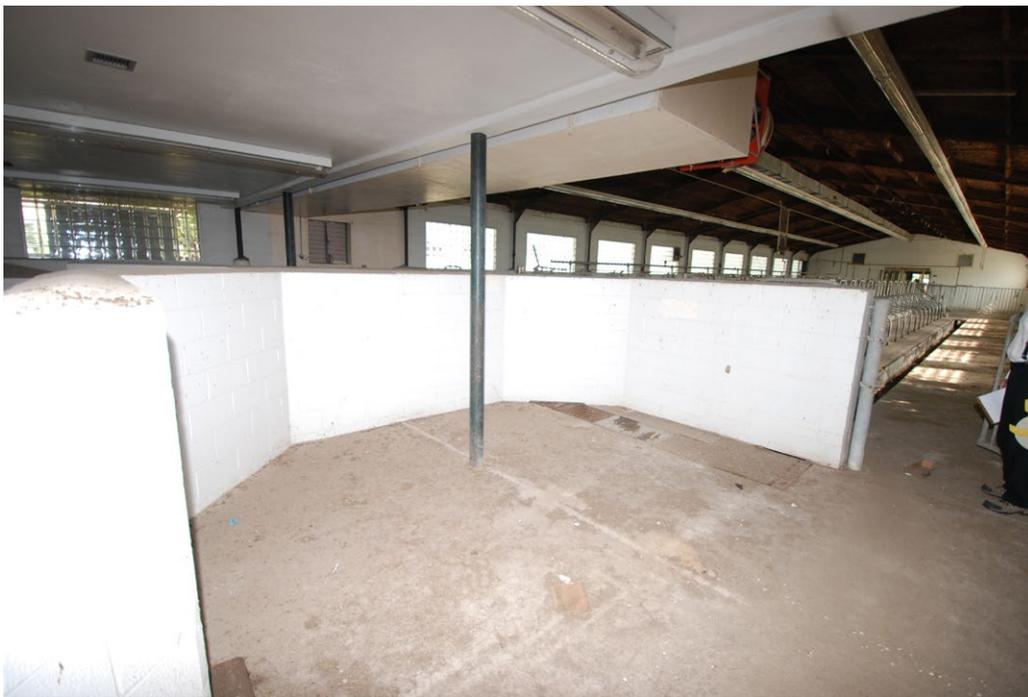
Plate 4.51: Area in the north end of the Building 7 for cleaning cows prior to shows.

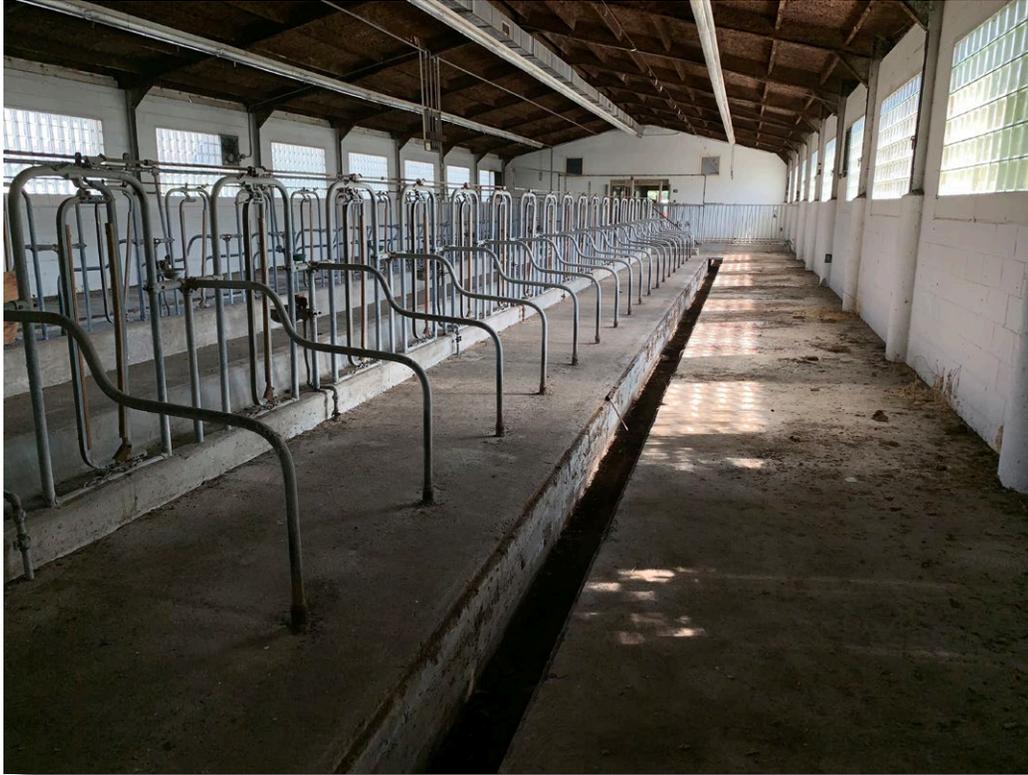
Plate 4.52: West wall of Building 7, showing the stanchions on the left and the waste trough on the right.

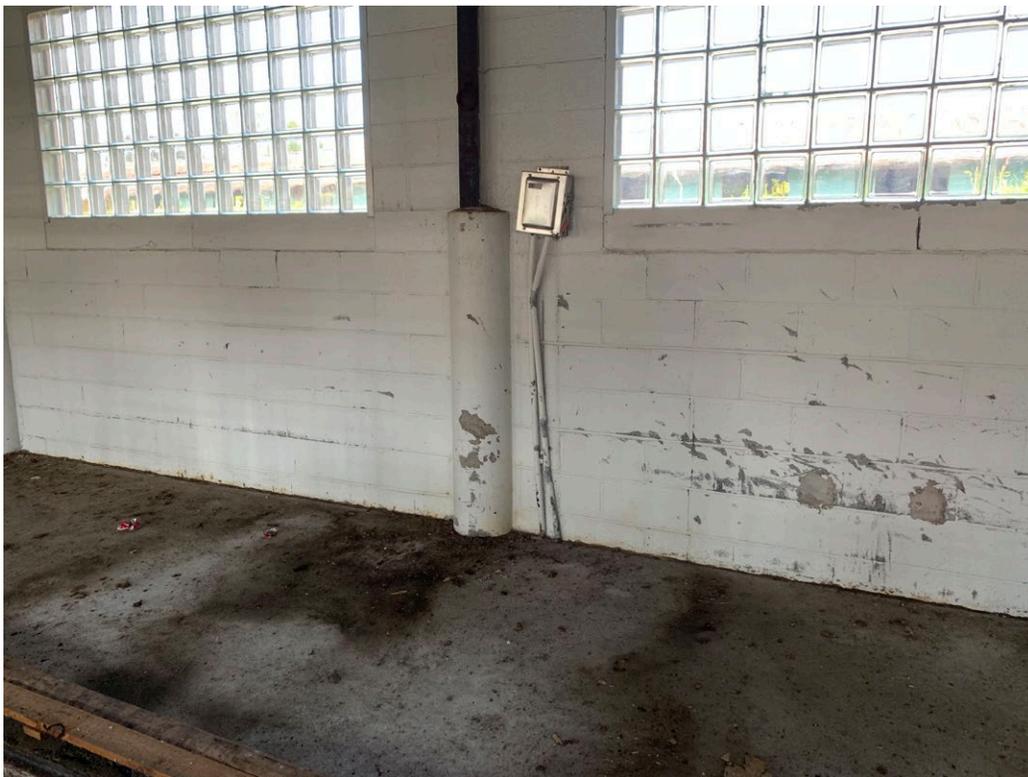
Plate 4.53: Concrete-encased steel I-beam in the Building 7.

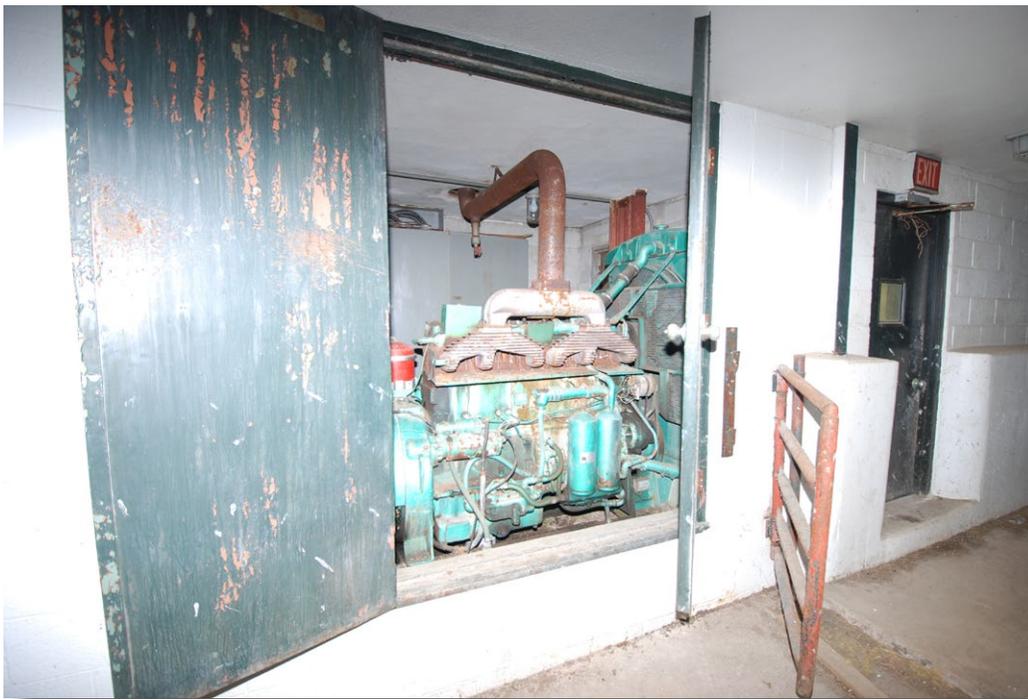
Plate 4.54: Engine room in the Building 7.

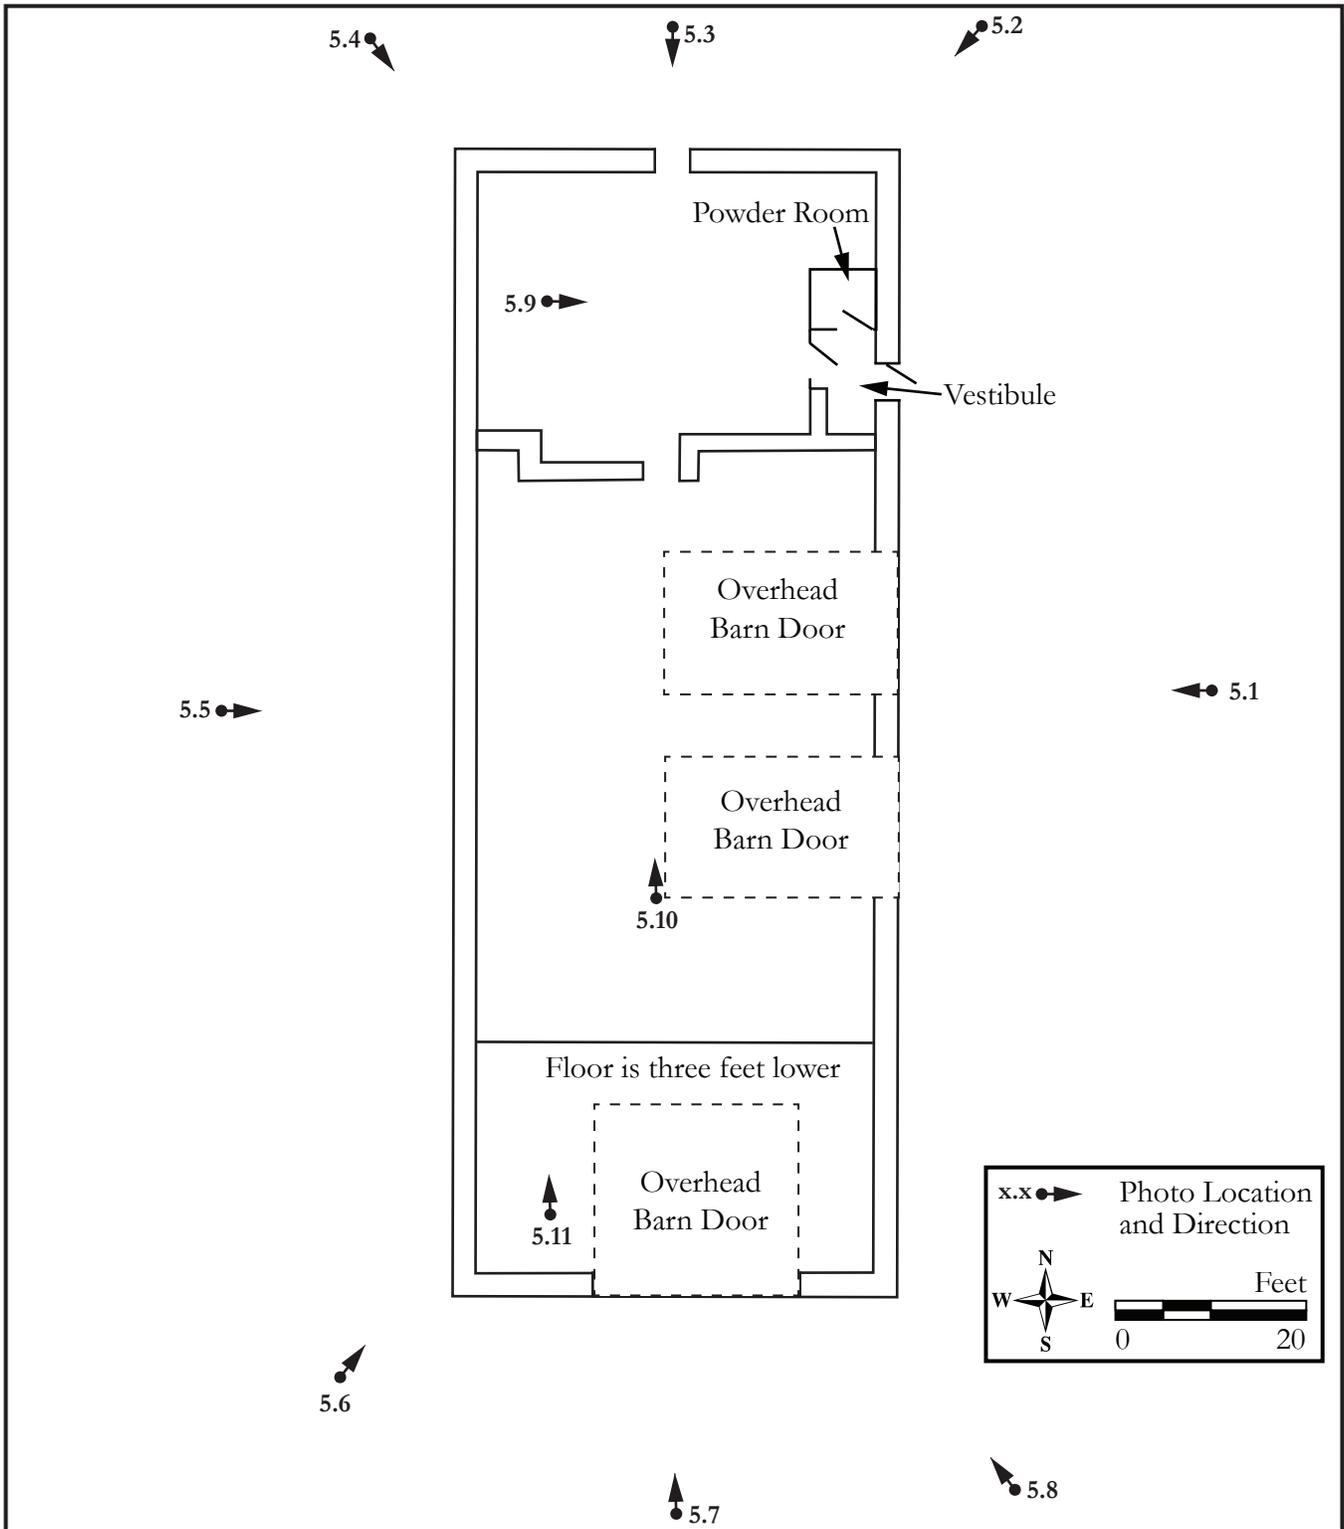
Figure 5.1: Building 10 West Office and Storage Shop Building.

Building 10 is a one-story concrete block building standing west of the Main Barn Complex (Plates 5.1 to 5.8; Figure 5.1). It measures 40 by 120 feet and is oriented north/south. The building was constructed on a sloping site, with its access on the south end opening on a lower grade than the doors on the north and east elevations. Concrete walks lead from the loop road to the office doors on the north and east elevations.

The building has an end gabled orientation and faces east. The roof is clad with standing seam tin. The concrete block walls are divided into 10 wide bays by vertical steel I-beams that are attached at the top to the interior rafters. Most bays feature one-over-one double hung sash windows that feature projecting sills and snap-in muntins that create the appearance of eight-over-eight sashes. The main (east) elevation features seven of these windows, plus two overhead garage doors and a metal hollow core door that originally featured a six-light inset light. The north end features a centered metal hollow core door flanked by paired windows. The rear (west) elevation features 10 windows in the 10 bays. On the south end, a wide open bay is sealed by an overhead garage door. The interior of the building contains an office in the north end and a two-part storage area in the center and south ends (Plates 5.9 to 5.11).

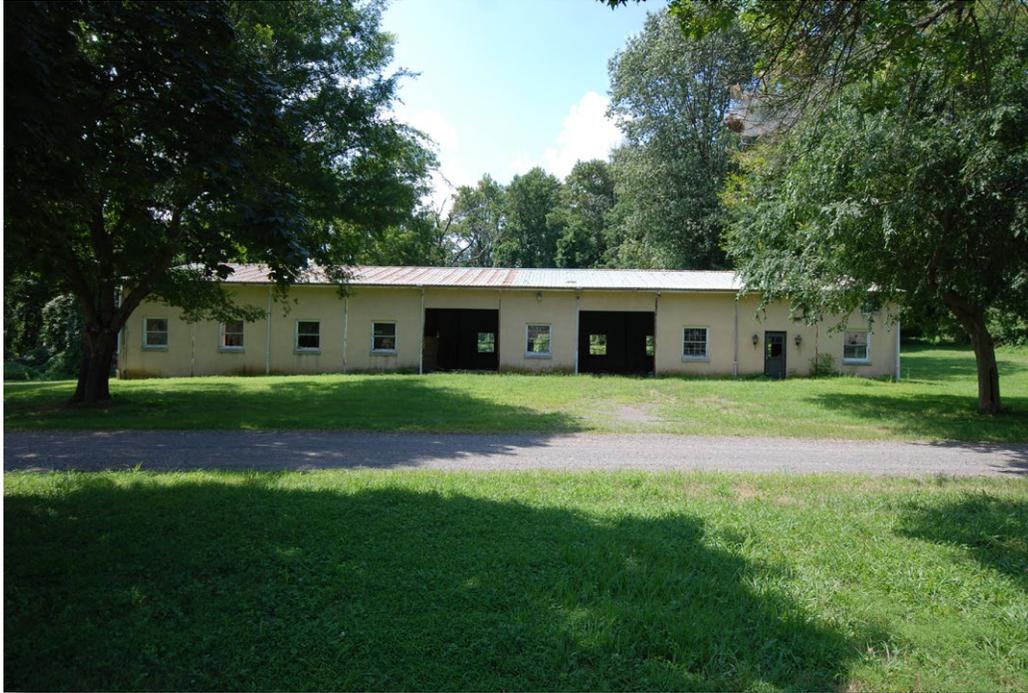
Plate 5.1: West Office and Storage Shop Building, main (east) elevation.

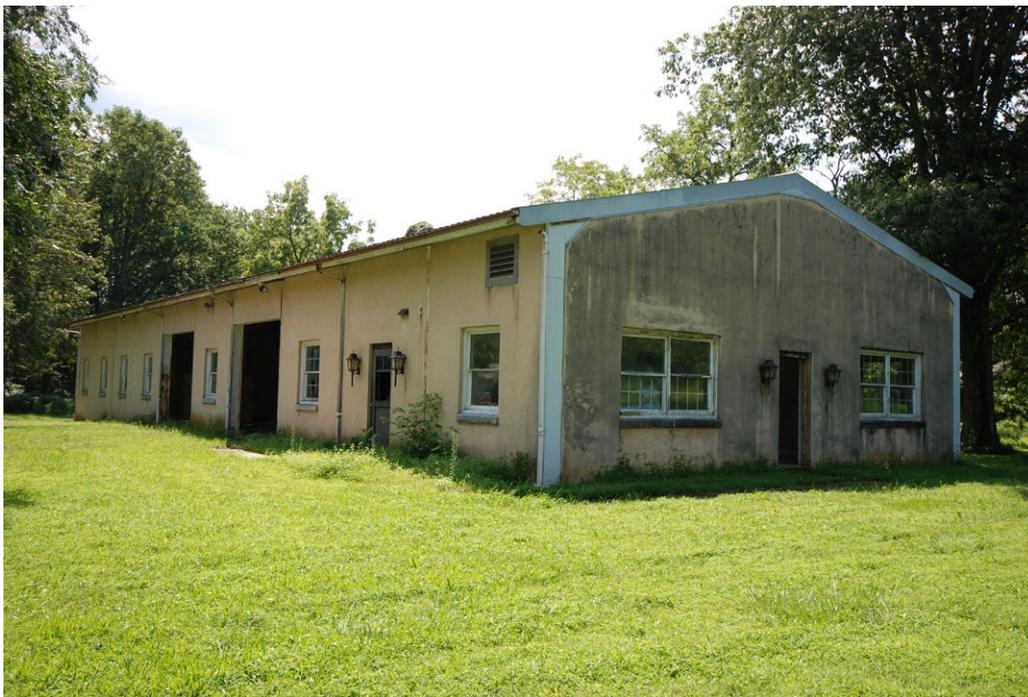
Plate 5.2: West Office and Storage Shop Building, northeast corner.

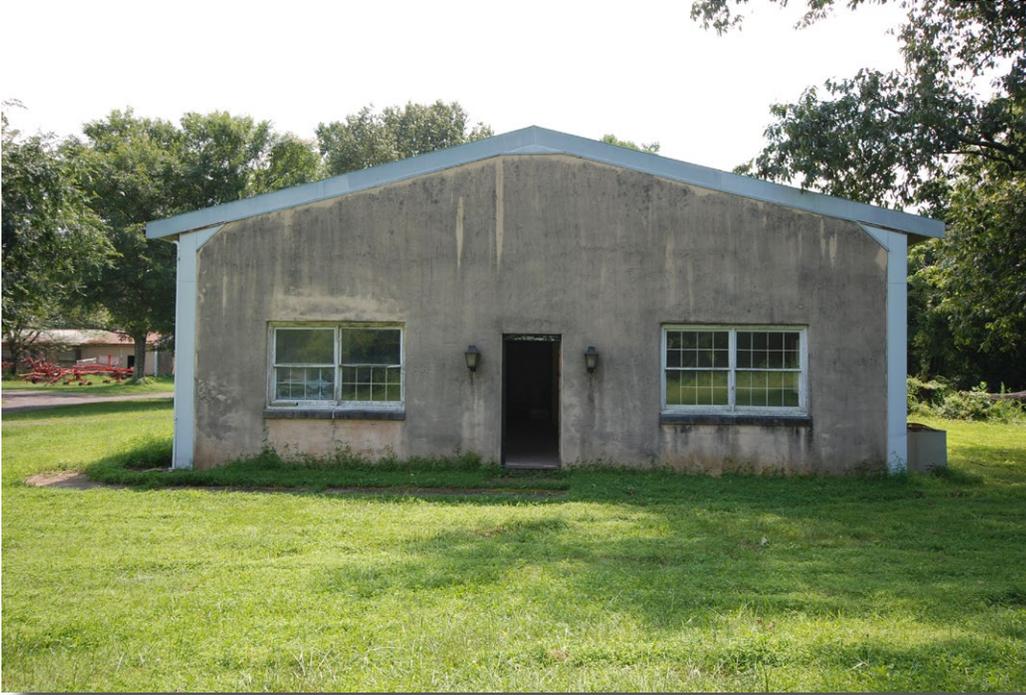
Plate 5.3: West Office and Storage Shop Building, north end.
