HISTORIC STRUCTURE REPORT

BRYN COED DAIRY FARM COMPLEX
1422 St. Matthews Road, West Vincent Township,
Chester County, Pennsylvania

October 2019

RICHARD
GRUBB &
ASSOCIATES

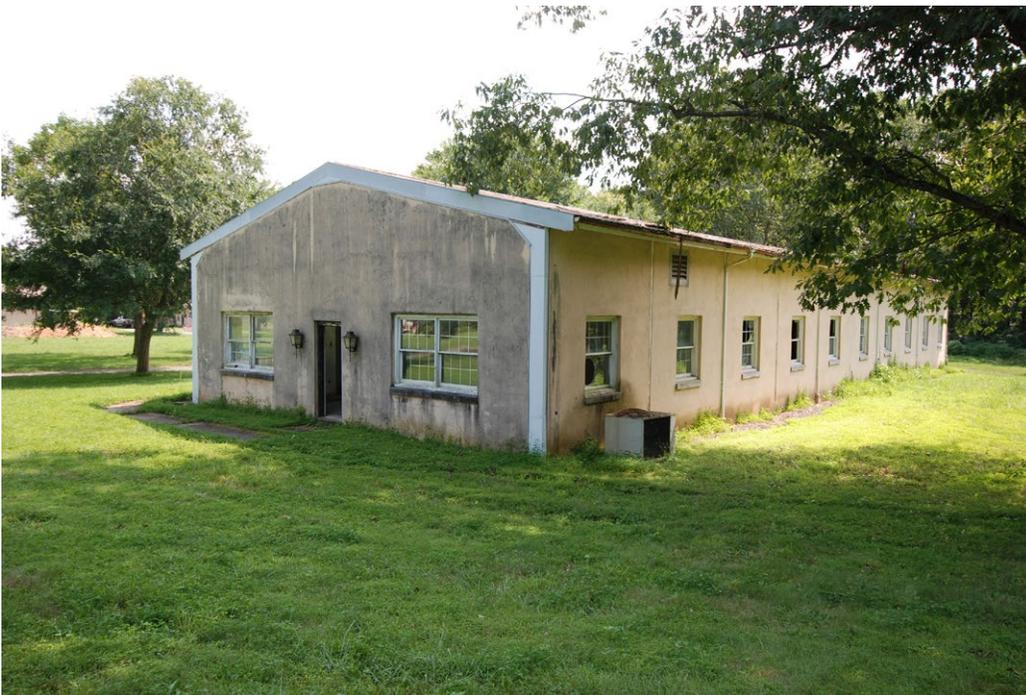
Plate 5.4: West Office and Storage Shop Building, northwest corner.

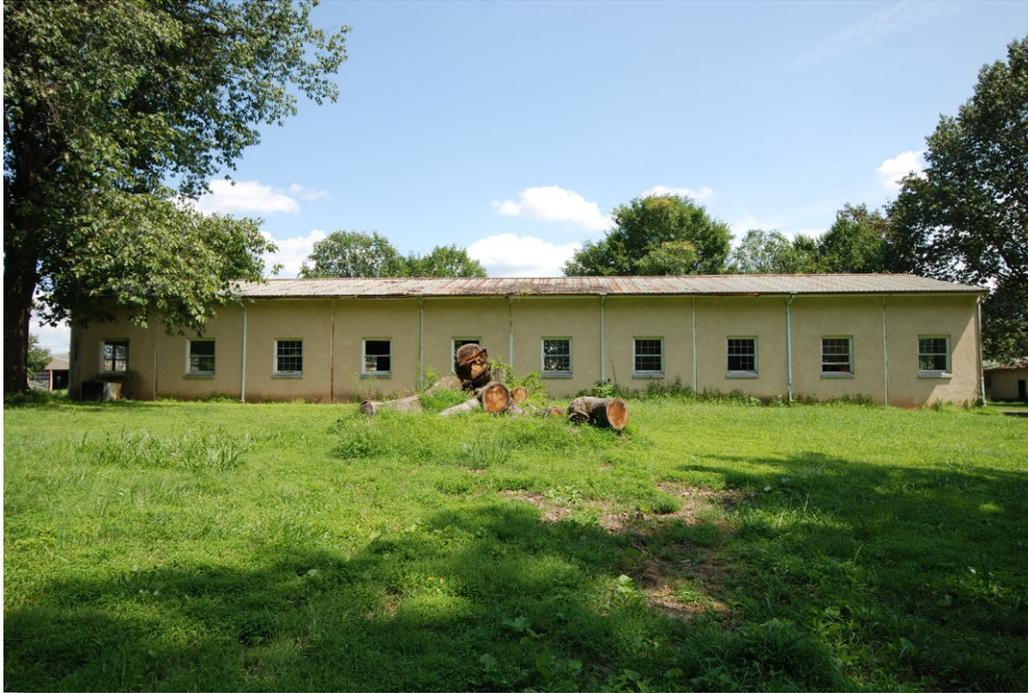
Plate 5.5: West Office and Storage Shop Building, west elevation.

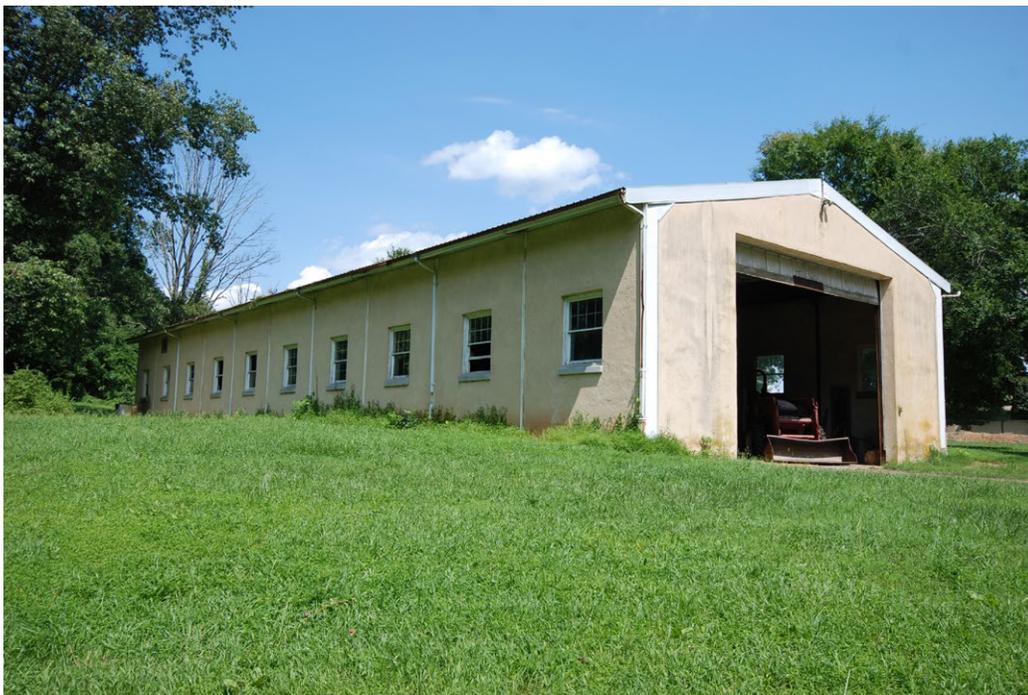
Plate 5.6: West Office and Storage Shop Building, southwest corner.

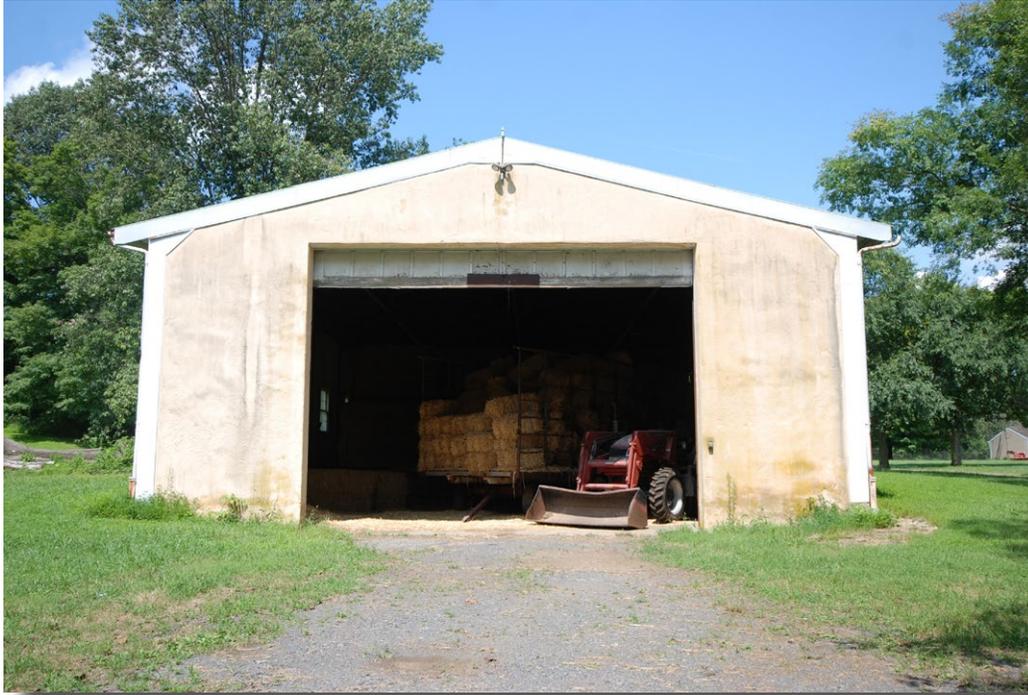
Plate 5.7: West Office and Storage Shop Building, south elevation.

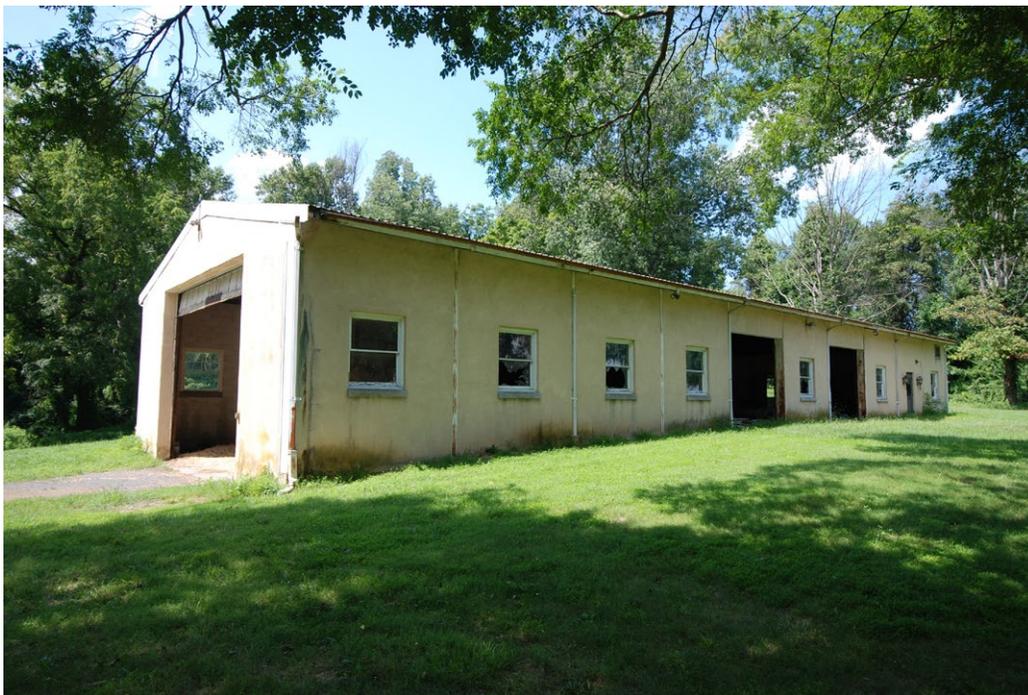
Plate 5.8: West Office and Storage Shop Building, southeast corner.

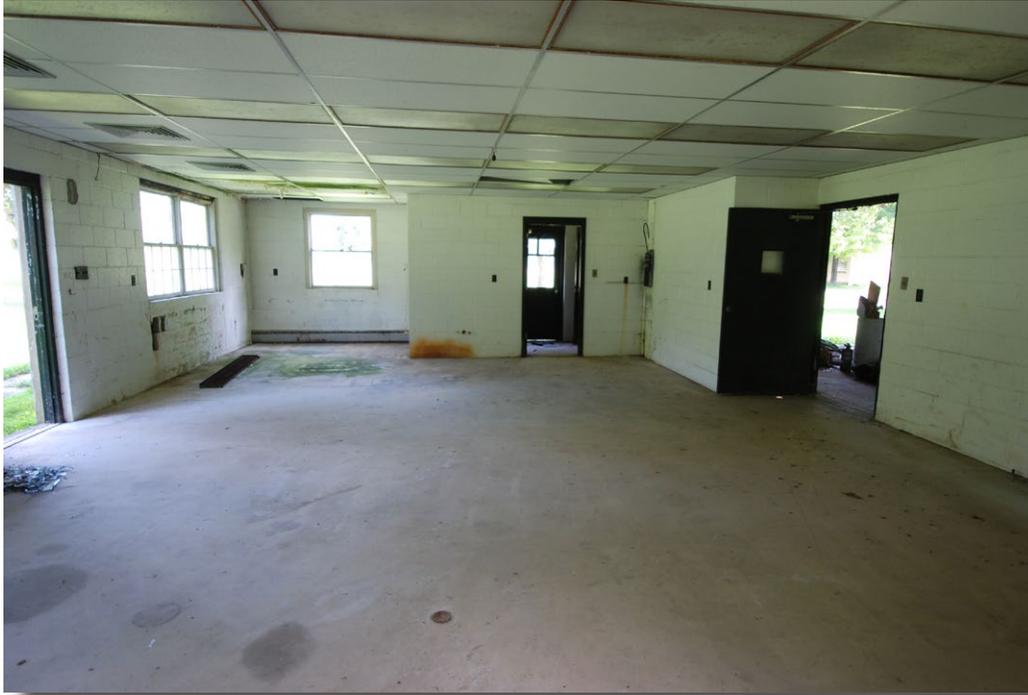
Plate 5.9: Office in north end of West Office and Storage Shop Building.

Note, a powder room is located behind the wall in the center of the plate.

The building has an end gabled orientation and faces east. The roof is clad with standing seam tin. The concrete block walls are divided into 10 wide bays by vertical steel I-beams that are attached at the top to the interior rafters. Most bays feature one-over-one double hung sash windows that feature projecting sills and snap-in muntins that create the appearance of eight-over-eight sashes. The main (east) elevation features seven of these windows, plus two overhead garage doors and a metal hollow core door that originally featured a six-light inset light. The north end features a centered metal hollow core door flanked by paired windows. The rear (west) elevation features 10 windows in the 10 bays. On the south end, a wide open bay is sealed by an overhead garage door. The interior of the building contains an office in the north end and a two-part storage area in the center and south ends (Plates 5.9 to 5.11).

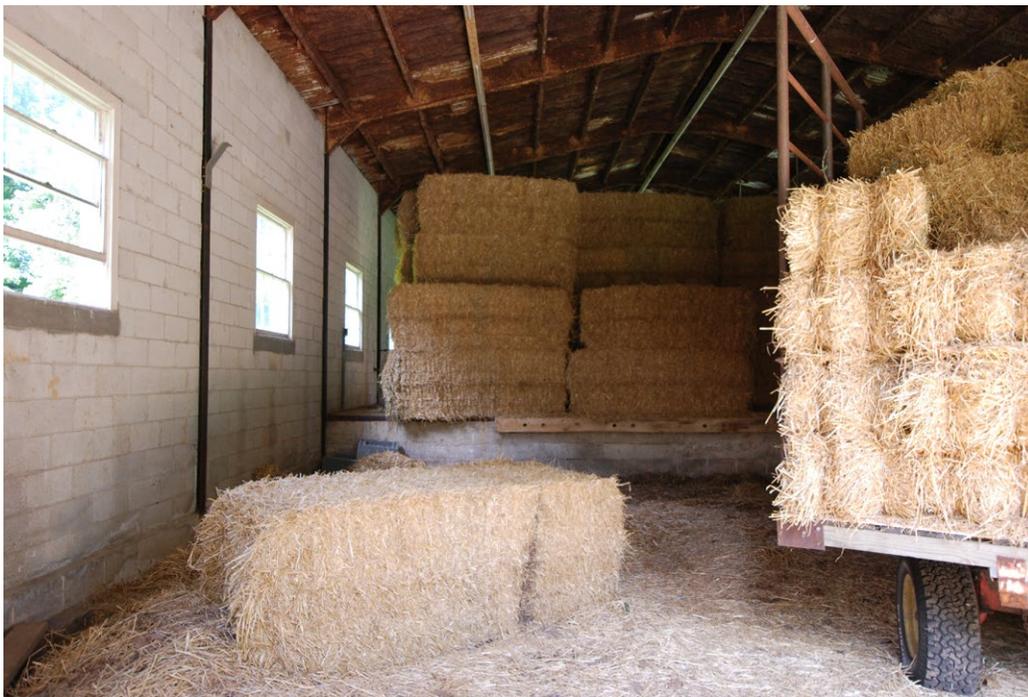
Plate 5.11: Storage area in the south end of the West Office and Storage Shop Building.

Note, the falling grade in this location results in a floor three feet below that of the remainder of the building.

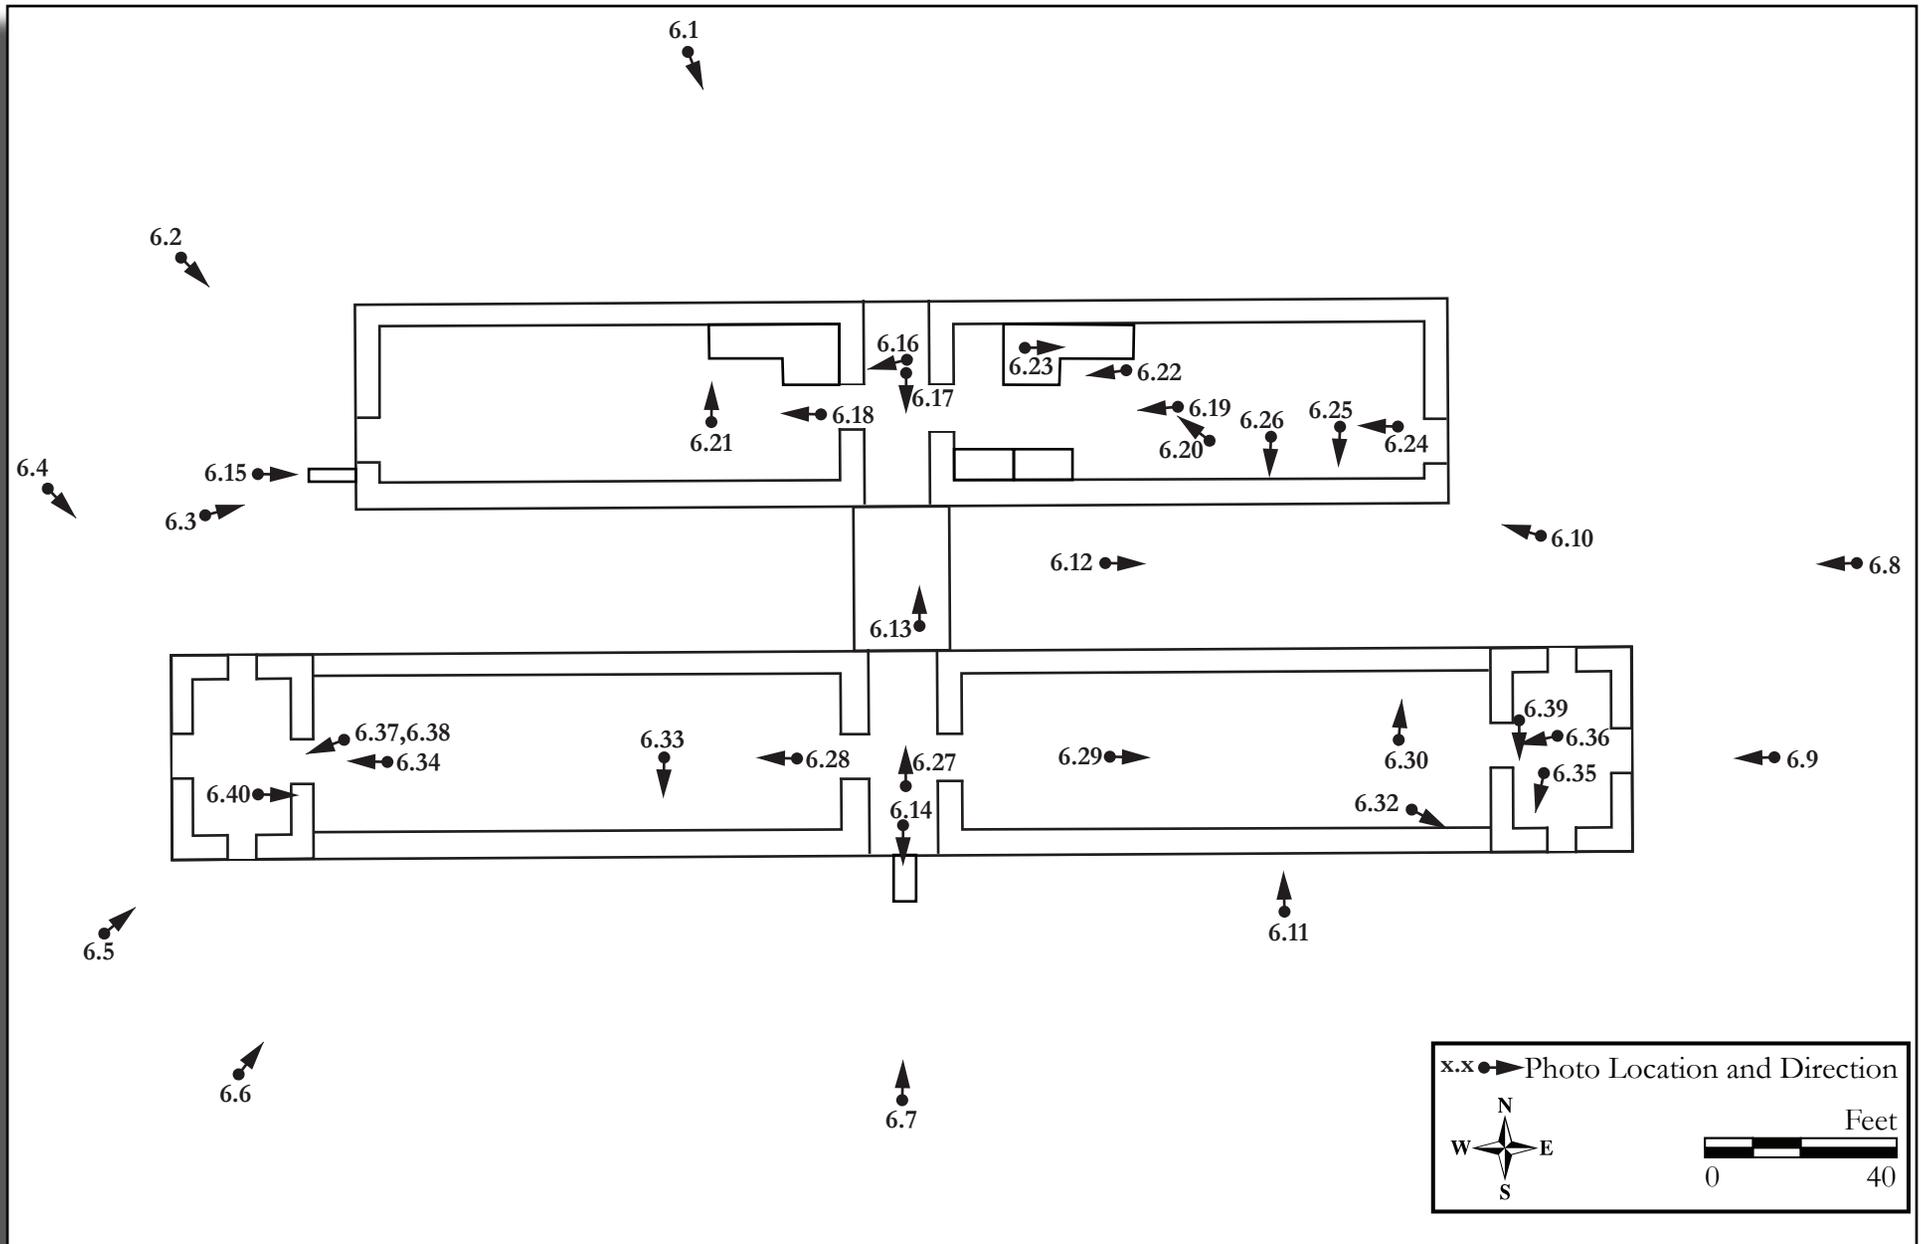
Figure 6.1: Calf Barn Complex.

The Calf Barn Complex is housed in Buildings 11 and 12. It is an elongated H-shaped building that stands near the southwest corner of the main barn (Figure 6.1; Plates 6.1 to 6.15). Two long rectangular sections (Building 11 forming the north element of the H and Building 12 forming the south element of the H) were built parallel to each other; a 12 foot wide hyphen at the center connects the two sections. The building complex has corrugated tin on the roof, and its walls and foundation are built of concrete block. Building 11 measures 228 feet long by 36 feet wide. Building 12 is longer, measuring 300 by 36 feet. The two sections have large open bays on each end. The open bays on Building 12 are centered, but the open bays on Building 11 are offset to the south. Building 11 has four metal hollow core doors near the center of the north elevation. Building 12 has ancillary metal hollow core doors on the sides near the ends and a door centered on the south elevation. Both buildings have large Belgian block windows and concrete foundations.

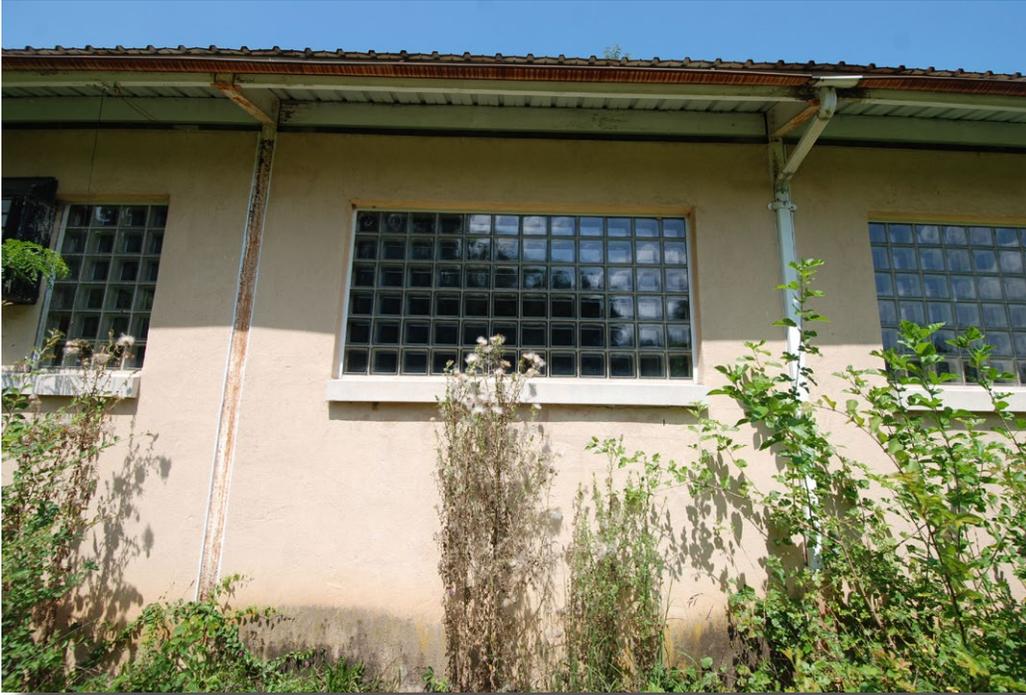
Plate 6.11: Belgian windows on south elevation.

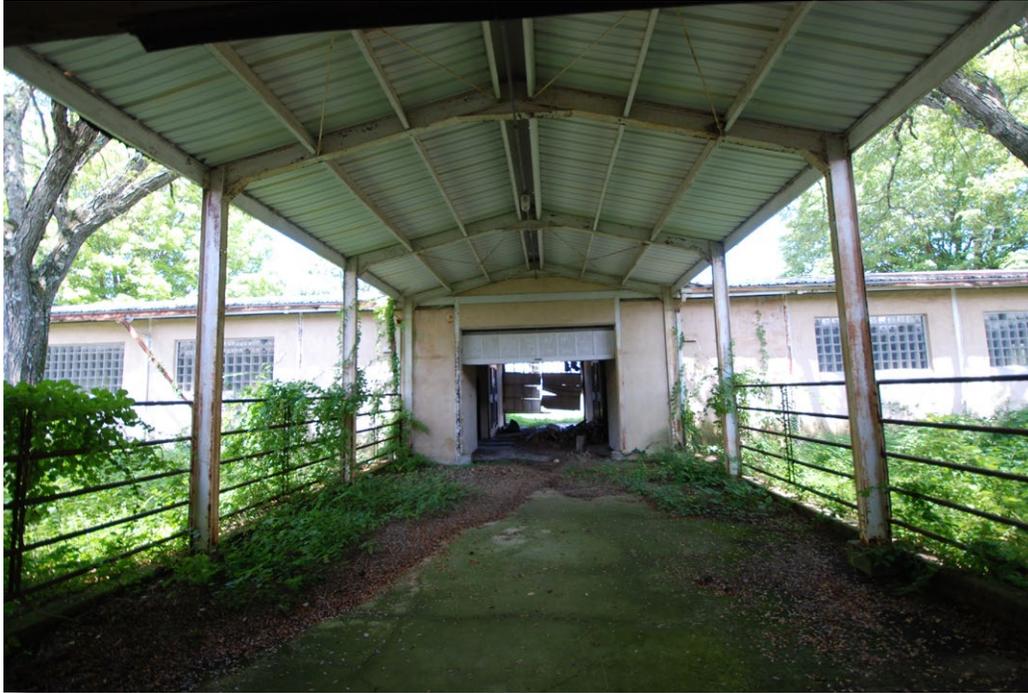
Plate 6.13: Connecting element between the north and south sections of the calf barn complex.

The hyphen that connects Buildings 11 and 12 is a one-story element spanning the 30 feet between the two sections and measuring 12 feet wide (Plate 6.13). It has a gabled roof supported by steel posts that are attached to rafters; the posts are connected by heavy gauge wire railings. The sides are otherwise open to enhance breezes through the space. The connection has a concrete foundation. Overhead garage doors along the walls of the two sections may be used to seal the connection.

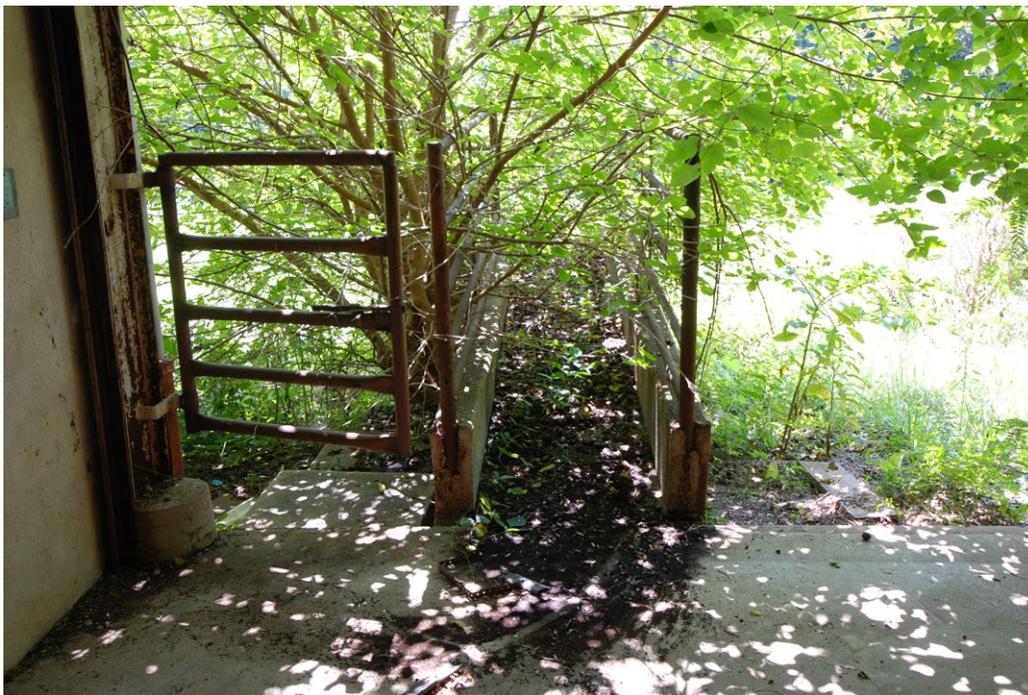
Plate 6.14: Cattle chute on south side of south section of calf barn complex.

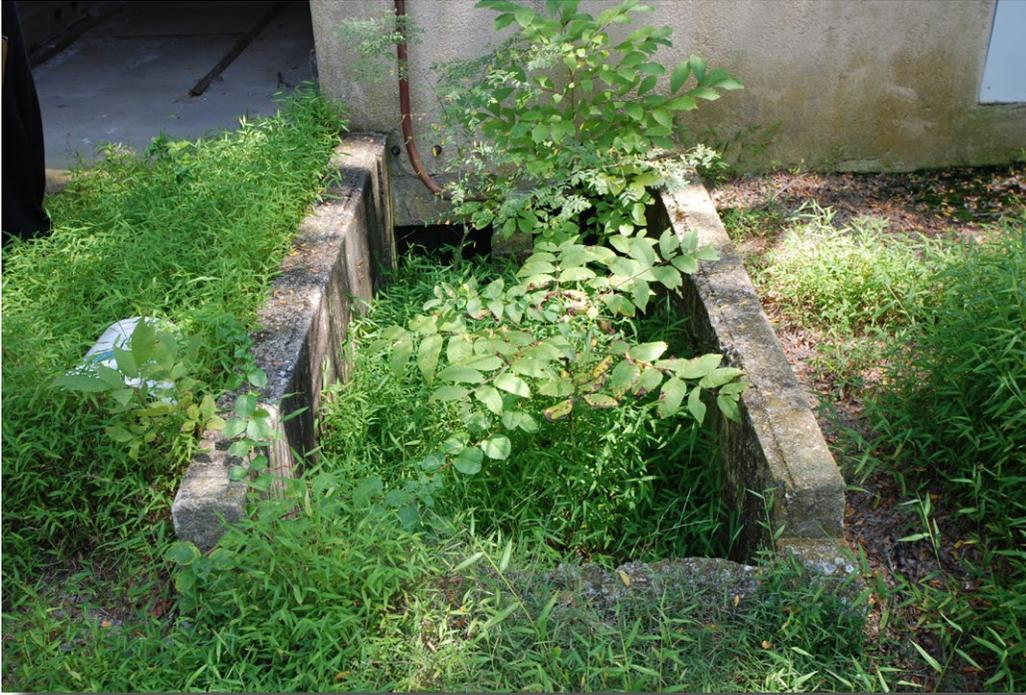
Plate 6.15: Waste chute on west end of north building, calf barn complex.

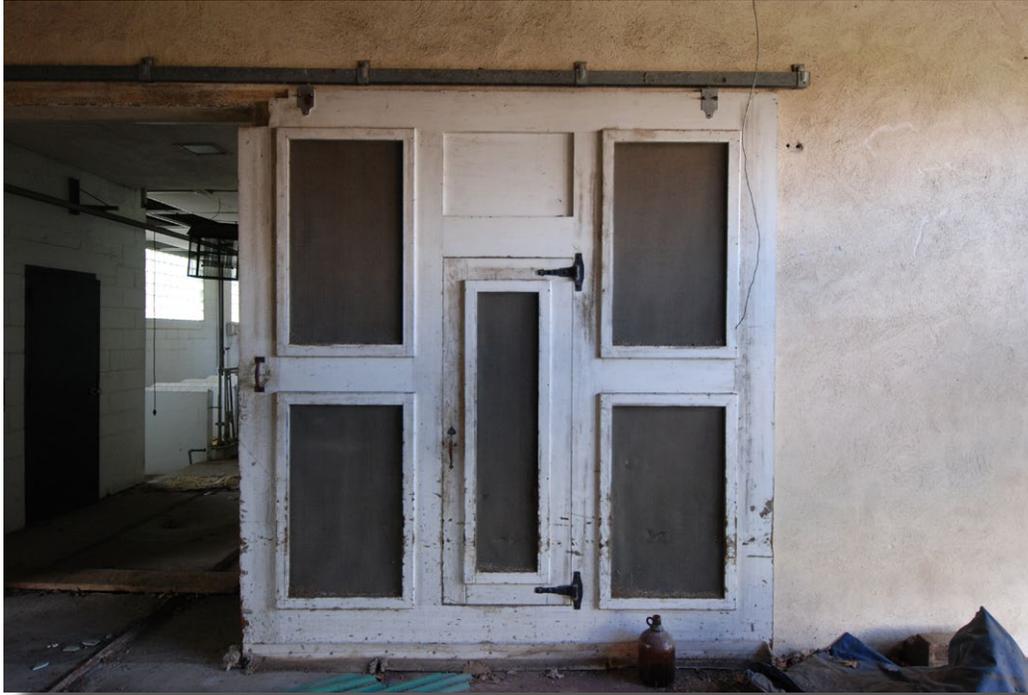
Plate 6.17: Large rolling doors that seal the central passageway of Building 11 of the calf building from the stall area.

Note, the doors include a wicket (inset) door.

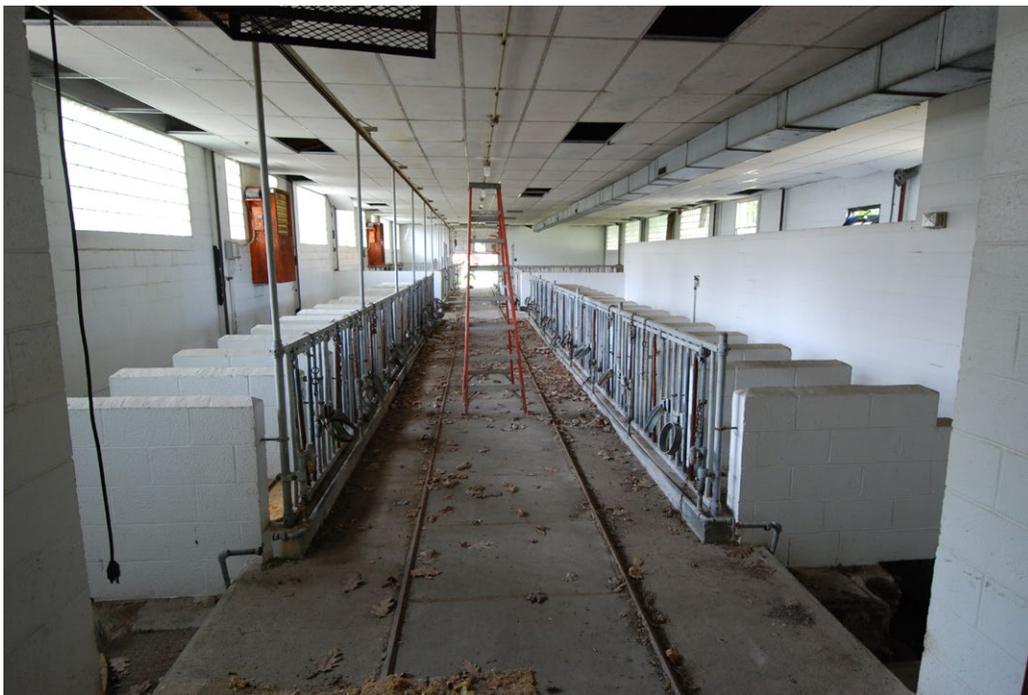
Plate 6.18: Concrete stall area of Building 11.

Note, the west half of the section has a drop ceiling.

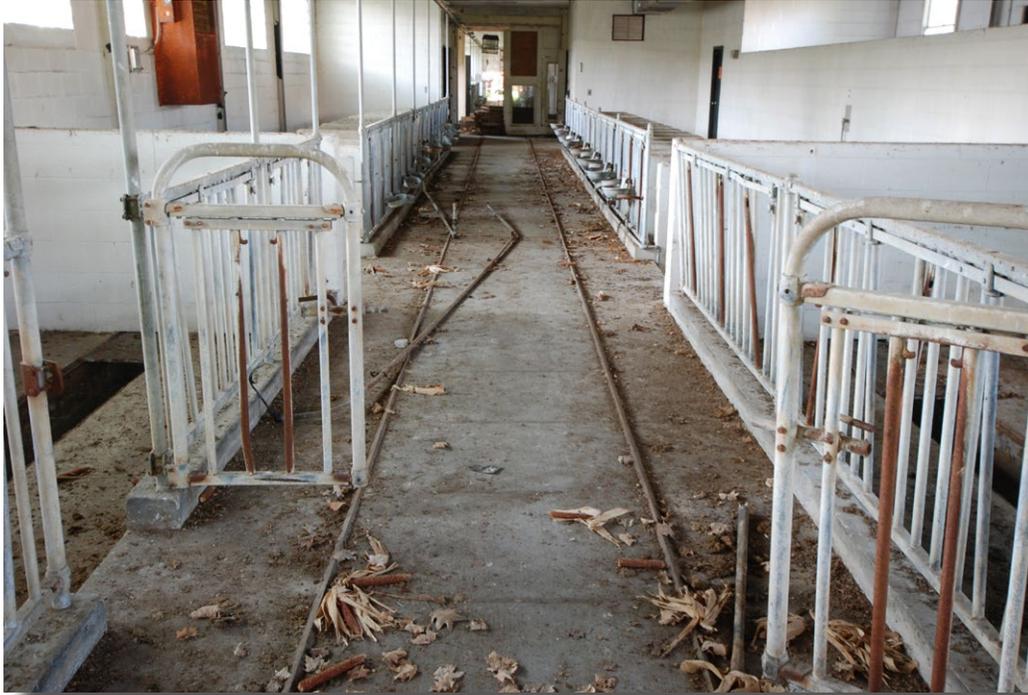
Plate 6.19: Concrete stall area of Building 11.

Note, two rails on the floor guided machinery that delivered food to the stalls.

Building 11 housed the younger calves (Plates 6.16 to 6.26). Stalls line the walls with a central alley through much of the building. Rails on the floor were used to guide equipment that rolled down the center aisle to feed the livestock. Fifteen block stanchions near the center (Plate 6.20) have rings that held water and feed bowls; most watering bowls survive. Moving further away from the center are four stalls on each side of the alley, each with metal gates and waste troughs running below grates to the ends of the building. Vent-O-Matic heaters mounted on the walls provided heat during the winter (Plate 6.26). To keep an eye on the animals, an elevated observation area is located along the north wall, near the center of the building (Plate 6.23). Rooms in the center of the building (between the stall areas and with access to the hyphen into Building 12) include restrooms and storage areas. The floors are concrete and the steel structural system, like all the buildings in the complex, is exposed.

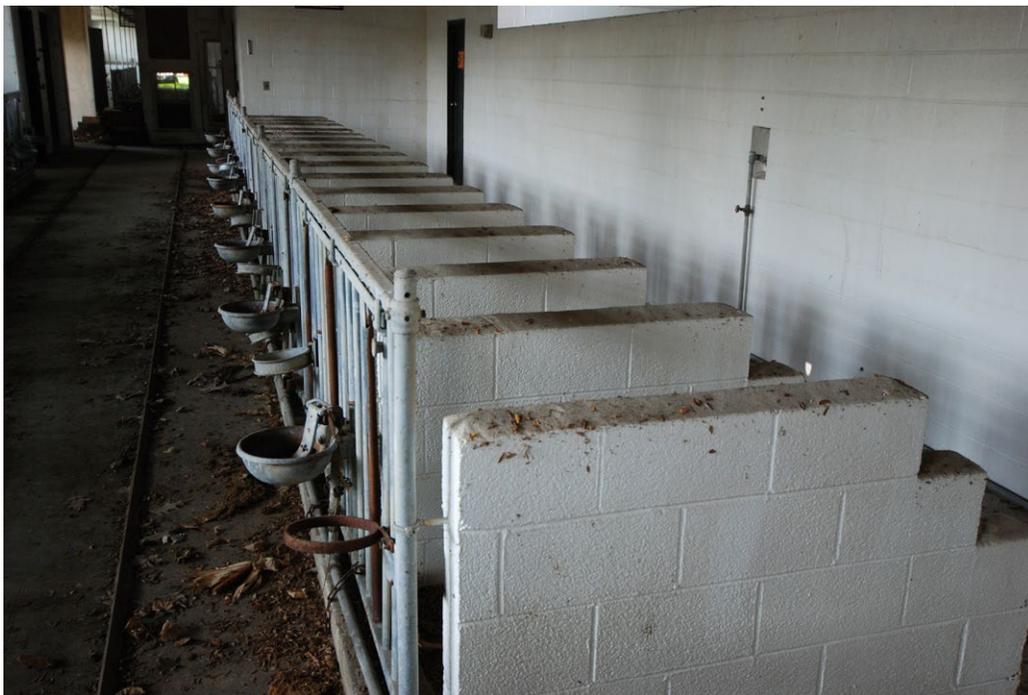
Plate 6.20: Concrete stalls in Building 11.

Note, the concrete stalls are narrow with stanchions facing the passageway; a water bowl and a ring to hold the feed are attached onto the stanchions.

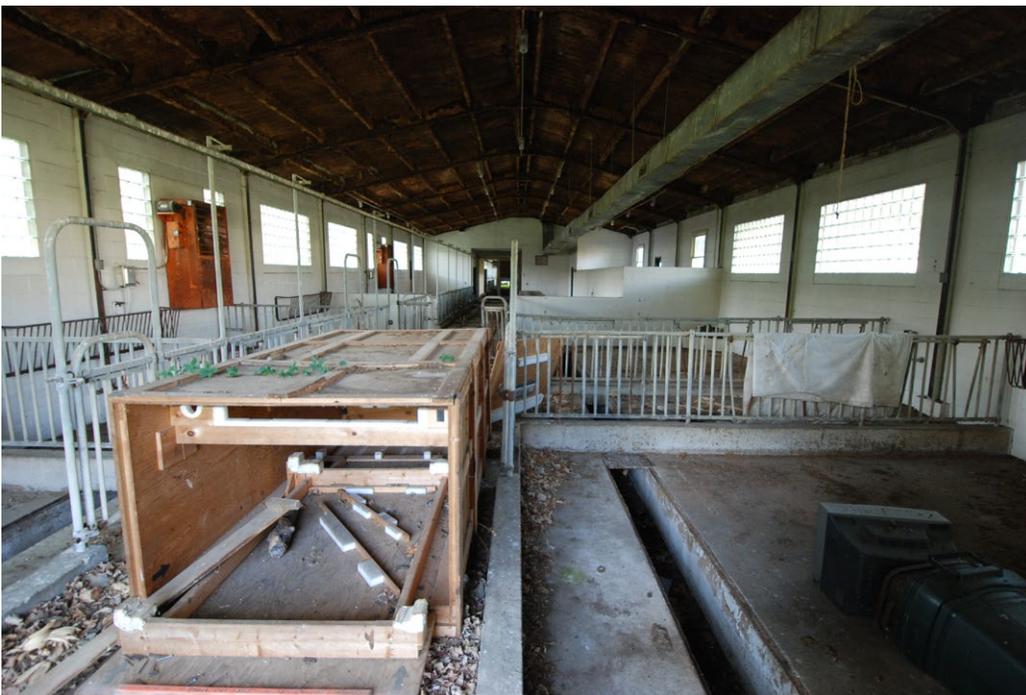
Plate 6.24: East stall area of Building 11.

Note, above, the rafters and the underside of the roof have been sealed with insulation, and ductwork running below the ridge was used to heat the space in the winter.

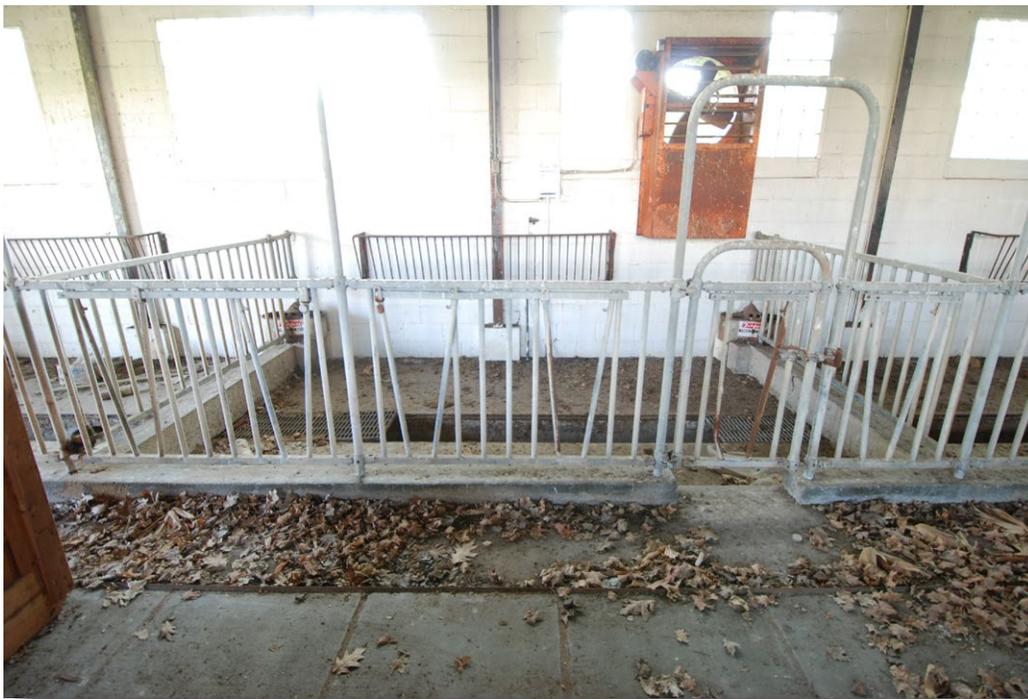
Plate 6.25: Typical stall in east end of Building 11.

Note, four stalls of this size are located in the ends of Building 11, with larger stalls on the north side of the aisle.

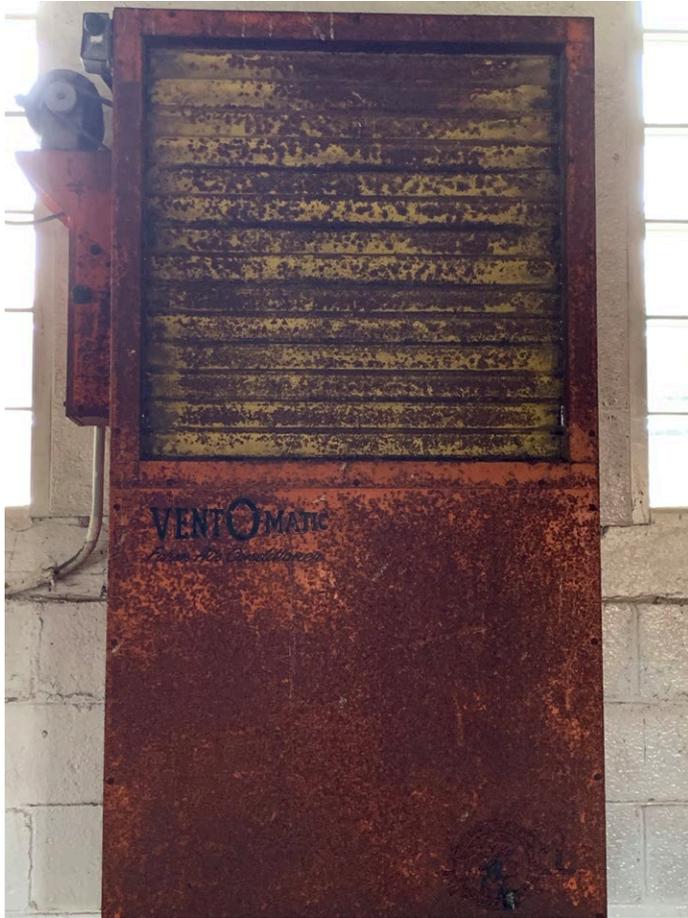
Plate 6.26: Vent-O-Matic heater on south wall of Building 11.

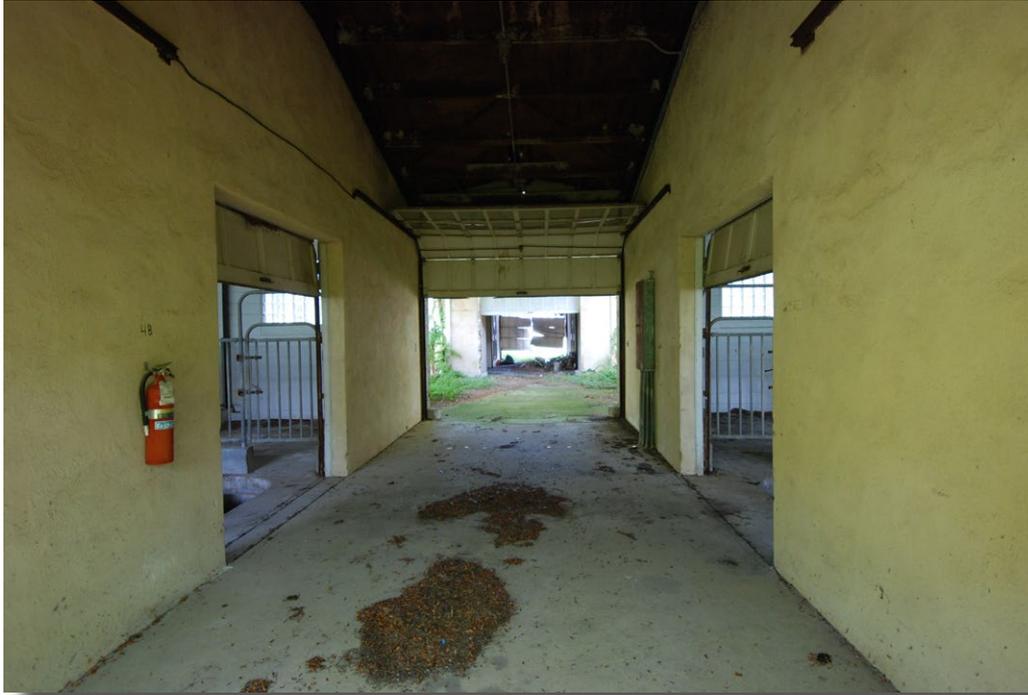
Plate 6.27: Central passageway of Building 12.

Note, a central aisle runs east/west through the stall areas, with a waste trough running along the sides of the aisle below concrete troughs used to feed the calves.

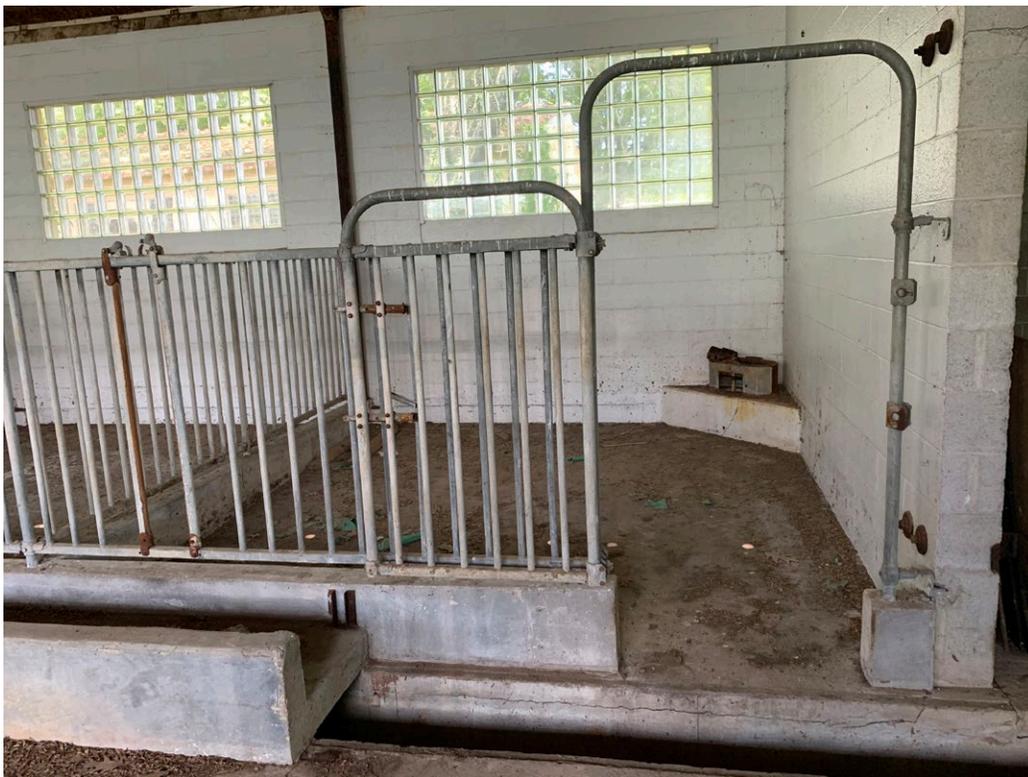
Plate 6.30: Typical stall in Building 12.

Note, individual troughs have a gate through the metal partition and a stanchion that was used during feeding.

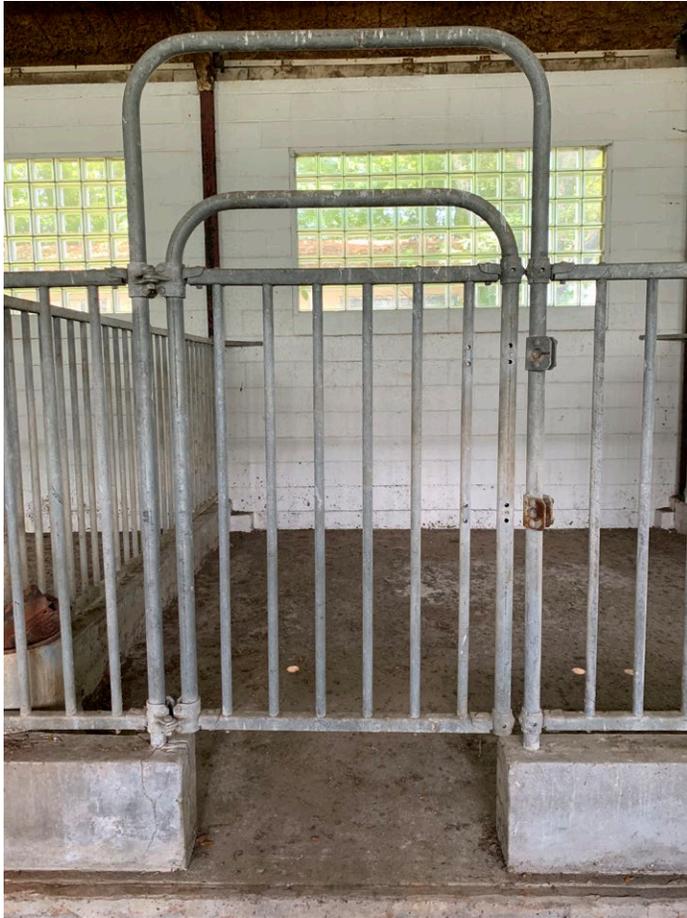
Plate 6.31: Typical gate in Building 12.

Note, the framing for the gates rises to a height of seven feet, and is embedded into concrete at the base.

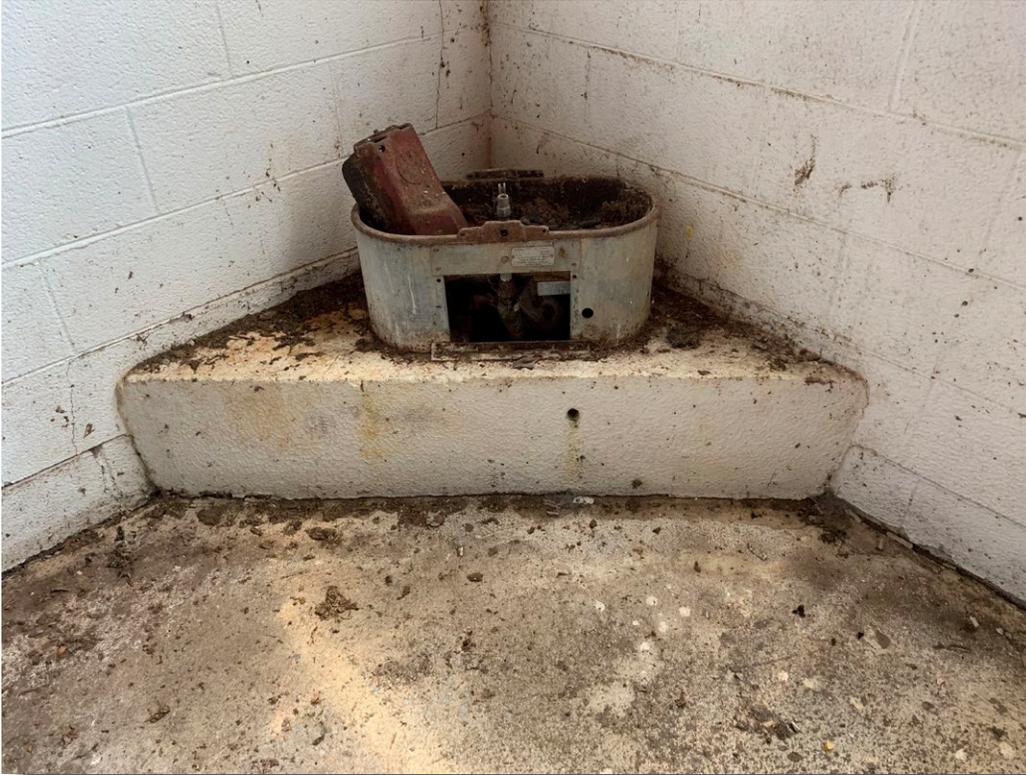
Plate 6.32: Corner heater in Building 12.

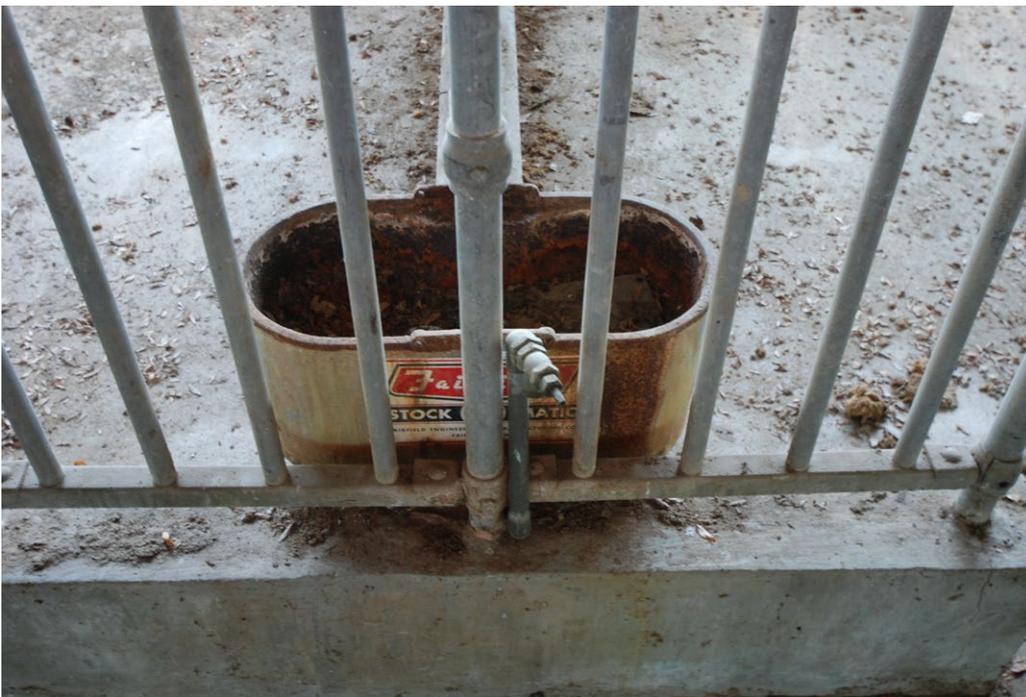
Plate 6.33: Fairfield StockMatic feeders in Building 12.

Note, each stall has access to a Fairfield StockMatic feeder in the front corners that was installed through the metal partition to feed two adjacent stalls.

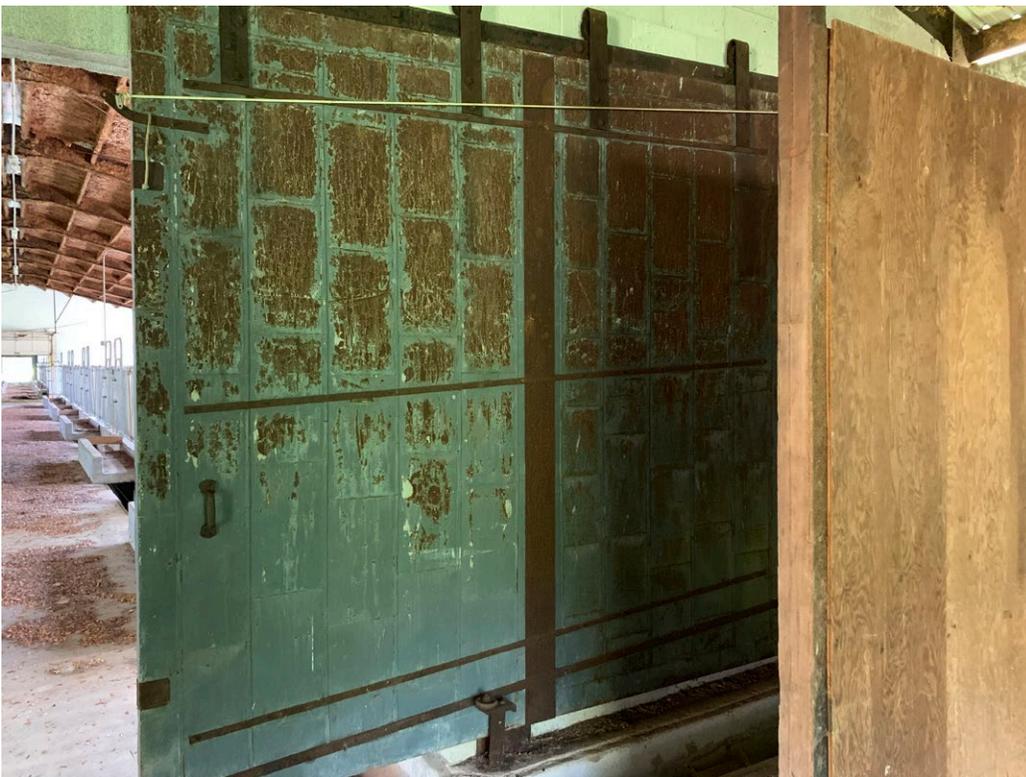
Plate 6.37: Large rolling door separating the storage room from the stall area in Building 12.

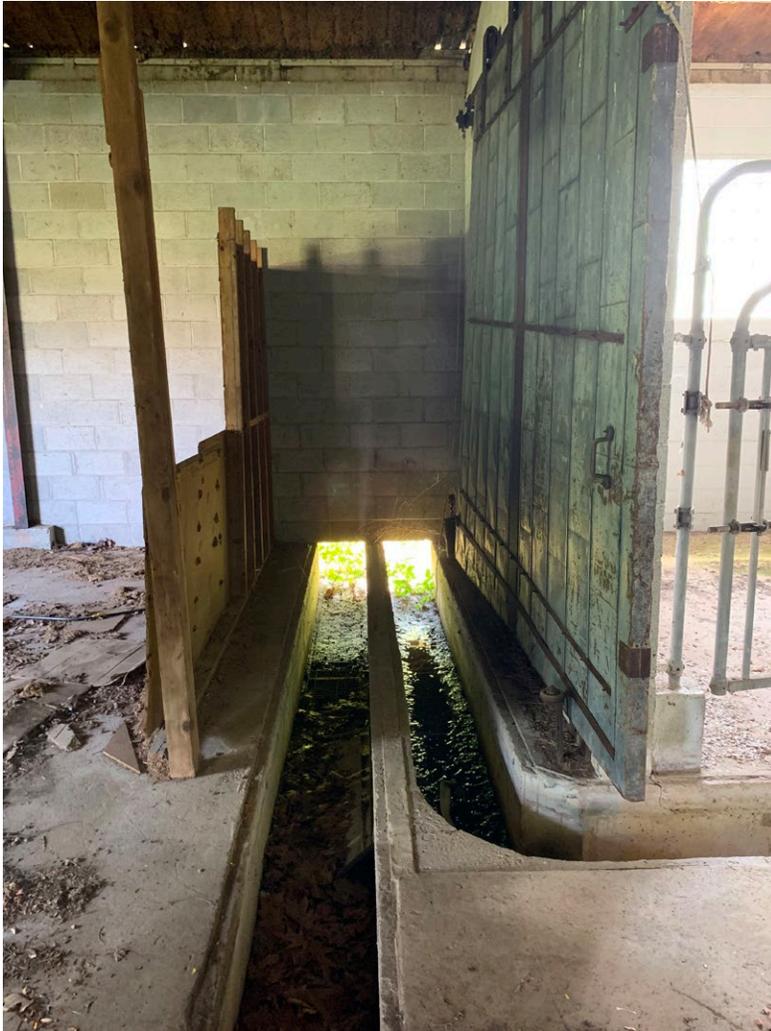
Plate 6.39: Detail of waste trough in east end of Building 12.

Note, the waste troughs extend into the storage rooms and turn south to exit the building.
