HISTORIC STRUCTURE REPORT

BRYN COED DAIRY FARM COMPLEX
1422 St. Matthews Road, West Vincent Township,
Chester County, Pennsylvania

October 2019

RICHARD
GRUBB &
ASSOCIATES

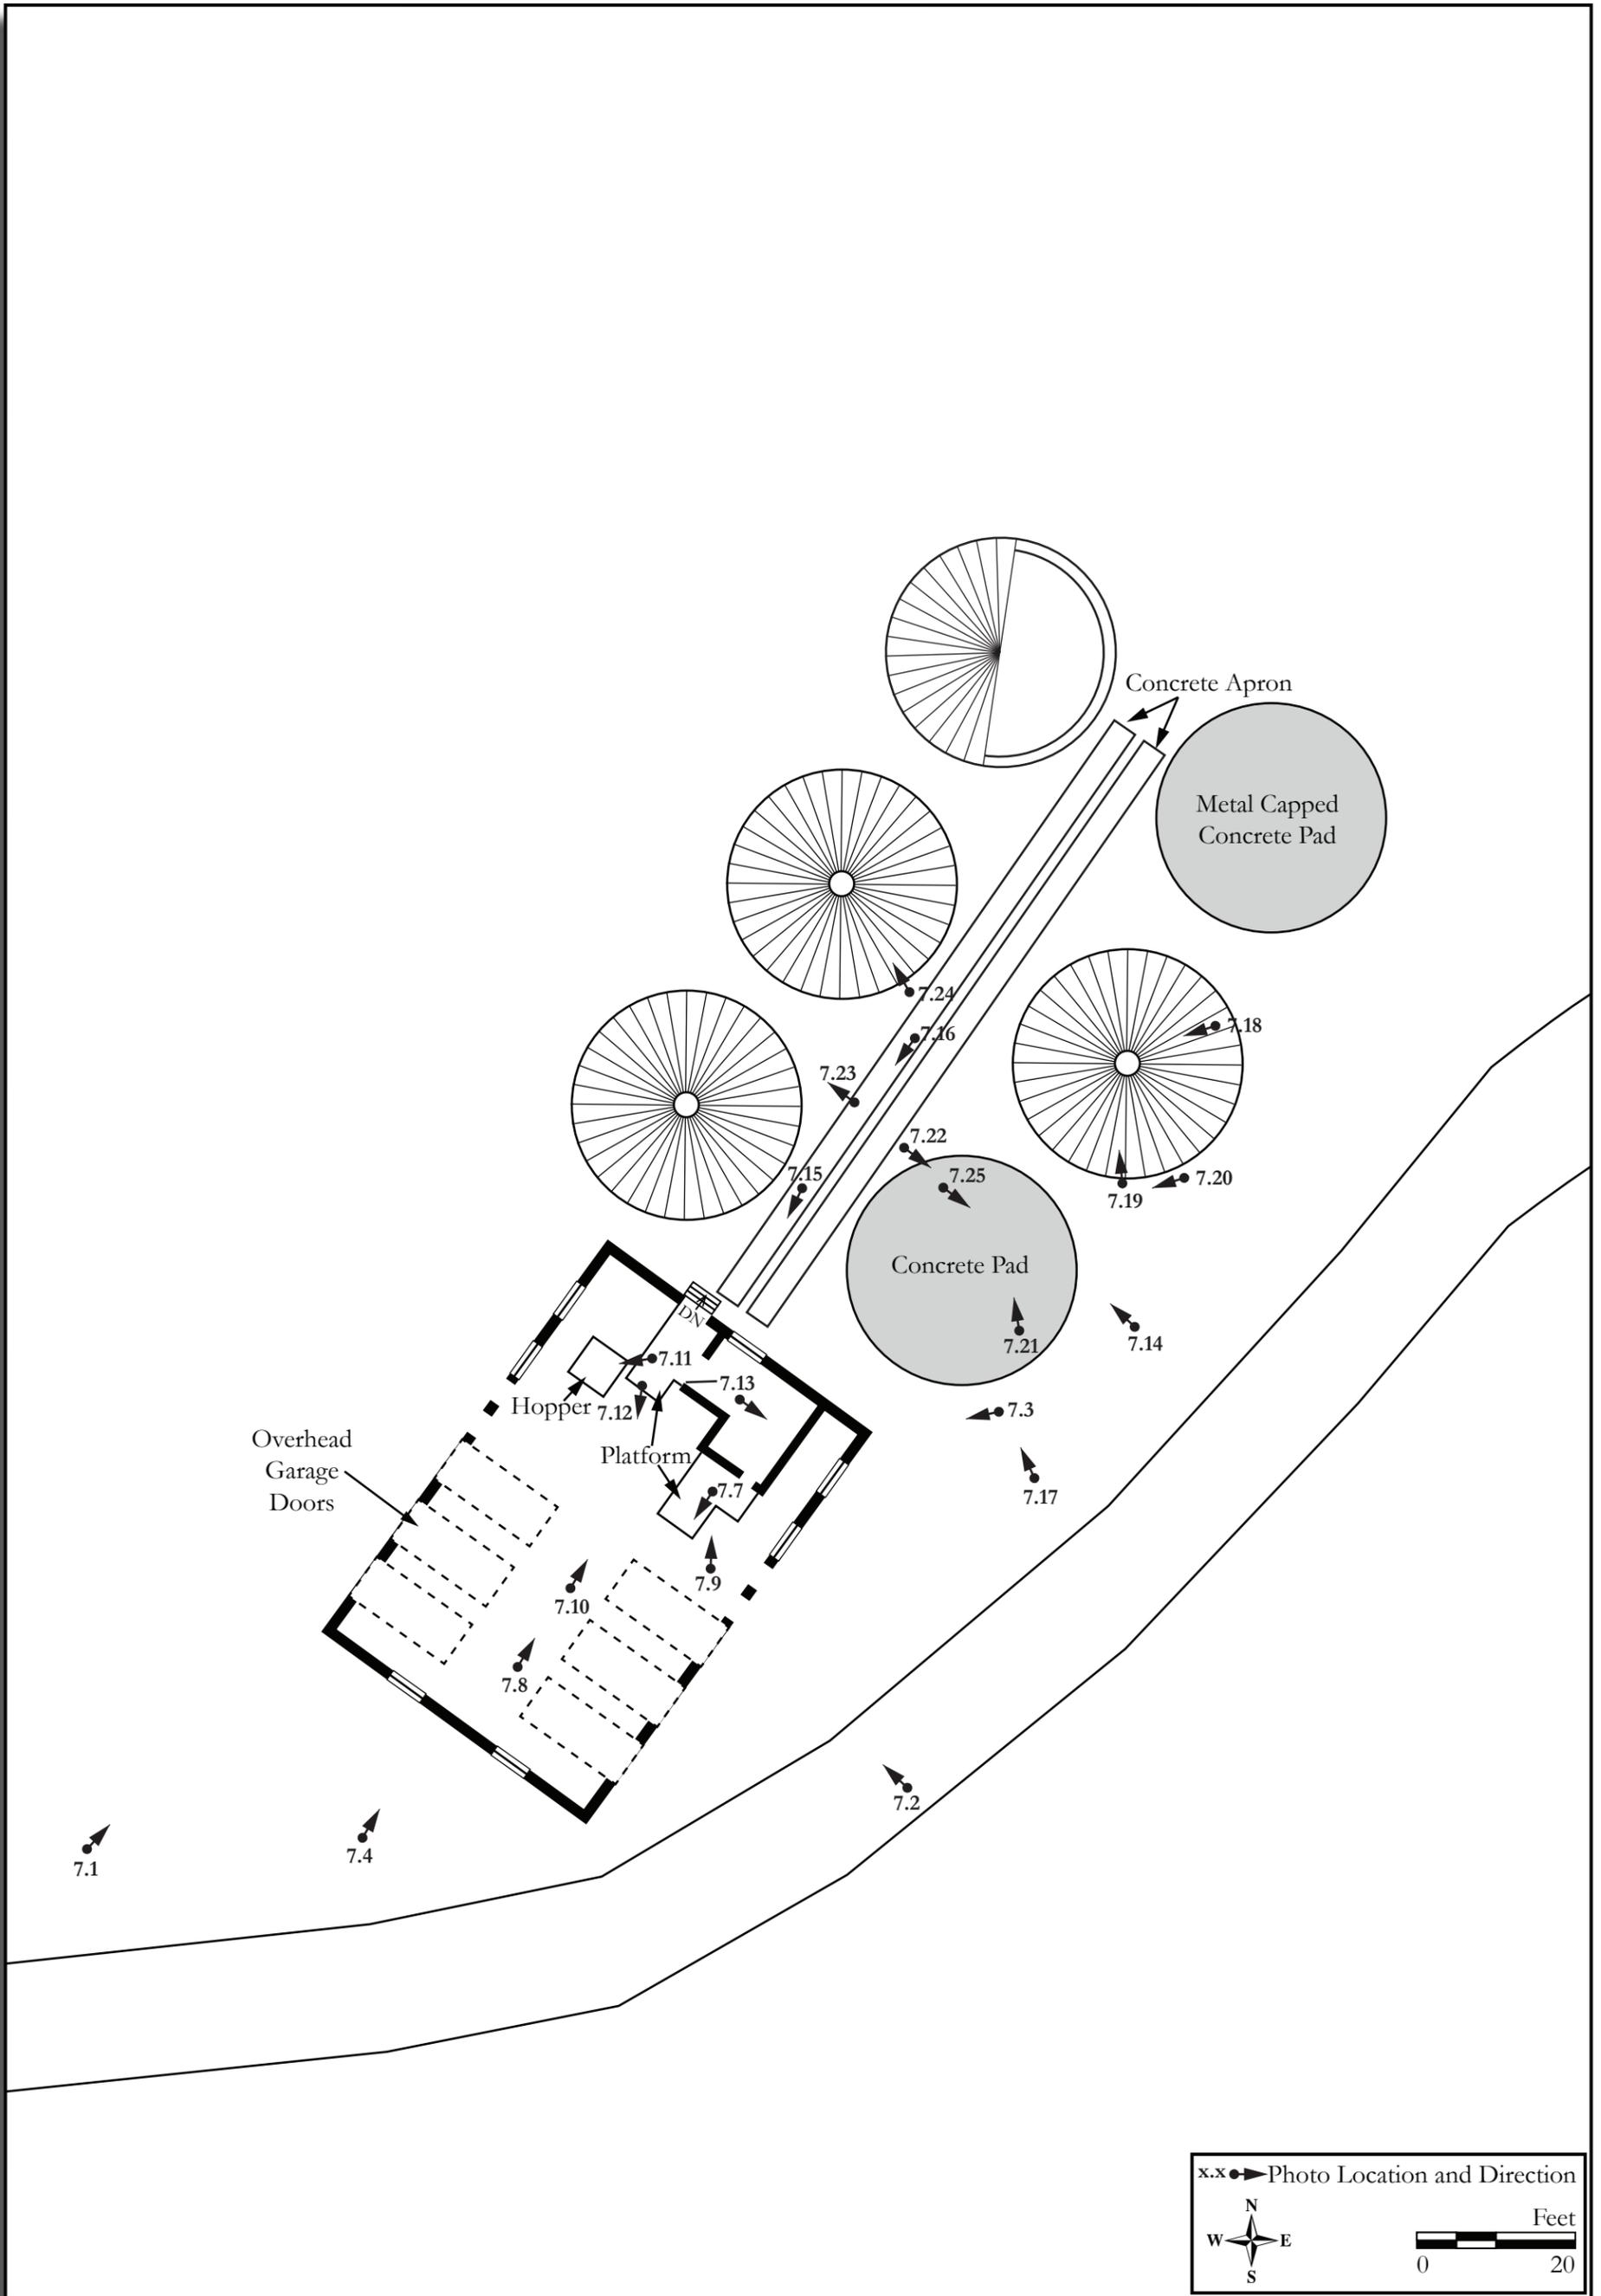
Figure 7.1: Silo and Feed Mixing Building Complex.

The Silo and Feed Mixing Building Complex is located approximately 600 feet east of the Main Barn Complex, on slightly lower ground (Plate 7.1; Figure 7.1). The complex is accessed by a gravel lane leading east from the Calf Barn Complex. The complex consists of a block building built for feed mixing operations and silo lot consisting of four associated silos to the northeast. A concrete apron with a recessed trough runs northeast from the northeast end of the Feed Mixing Building and through a paved concrete passageway between the silos. It appears that the trough transported silage from the silos to the Feed Mixing Building. The concrete apron surrounding the silos was used by machinery that loaded the silage into the silos. The silo lot is one of the largest on farm silage storage facilities in Chester County.

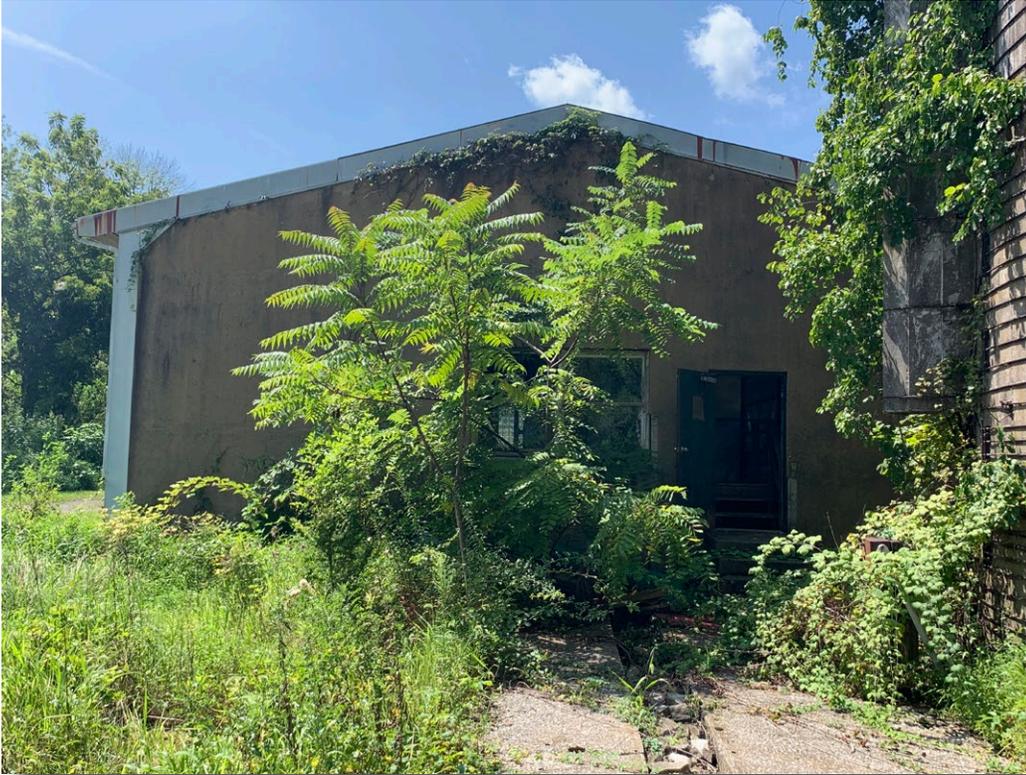
Plate 7.5: Feed Mixing Building, northeast end.

Note, the metal hollow core door with a square inset light accesses the exterior of the building atop a frame stoop.

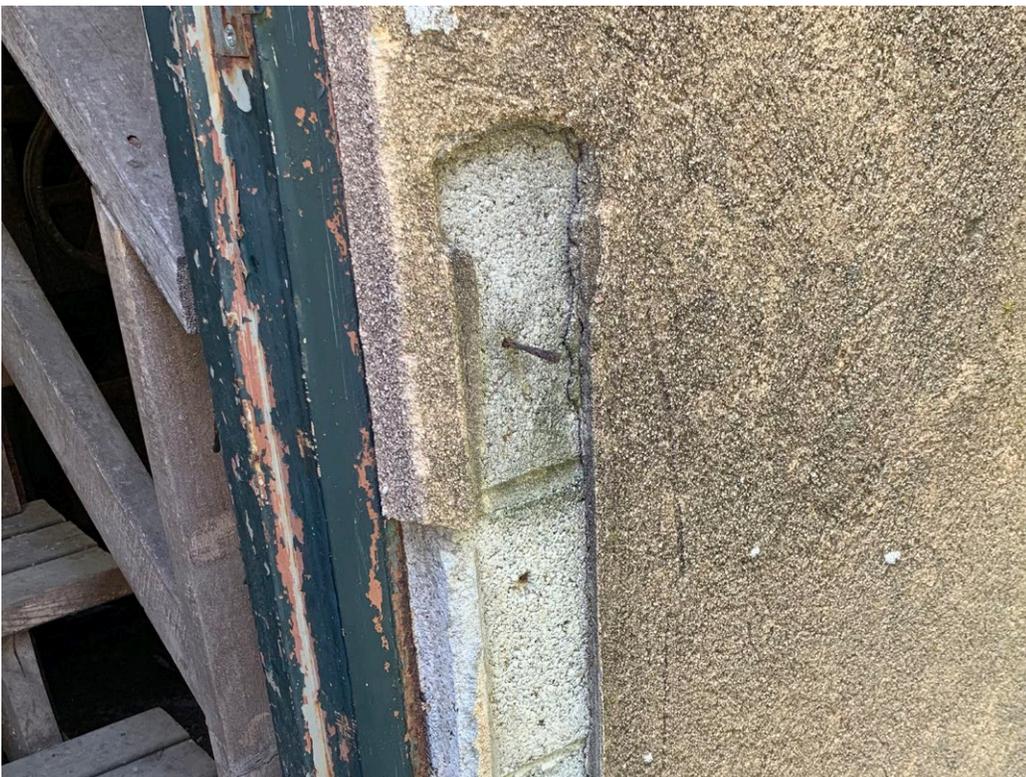
Plate 7.6: Detail of northeast elevation of Feed Mixing Building showing the imprint of the now-removed wooden railing for the porch.

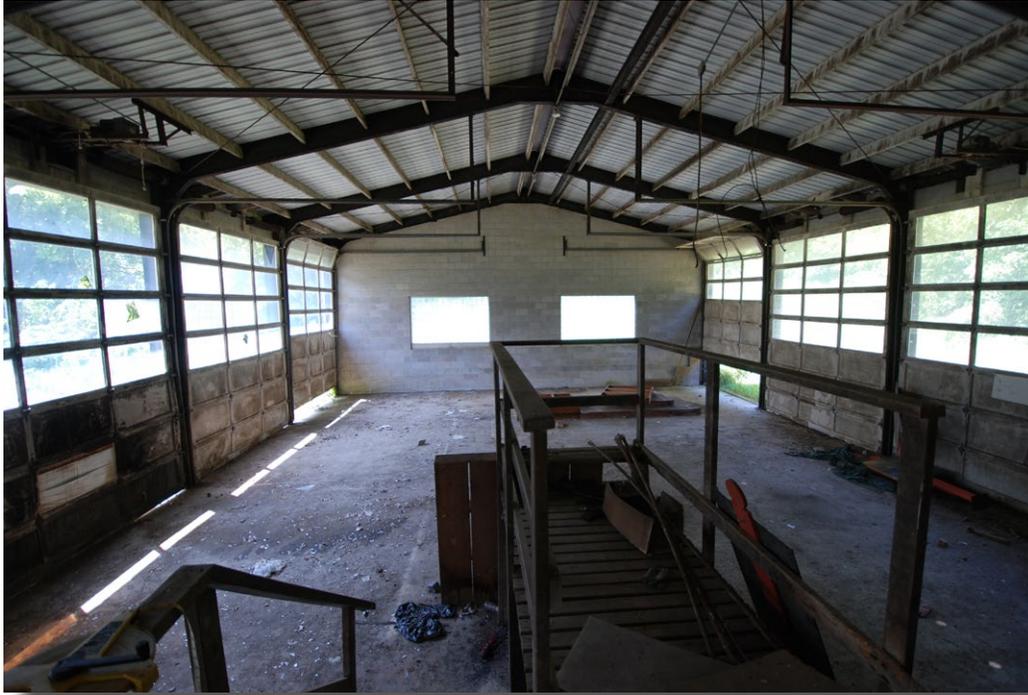
Plate 7.7: Interior of Feed Mixing Building, as viewed from the interior platform.

Note, the main room, which has the three drive-through bays for farm machinery, has steel I-beams along the outer walls that are attached to steel rafters.

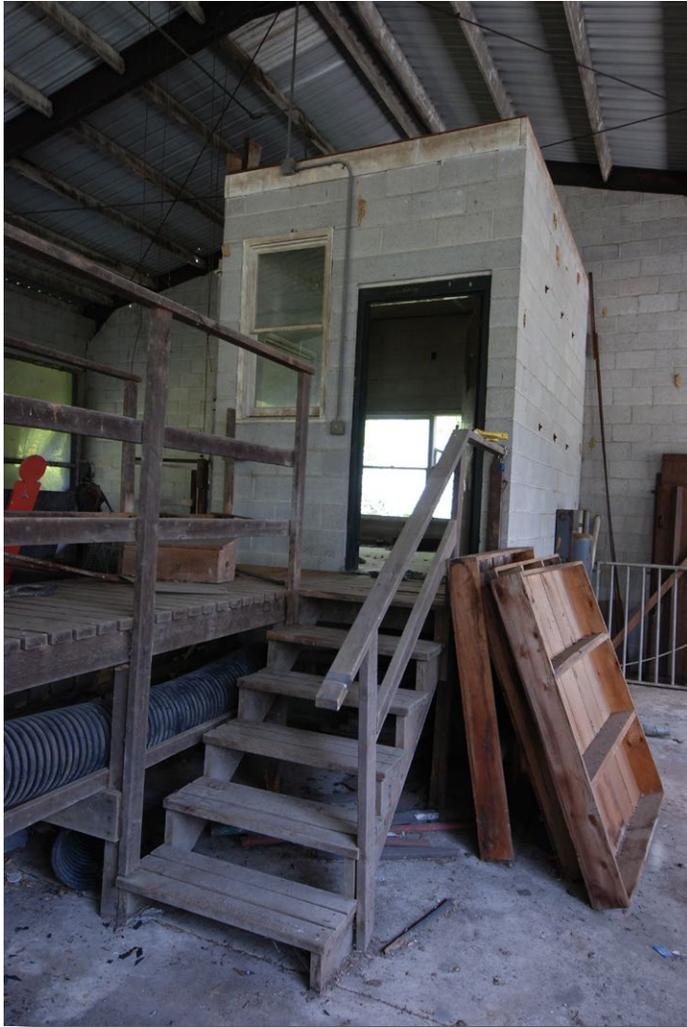
Plate 7.9: Mechanical control room and frame steps to the main platform in Feed Mixing Building.

Note, the steps lead to the mechanical control room, which is elevated off the main floor of the building.

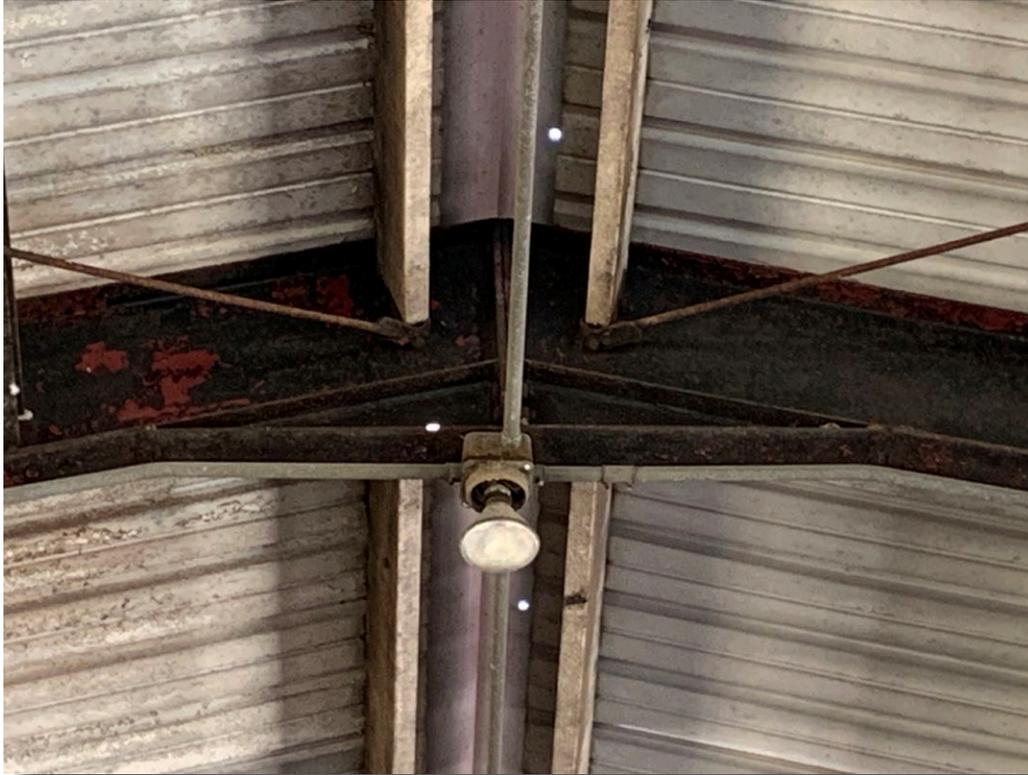
Plate 7.10: Detail of the joint at the ridge where the steel I-beams meet in the Feed Mixing Building.

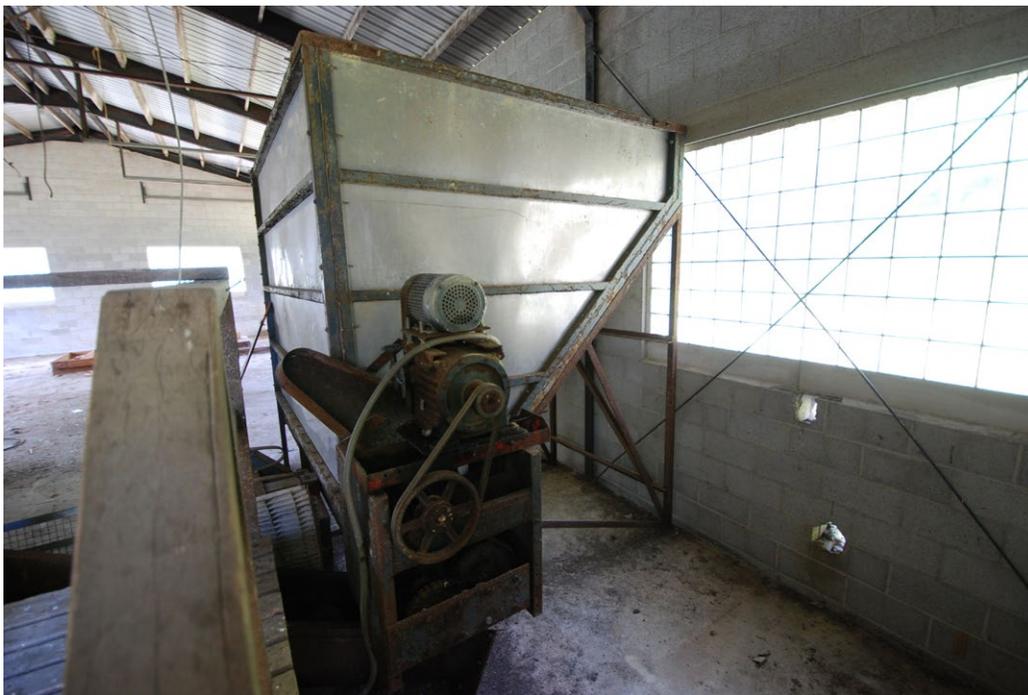
Plate 7.11: Silage hopper near north corner of Feed Mixing Building, as viewed from the platform.

Note, the hopper ground silage, and an auger conveyed the silage into a trough that carried the silage northeast to the silos.

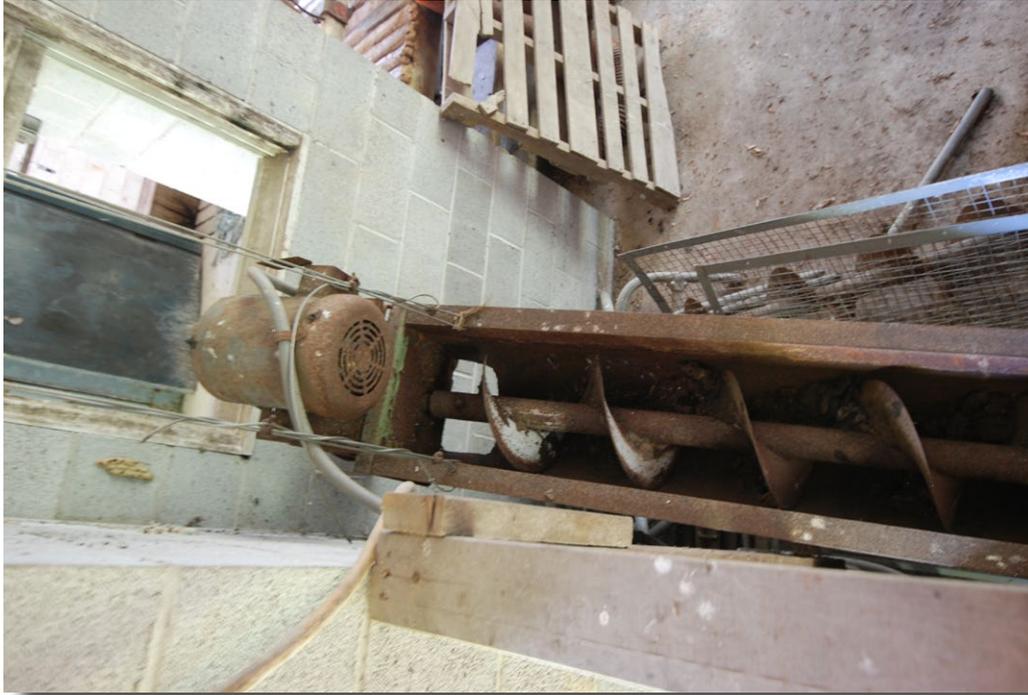
Plate 7.12: Auger that delivered silage from the hopper to the trough leading to the silos.

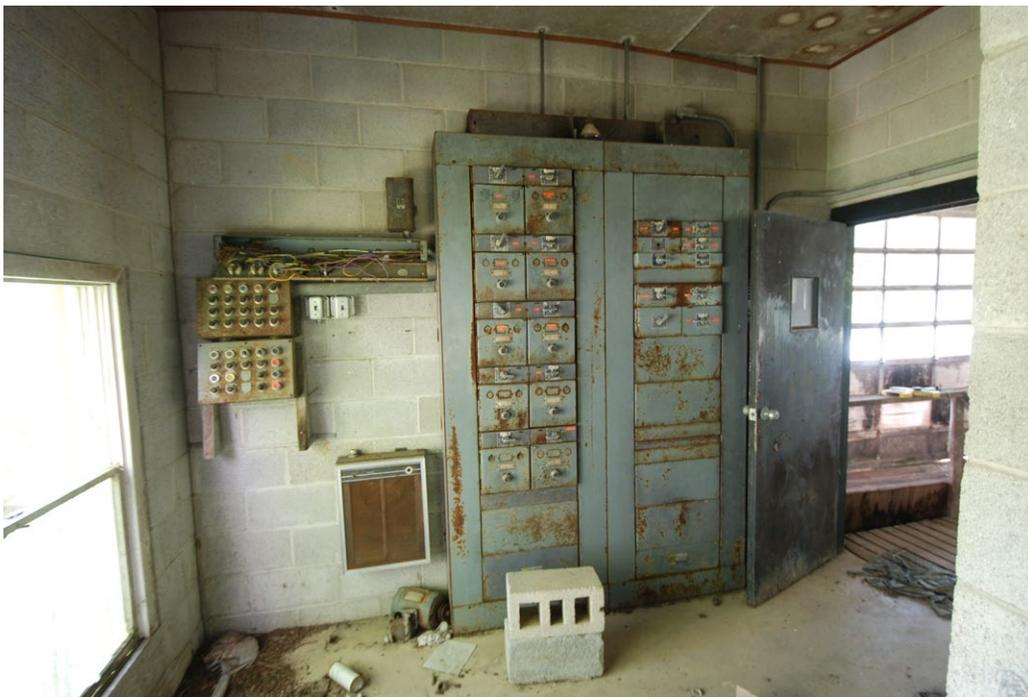
Plate 7.13: Mechanical control room in Feed Mixing Building.

Note, electric control panels on the southeast wall of the room managed the silage operations.

The Feed Mixing Building is a one-story, five-bay building facing southeast (Plates 7.2 to 7.13). The building's overall measurements are 60 by 40 feet. Its end-gabled roof is clad with corrugated tin, and the walls are stucco over concrete block. On the main (southeast) and rear (northwest) elevations, the three bays to the southwest feature large overhead garage doors that allowed farm equipment to drive through the building. The fourth bay on the southeast side and the second bay on the northwest side have a metal hollow core door and a large Belgian block window unit. The remaining bay on each side has a large Belgian block window. The southwest end, which is the first elevation viewed from the property drive, features two large Belgian block window units. The northeast end features concrete steps leading up to an elevated metal hollow core door. A wooden railing formerly lined the sides of the steps to the entrance, and the stucco was installed around this railing (leaving an impression of the shape of the railing when it was removed). The building has a concrete foundation. The key feature in the building is a mixer located in its north corner, closest to the silos. Silage was transported from the silos via the concrete troughs, mixed, and then loaded on trucks within the building. An elevated office enabled observation of the process.

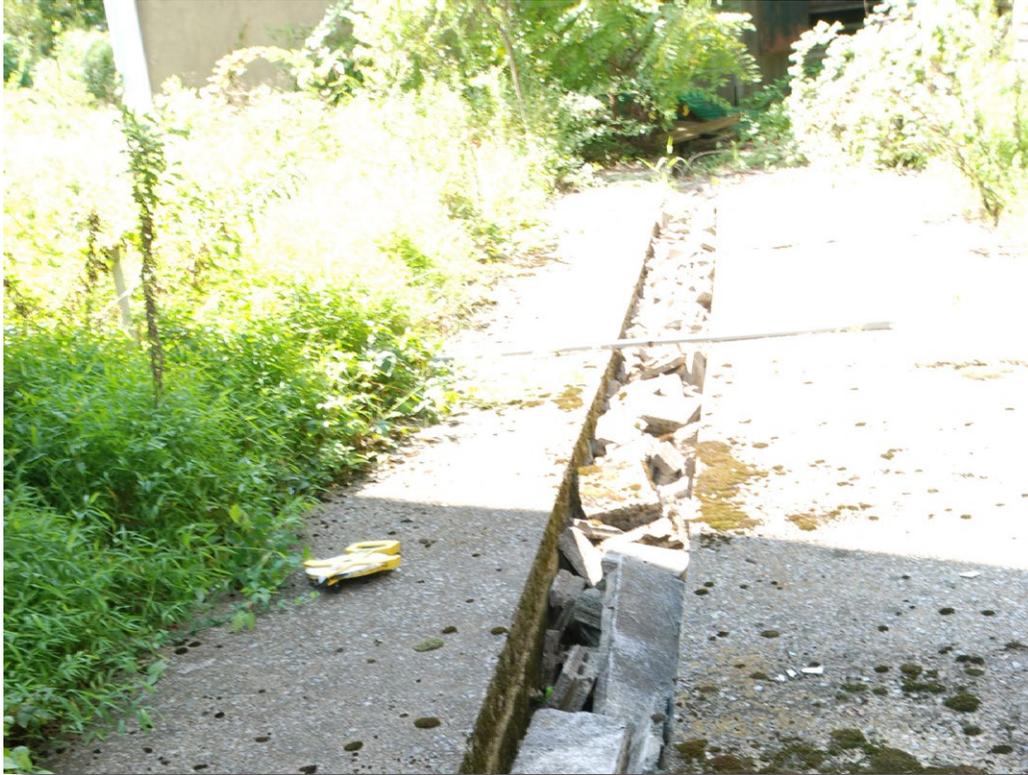
Plate 7.15: Silage trough leading through the concrete apron between the silos.

Four silos and two silo foundations are located northeast of the Feed Mixing Building (Plates 7.14 to 7.25). As mentioned, a concrete apron with a centered trough runs through the middle of the silos, with three silos to the northwest and one (plus the two silo foundations) to the southeast. The silos measure approximately 72 feet tall and 29 feet in diameter. All silos were built with a metal silo cap in the shape of a half-globe, although the northern silo has lost its cap. The silo walls are built of concrete staves measuring 30 by 10 inches and four inches thick. Iron bands were installed around the perimeter to hold the staves in tension; as the silos rise, the bands are spaced further apart because the staves are gradually under less compression. The hoistways are located on the side of the silo facing the trough, and open ladders on the opposite side of each silo extend upward to the entrance into the cap.

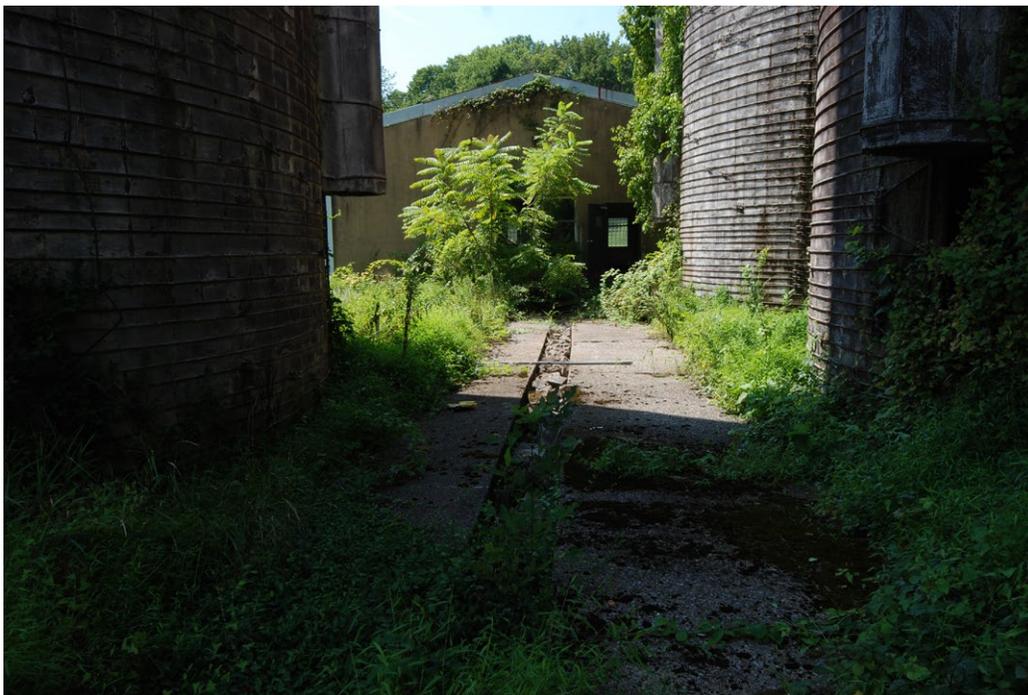
Plate 7.16: Silage trough leading through the concrete apron between the silos.

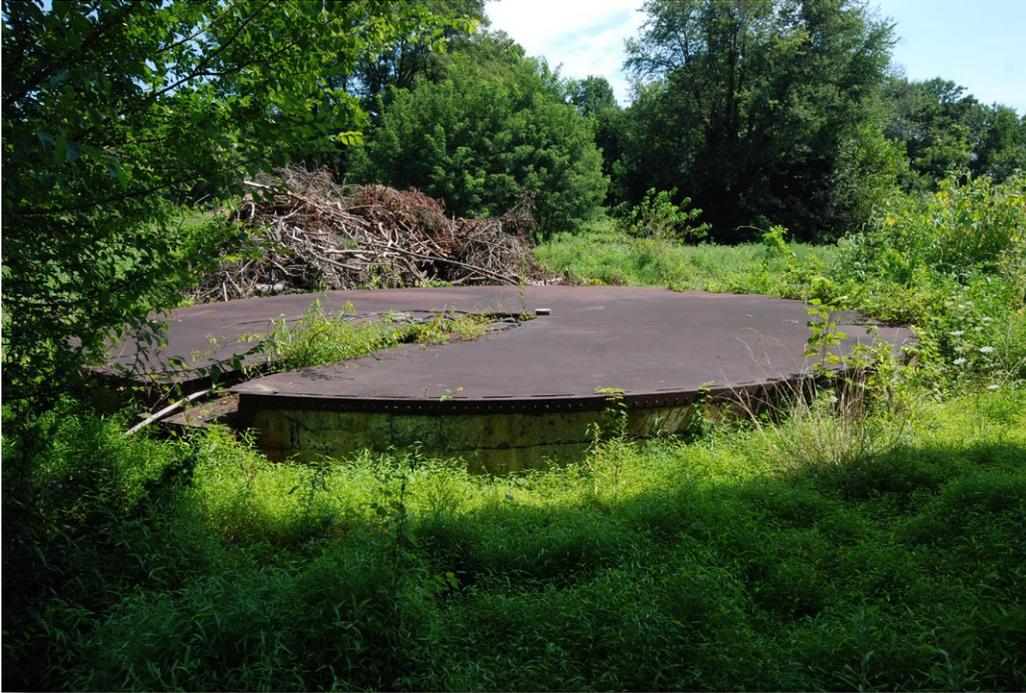
Plate 7.19: Foundation of a now-removed silo.

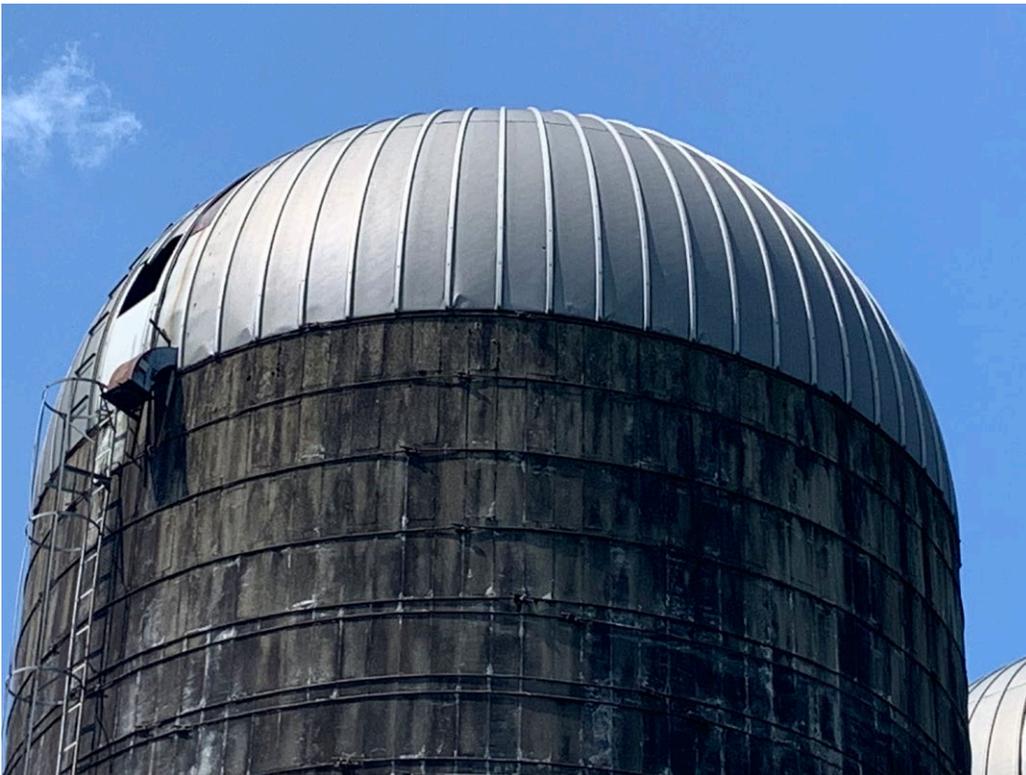
Plate 7.20: Detail of the metal half-globe silo cap.

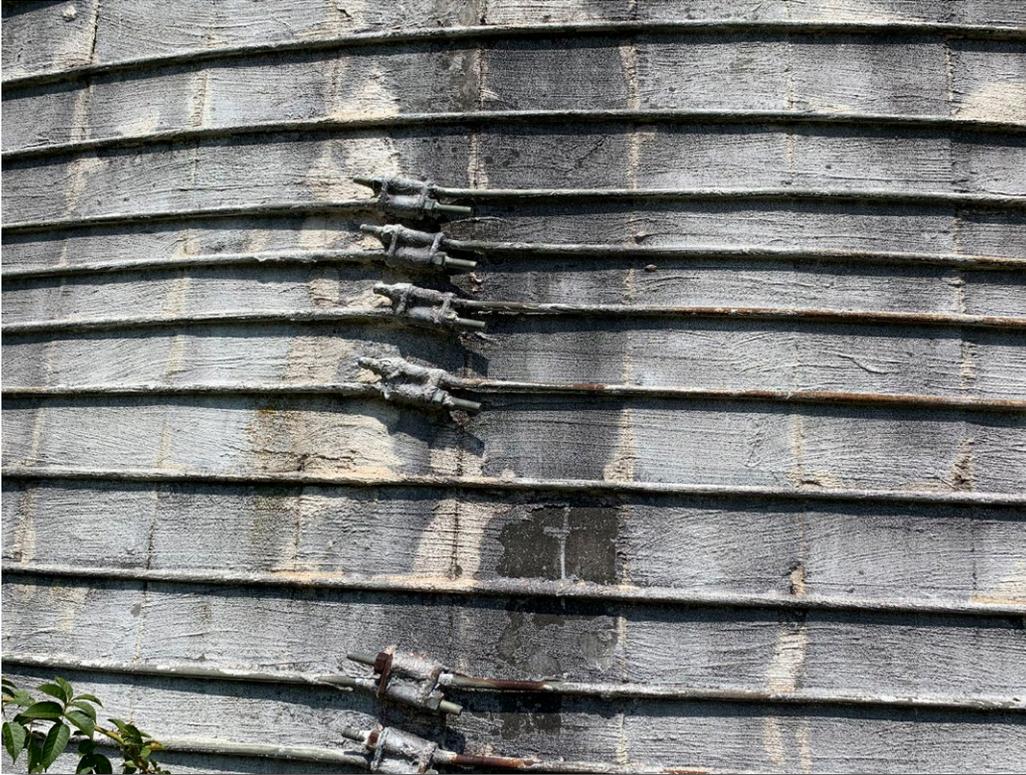
Plate 7.21: Detail of iron bands that hold the silos in place.

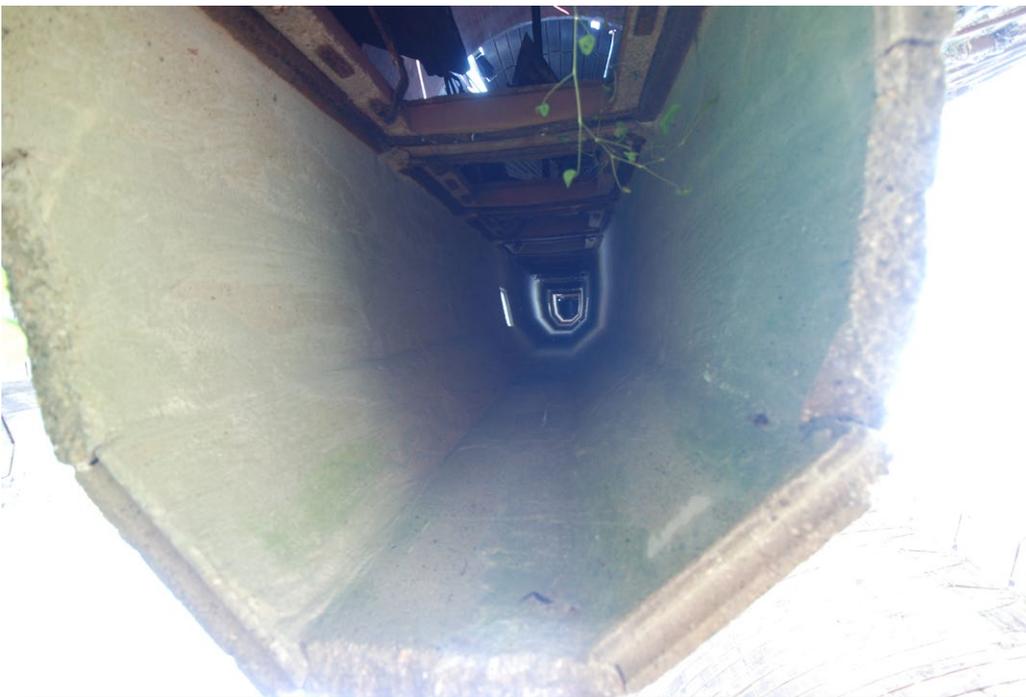
Plate 7.22: View facing up into a hoistway.

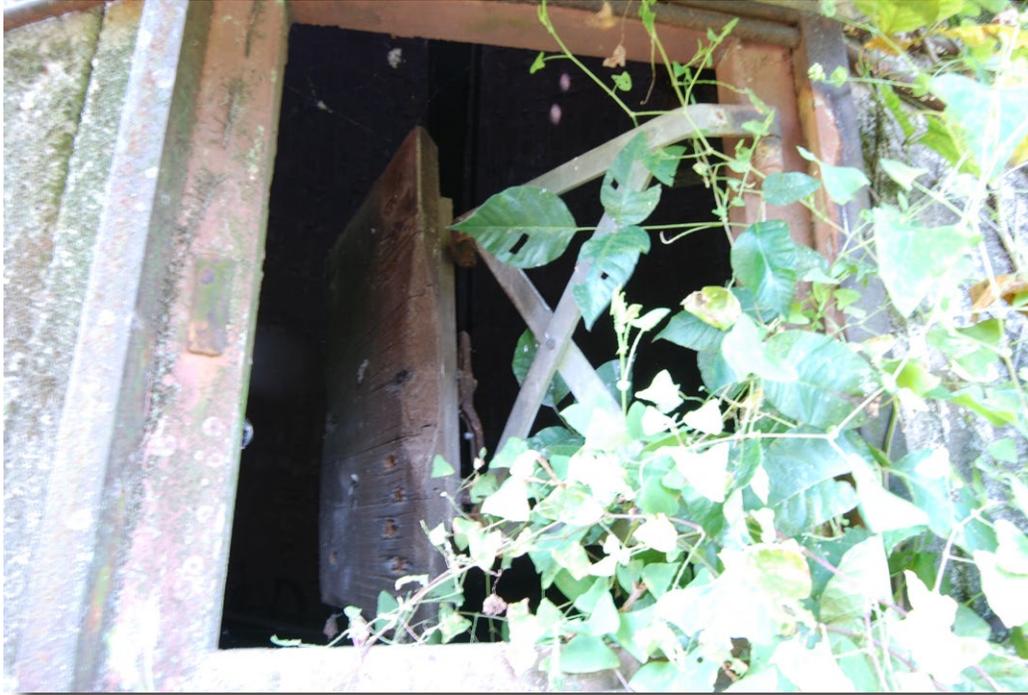
Plate 7.23: Detail of a silo closeable door below the hoistway.

Note, as the silo is filled from the bottom, these special doors can be closed and locked in place.

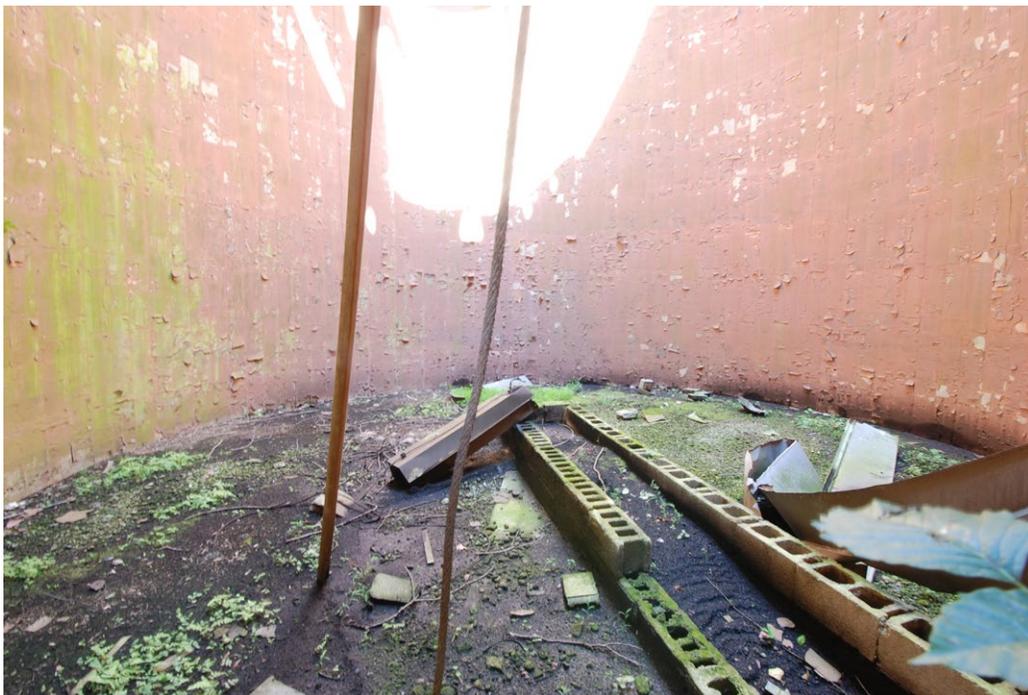
Plate 7.24: Interior of a silo without its cap.

Note, a reddish pink interior coat was installed over the inside of the concrete staves. The concrete floor features two rows of concrete blocks that were used to assist in unloading the silage.

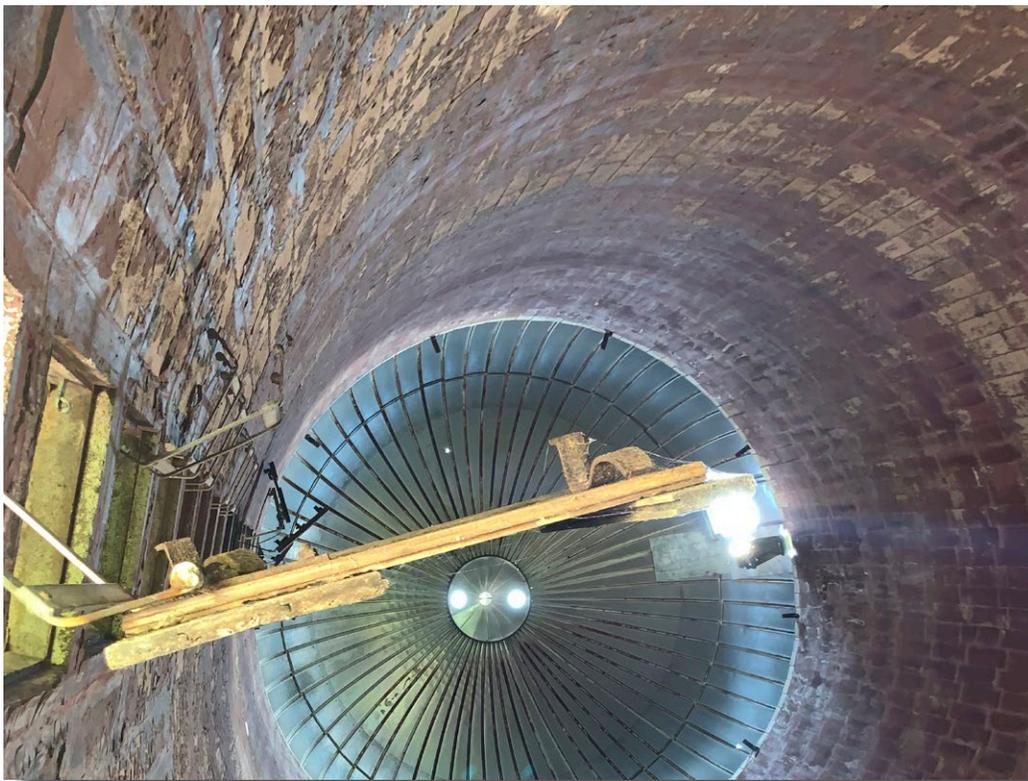
Plate 7.25: Interior of the southeast silo, facing up to its cap.

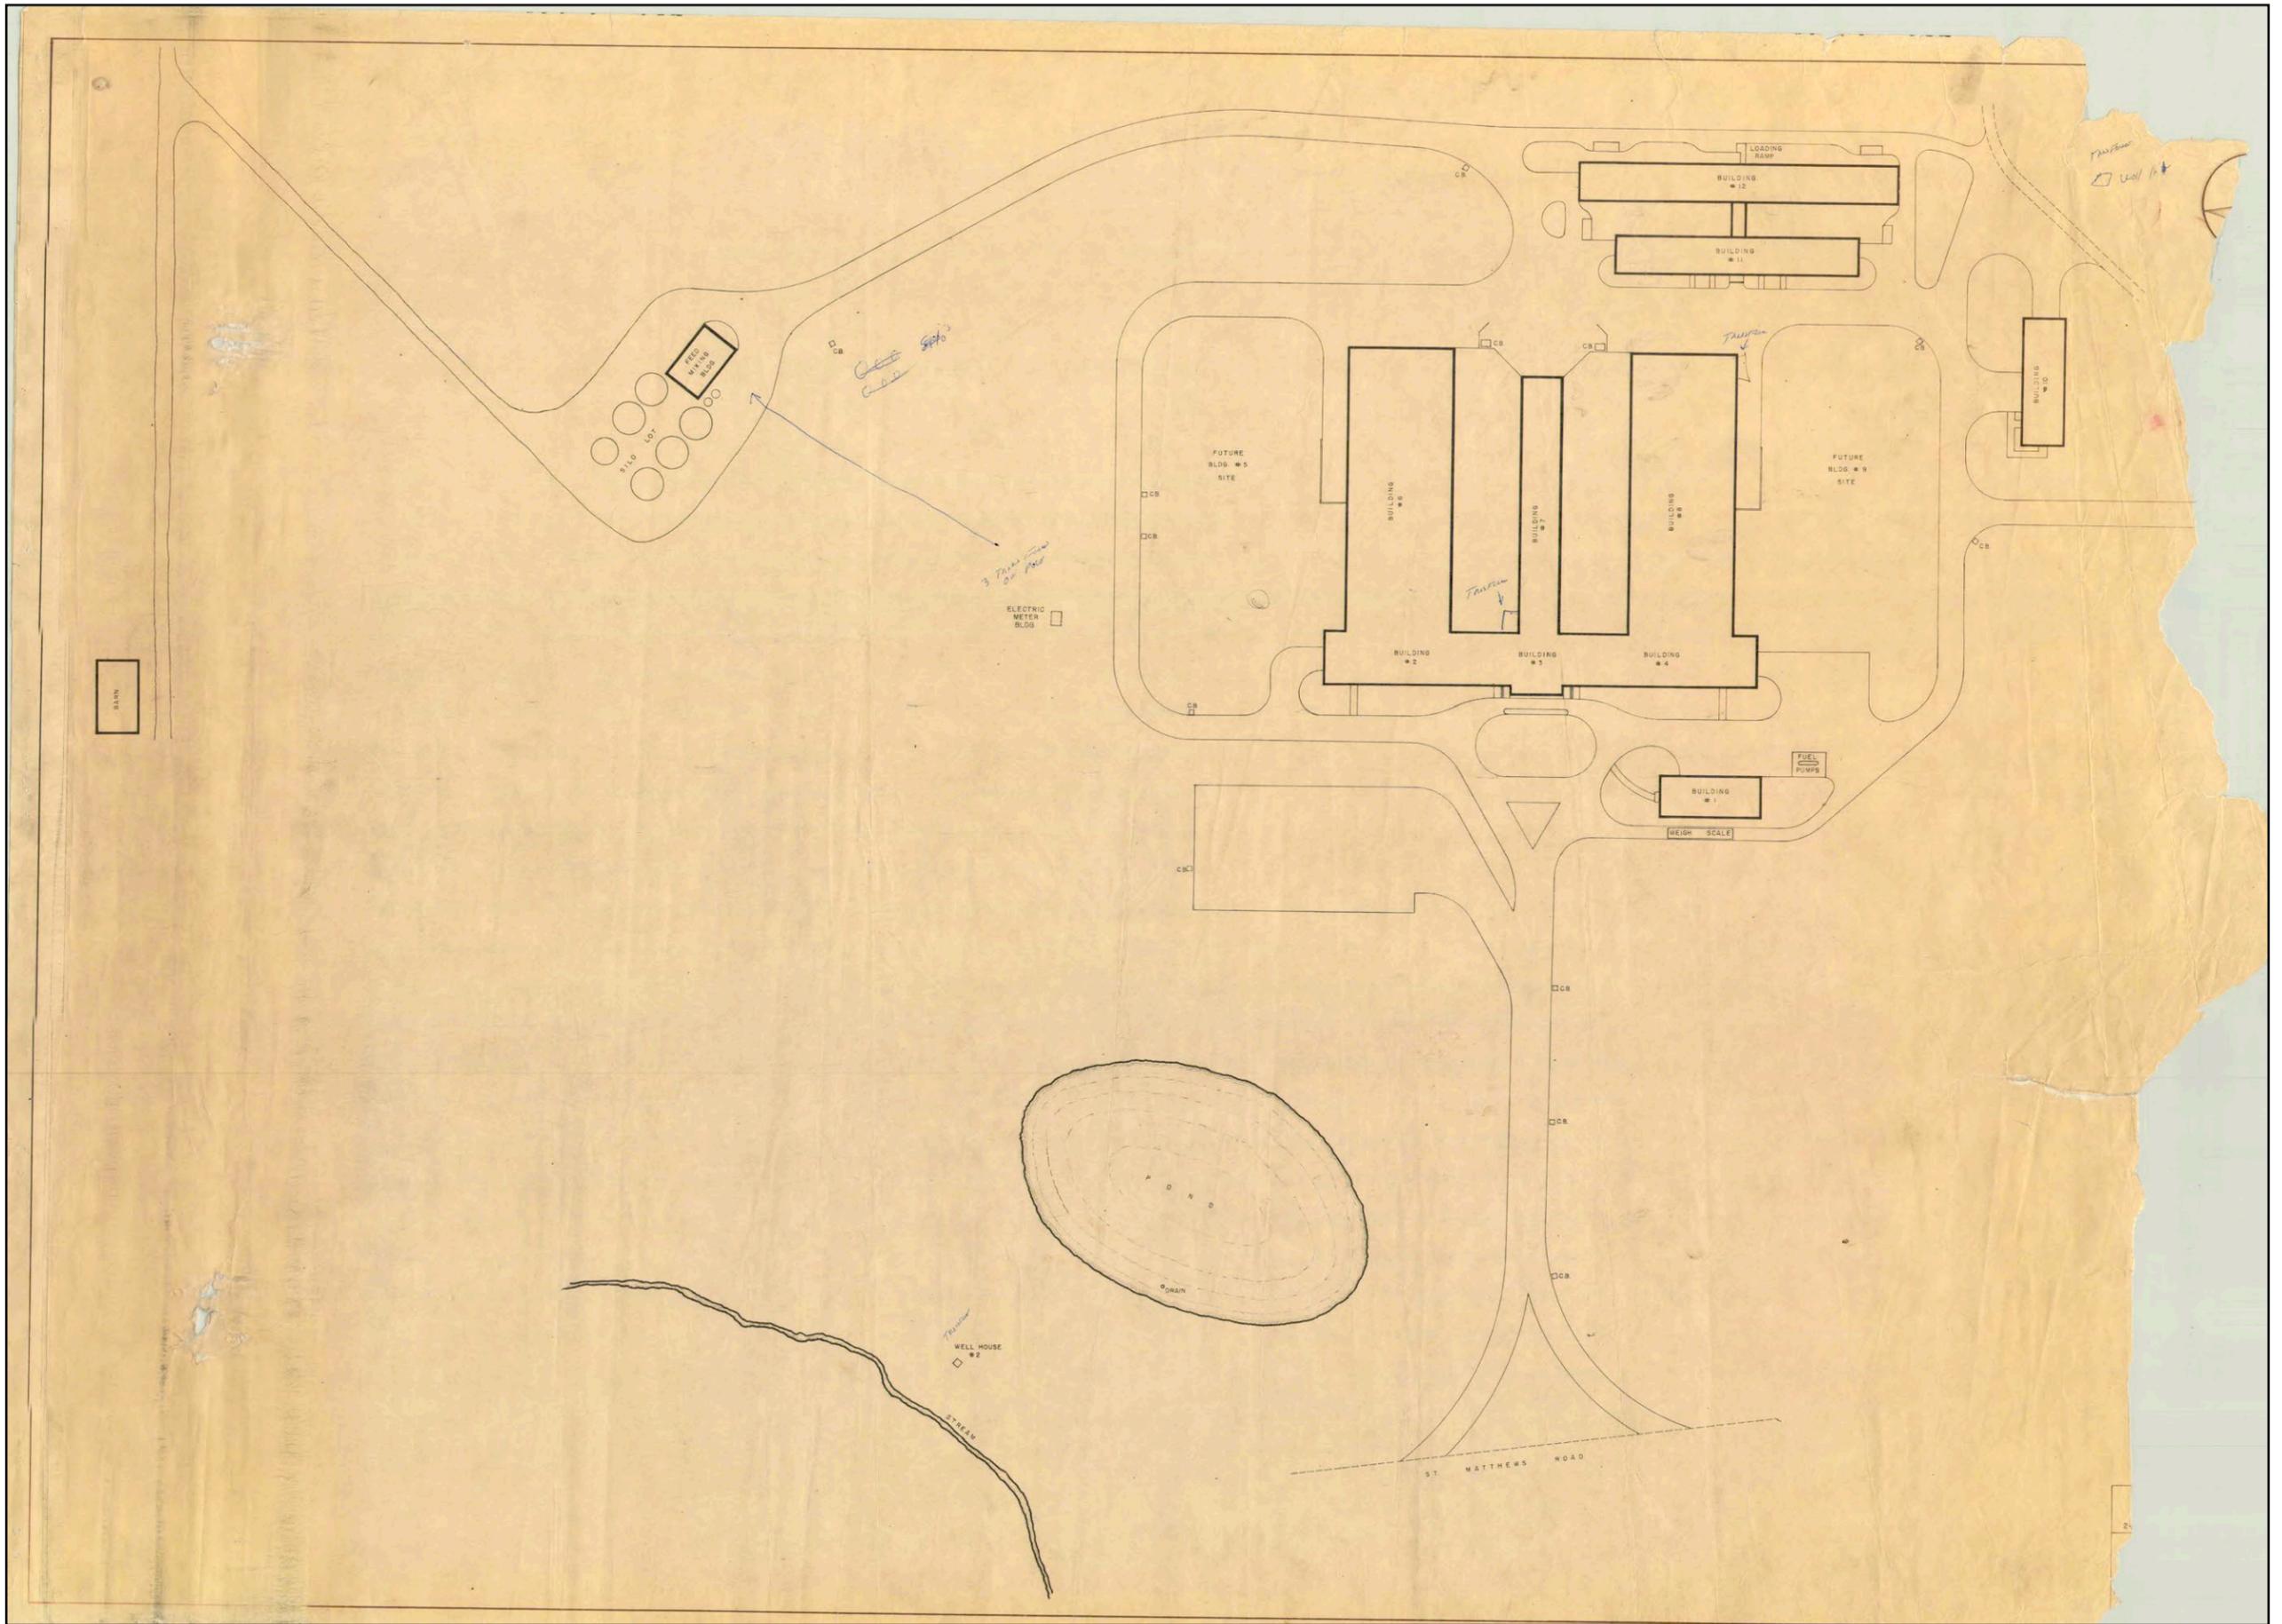
1 - Site Layout Plan.
