HISTORIC STRUCTURE REPORT

BRYN COED DAIRY FARM COMPLEX
1422 St. Matthews Road, West Vincent Township,
Chester County, Pennsylvania

October 2019

RICHARD
GRUBB &
ASSOCIATES

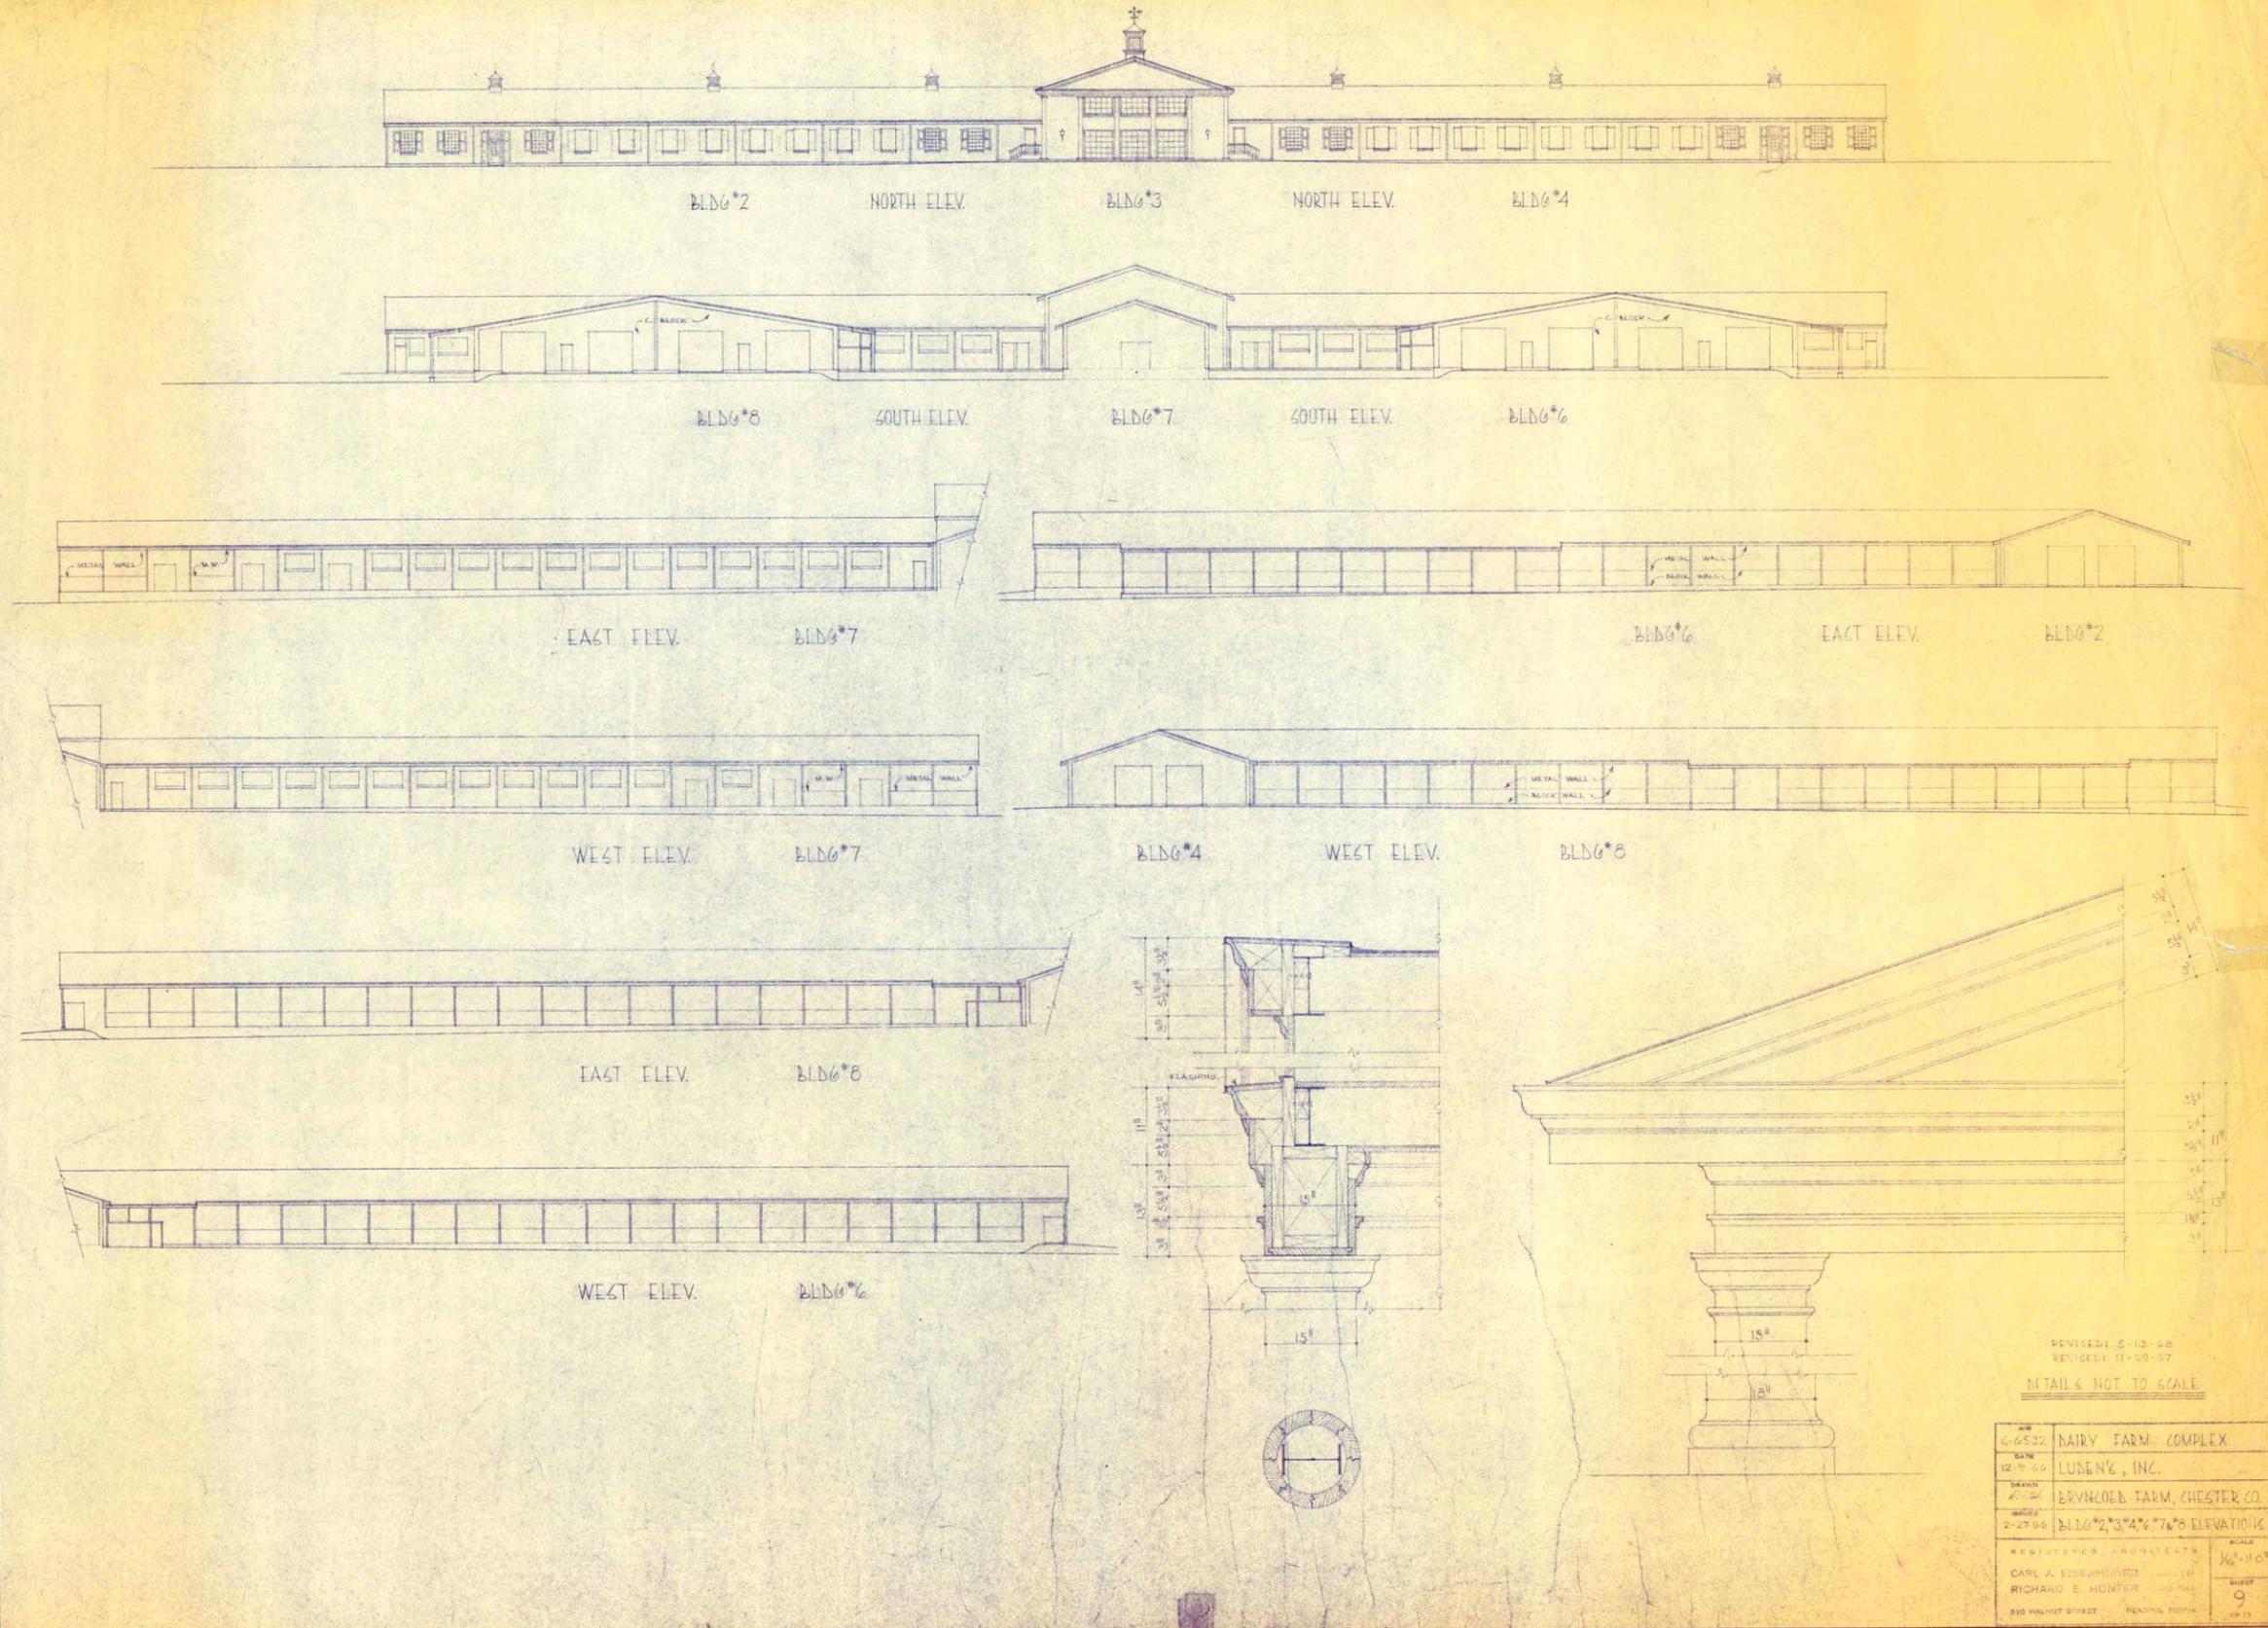
2 - Elevations of Main Barn Complex.

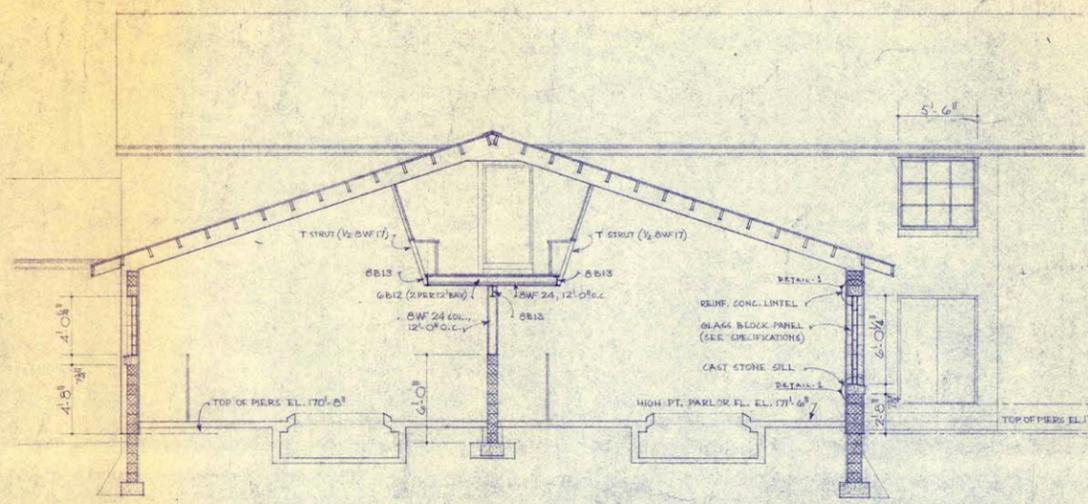
SECTION THRU BLDG #2 FACING WEST & BLDG #3

SCALE: 1/4" = 1'-0"

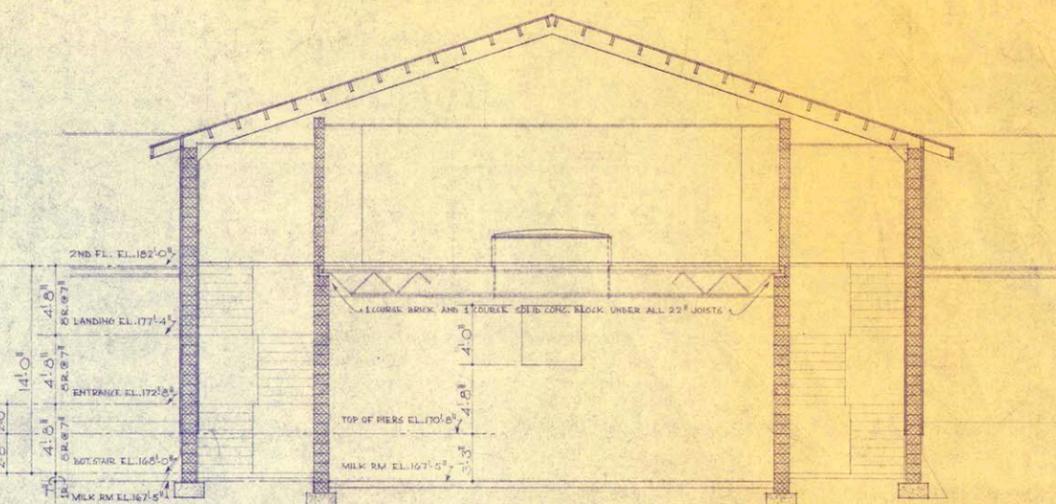
SECTION THRU BLDG #3 FACING SOUTH

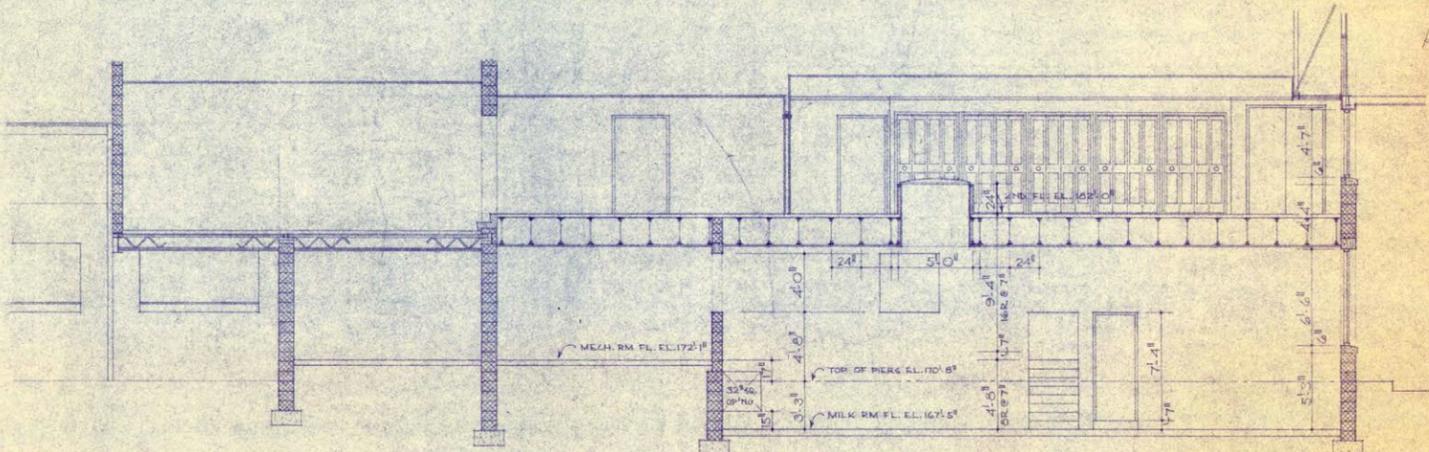
SECTION THRU BLDG #7 & #3 FACING WEST

SCALE: 1/4" = 1'-0"

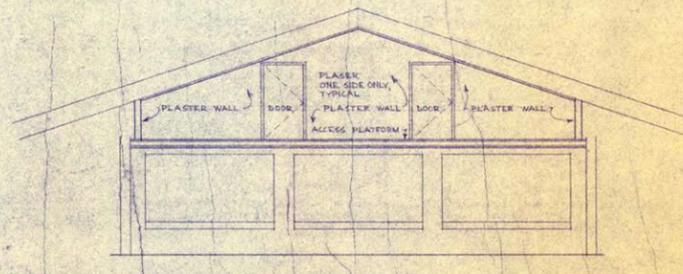
SECTION THRU MEETING RM. FACING NORTH

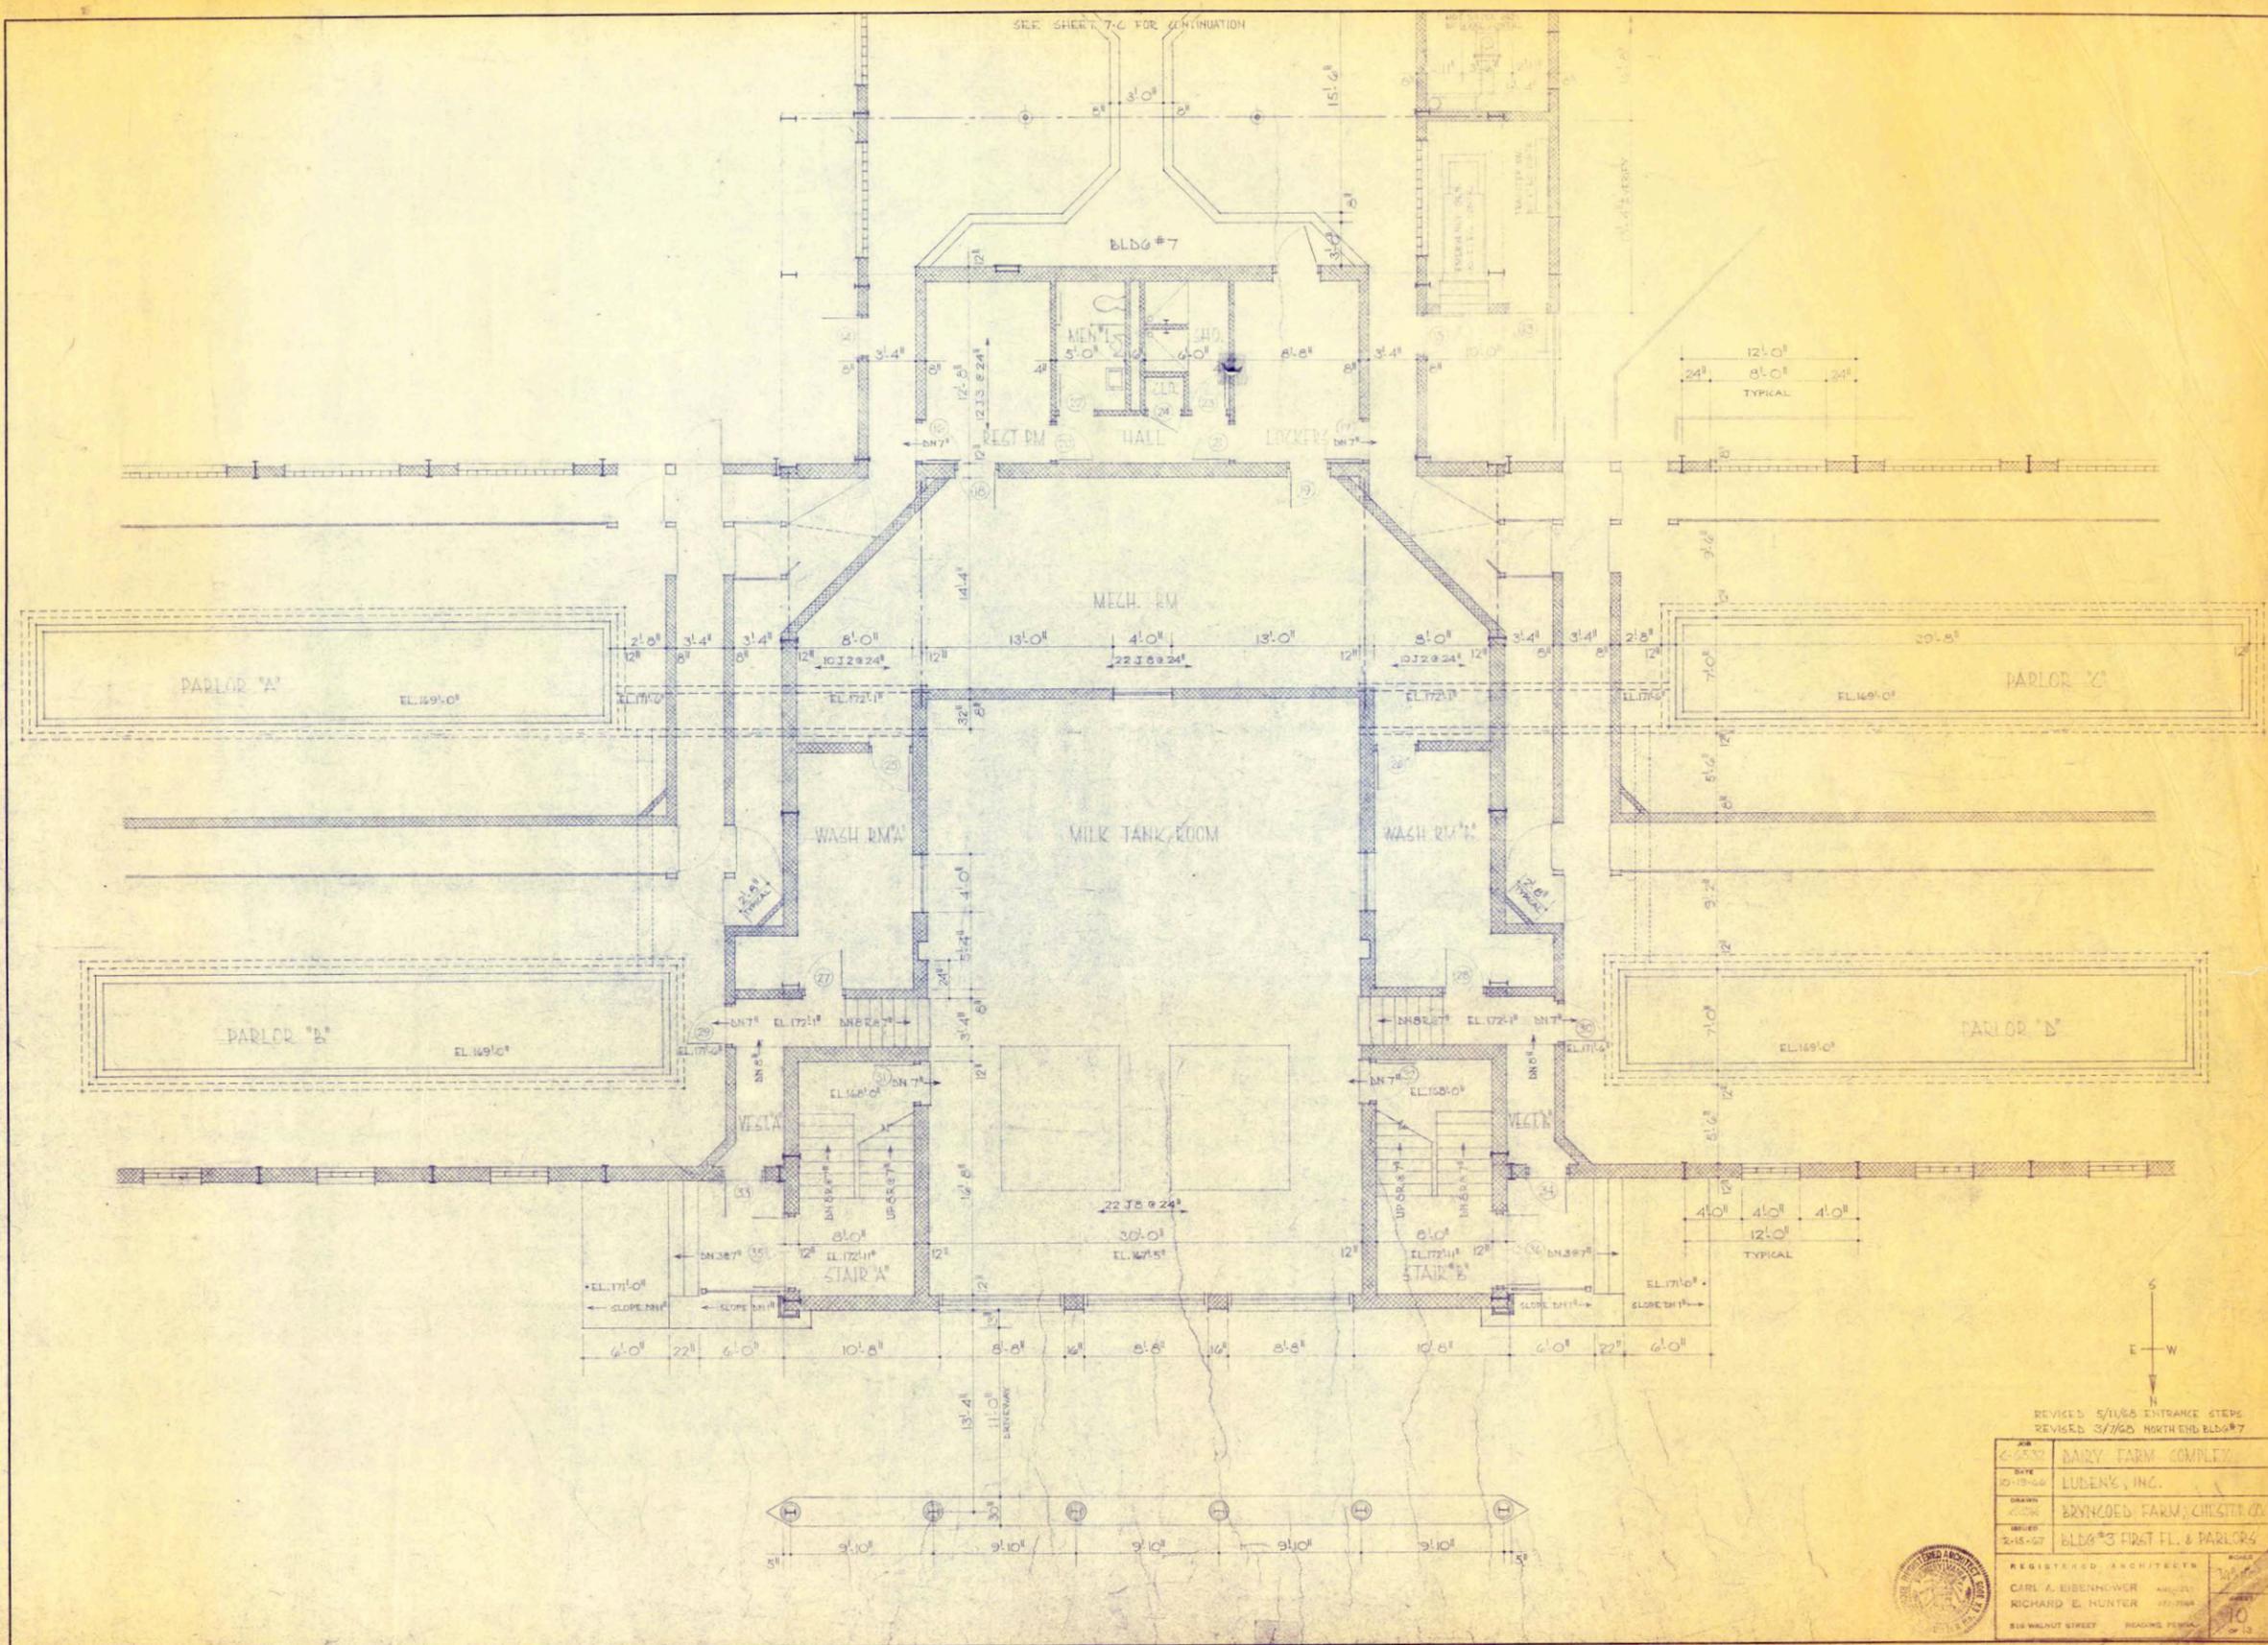
4 - Building 3 First Floorplan.
